June 8, 2011

ENT-LTR-7011-62

**Re: Summary Report for 8-Acre Cap and Site Problem Areas
National Zinc Company Site, Montgomery County, Kansas
KDHE Project #C3-063-00026
Consent Order: 03-E-0022**

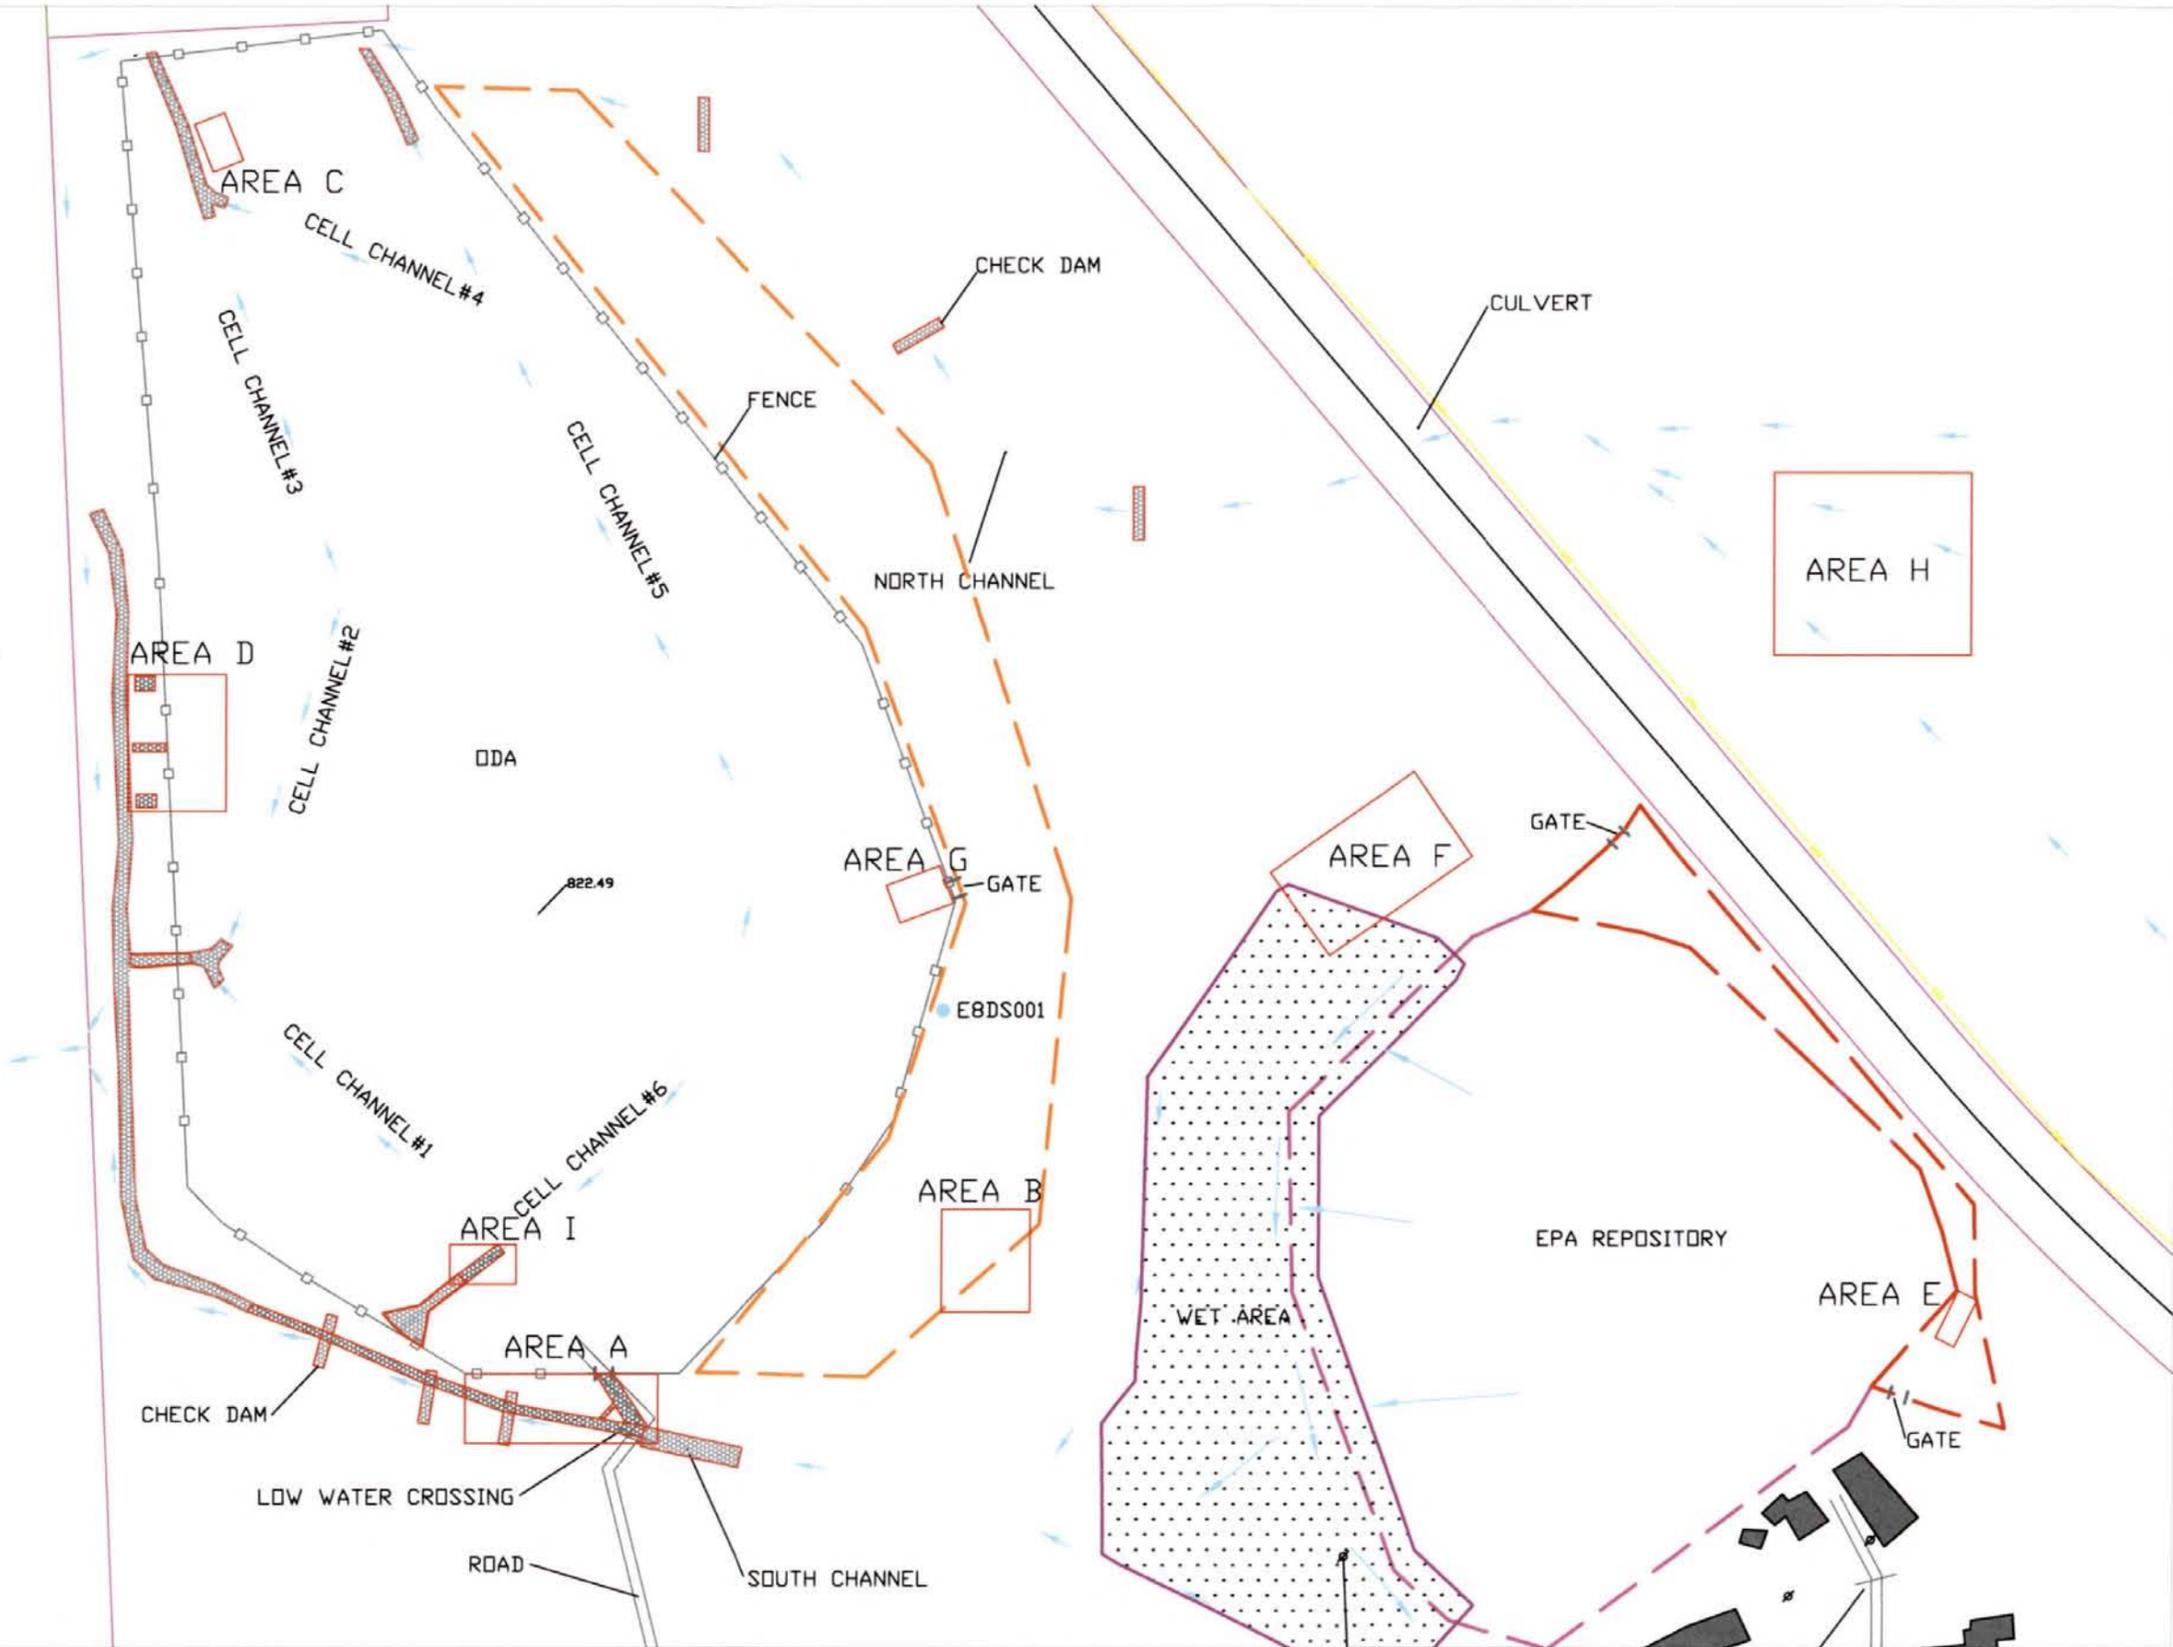
Several areas onsite required repairs due to erosion or poor vegetative growth. Erosion and inadequate vegetation growth have been routinely observed in the area north of the south drainage channel (Area A of Figure 2) although the area has been re-seeded multiple times. Soil was imported from the borrow source to this area to repair rills and grade the area to reduce the slope from the Onsite Disposal Area (ODA) to the southern drainage channel. It was determined to place topsoil in this area to increase the organic content of the soil to allow for vegetative growth. Following grading activities, the area was drill seeded with the native grass seed mixture previously recommended by the NRCS Representative. This area was also drill seeded with an annual rye grass to quickly establish vegetative growth in the area to prevent erosion from occurring before the native seed has time to establish. Temporary erosion control measures in the form of hay bales were placed along approximately 300 feet of disturbed area along the fence between the ODA and the south drainage swale and will remain in place until the vegetation is adequately established.

Two areas in the south portion of the 8-Acre Cap had not grown vegetation in previous attempts (Area B, Figure 2). The top four inches of soil in these two areas was excavated and placed in the temporary stockpile area. Topsoil was placed on these areas, graded, re-seeded and mulched in concurrence with the 8-Acre Cap repairs.

Erosion along the north and west slopes of the ODA was addressed during the 8-Acre Cap repair (Area C and D respectively, Figure 2). Three areas along the western slope of the ODA and one area along the north slope of the ODA had significant erosional rills. Soil was imported from the offsite borrow source, placed and compacted in the areas with rill erosion. The areas were then re-seeded and mulched. Silt fence was re-installed along the slopes of the ODA where it had come down.

Standing water was prevalent in the Wedge Area and along the fenceline where surface water drained from the southeast corner of the EPA Repository (Area E, Figure 2). The existing soil was graded to allow the standing water to drain. When the area was dry enough to proceed, soil was imported to fill the area and graded to allow sheet flow from the EPA Repository to continue to drain to the southeast. After grading activities were complete, the Wedge area was re-seeded and mulched.

Poor vegetation was prevalent in two areas northwest of the EPA Repository (Area F, Figure 2) and at the gate located on the east side of the ODA (Area G, Figure 2). Topsoil was imported to these locations, graded to achieve positive drainage, re-seeded and mulched.

Erosion repairs north of the southern drainage swale (Area A of Figure 2) were made using rip rap and soil import. Rip rap was installed along the south drainage channel's northern slope to reduce washouts and scouring of vegetation where sheet flow and channeling of water had previously occurred from the ODA. Rip rap was installed along the northern slope of the south drainage swale from the low water crossing to the area of existing flowable fill with 8 ounce non-woven fabric placed beneath the rip rap armor as depicted in Area A of Figure 2.

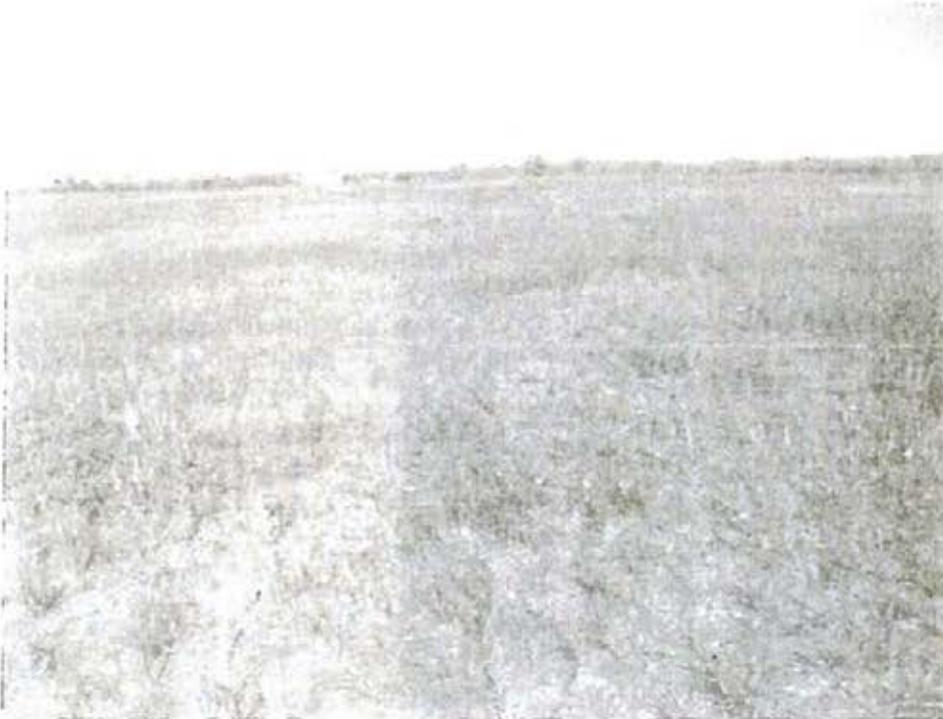
Photo 3

Comments Area with inadequate or deadened vegetation. Photo taken just north of the EPA Repository This and other areas were seed drilled by ENTACT in May 2009

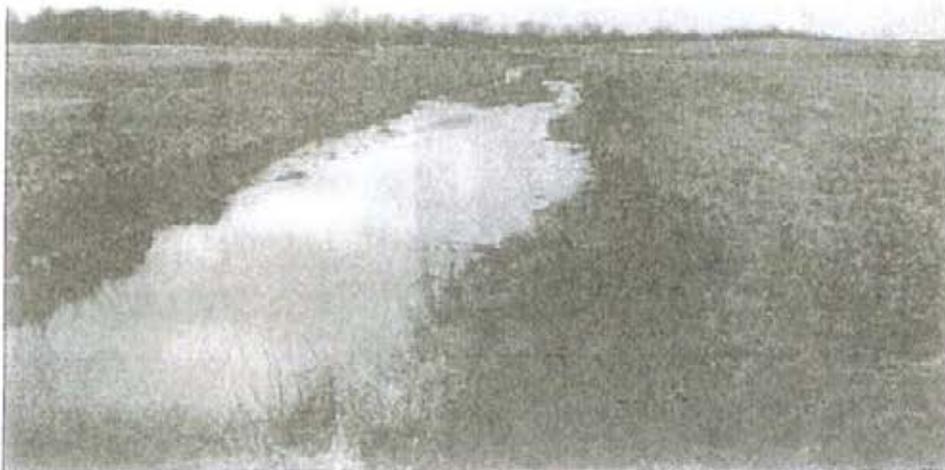
Comments Area of ponding along southern storm water drainage channel

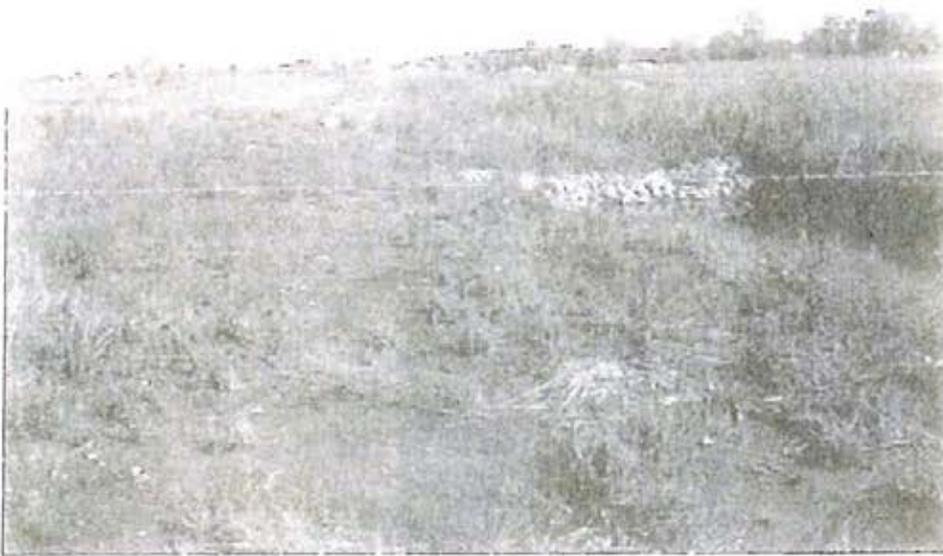
Photo 1

- 1) Place rip rap along southern drainage, – Inadequate vegetation and erosion are routinely noted north of the southern drainage swale where rip rap is not present between the low

Comments. Sparse vegetation and erosion along southern drainage where slope is not riprapped.

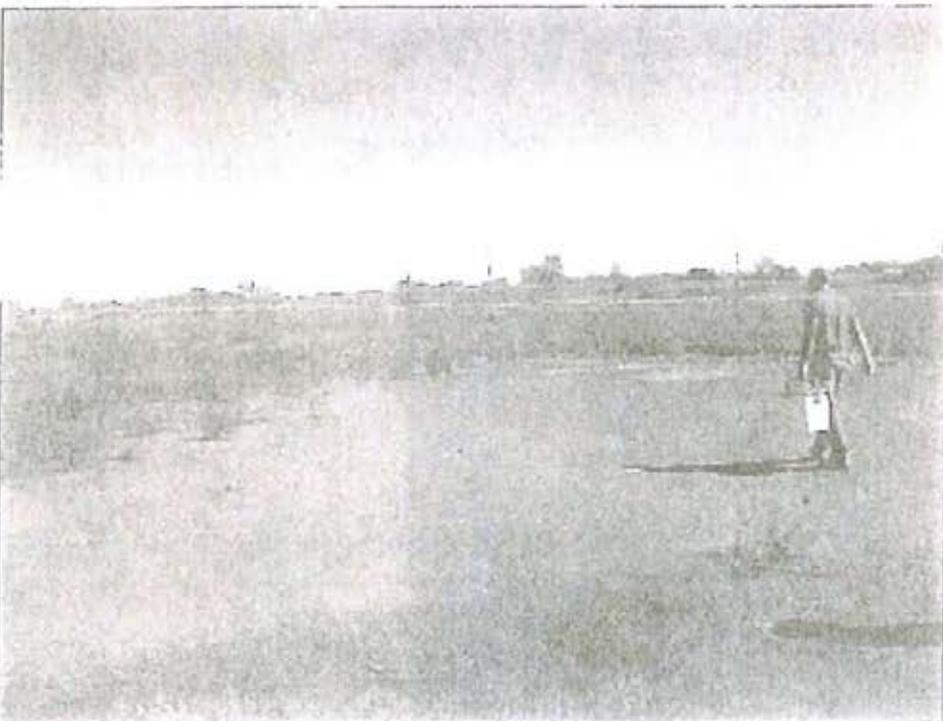
Photo 2

- 2) Revegetate bare spots within 8-Acre Cap Area, – Spots barren of vegetation are routinely noted within the 8-Acre Cap Area. Several attempts at reseeding these areas have been to no avail Refer to *Figure 1* and *Photo 2* As noted in post-Removal Action documents, the existing cover and vegetation on the 8-Acre Cap Area were left intact and not supplemented. However, this area is a capped structure that must have an effective vegetative cover as required of other capped areas at the Site. Therefore, KDHE/BER requests that necessary supplements or additional top soil be provided to augment reseeding efforts.

Comments. Spot barren of vegetation routinely noted after multiple reseeding efforts.

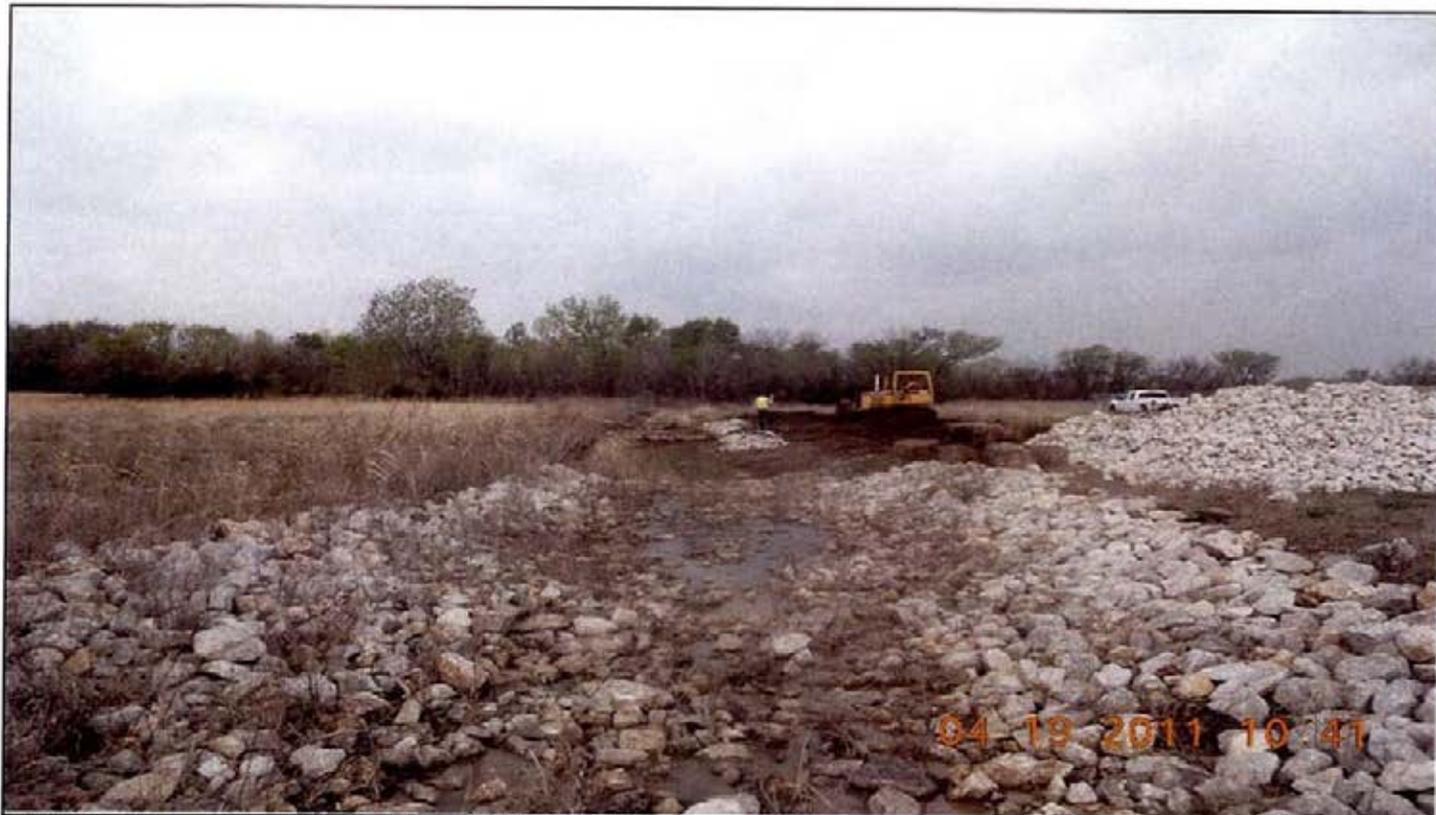
PHOTOGRAPH:	1	PHOTOGRAPHER:	RR
DATE:	19-Apr-11	TIME:	1041
PROJECT:	8-Acre Cap Repair Work Cherryvale Kansas April-May 2011		
SUBJECT:	Installation of rip rap along northern slope of southern drainage channel

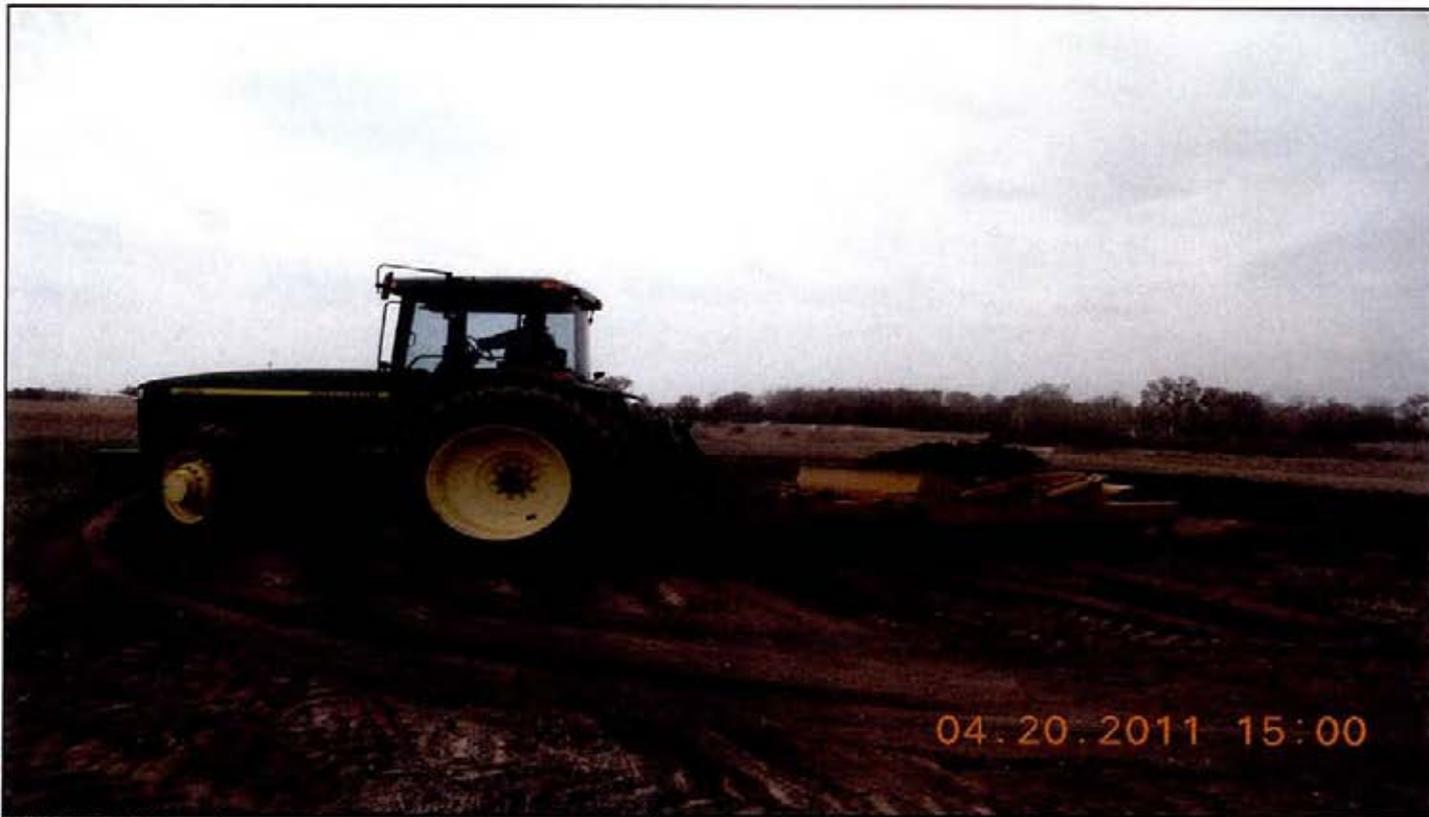
PHOTOGRAPH:	3	PHOTOGRAPHER:	RR
DATE:	20-Apr-11	TIME:	1500
PROJECT:	8-Acre Cap Repair Work Cherryvale Kansas April-May 2011		
SUBJECT:	Removal of material in sparsely vegetated areas of southern section of 8-Acre Cap

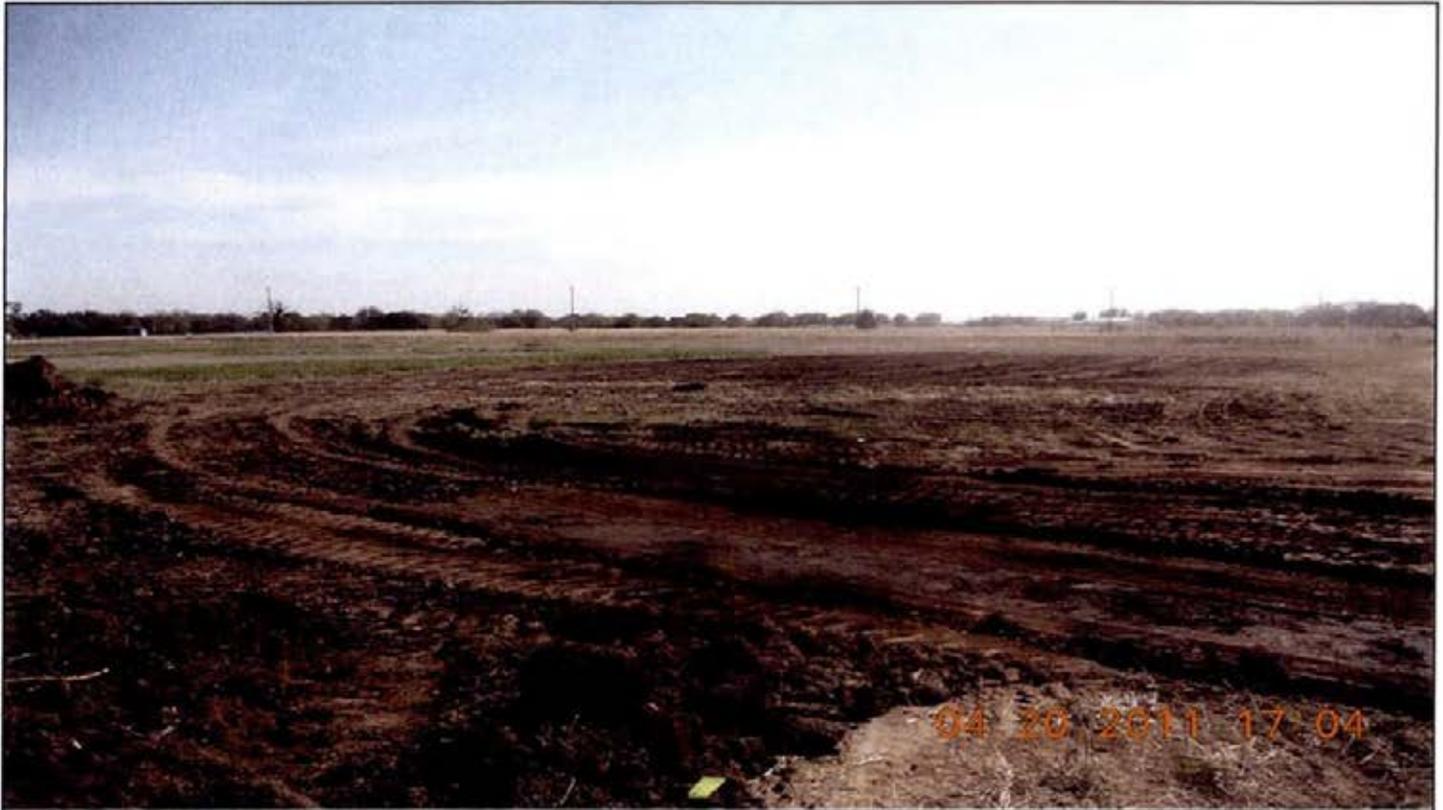
PHOTOGRAPH:	5	PHOTOGRAPHER:	RR
DATE:	20-Apr-11	TIME:	1704
PROJECT:	8-Acre Cap Repair Work Cherryvale Kansas April-May 2011		
SUBJECT:	Two excavated areas of southern section of 8-Acre Cap

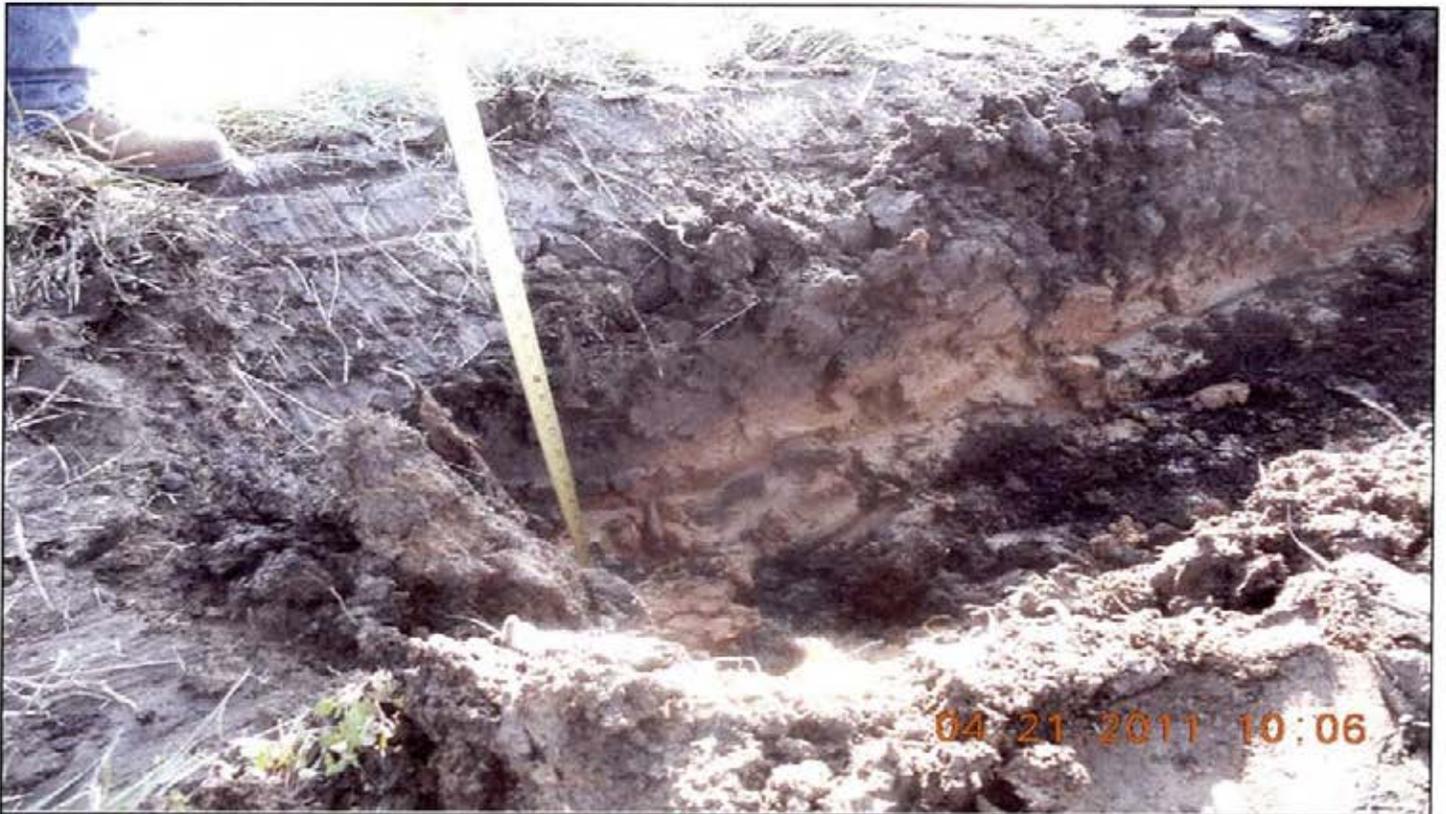
PHOTOGRAPH:	7	PHOTOGRAPHER:	RR
DATE:	21-Apr-11	TIME:	1006
PROJECT:	8-Acre Cap Repair Work Cherryvale Kansas April-May 2011		
SUBJECT:	Measurement of clean cap material over slag in 8-Acre Cap drainage swale excavation

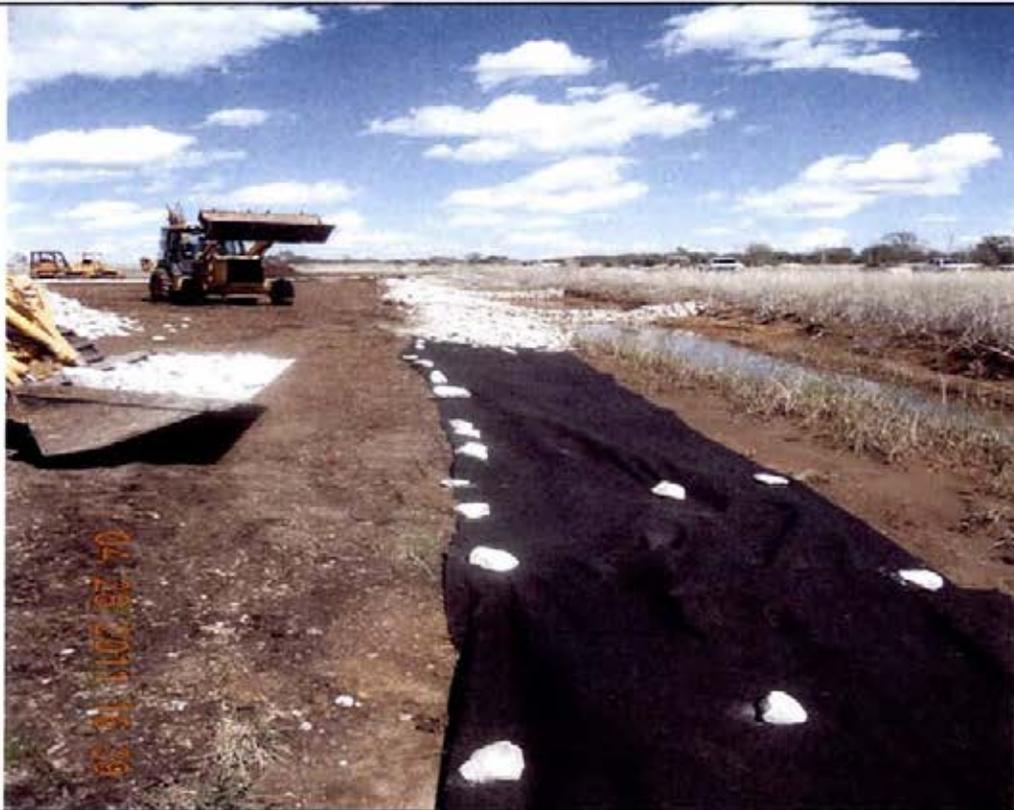
PHOTOGRAPH:	11	PHOTOGRAPHER:	RR
DATE:	28-Apr-11	TIME:	1639
PROJECT:	8-Acre Cap Repair Work Cherryvale Kansas April-May 2011		
SUBJECT:	Installation of rip rap and fabric on northern slope of southern drainage swale

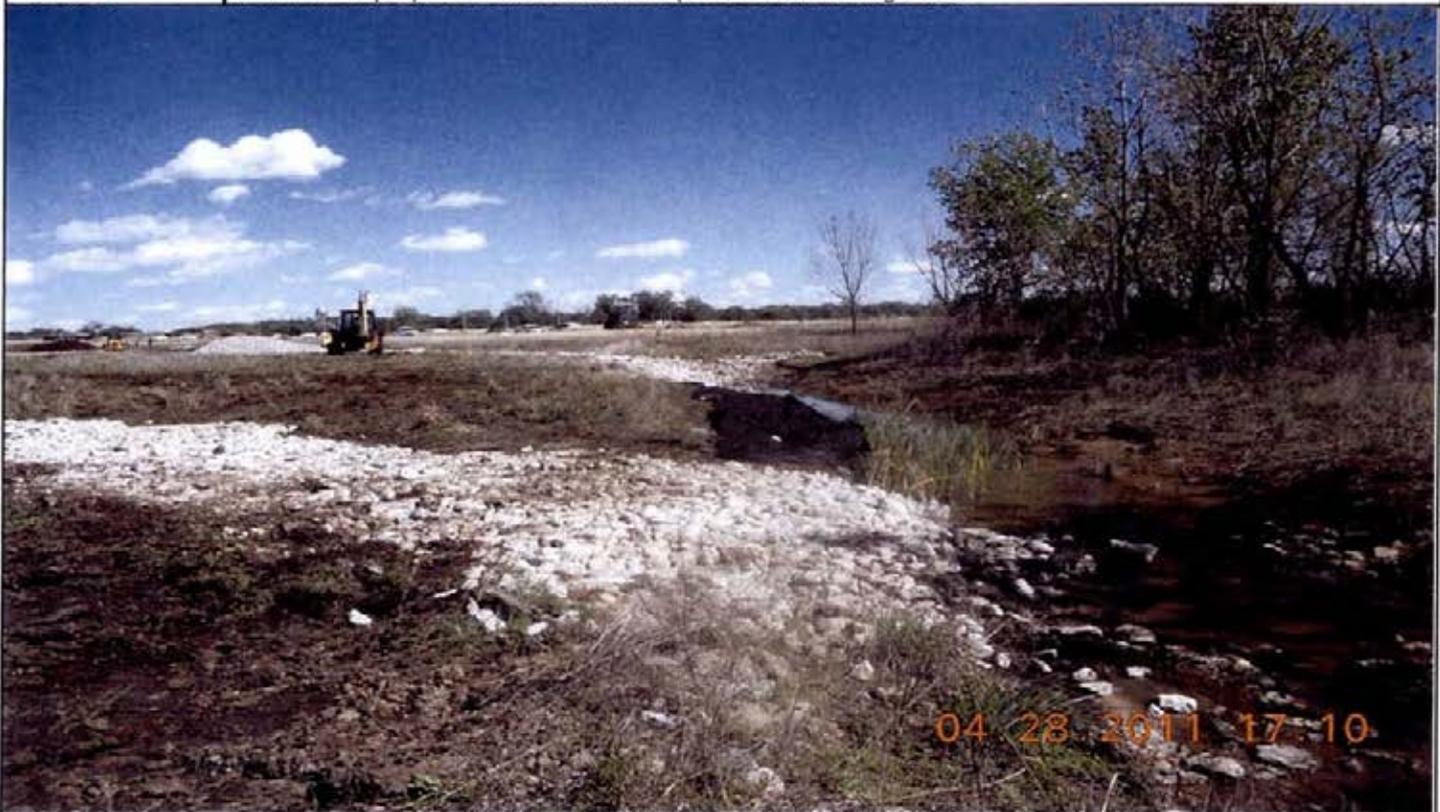
PHOTOGRAPH:	12	PHOTOGRAPHER:	RR
DATE/TIME:	28-Apr-11	TIME:	1710
PROJECT:	8-Acre Cap Repair Work Cherryvale Kansas April-May 2011		
SUBJECT:	Installation of rip rap along southwest corner of ODA where erosion continually occurs

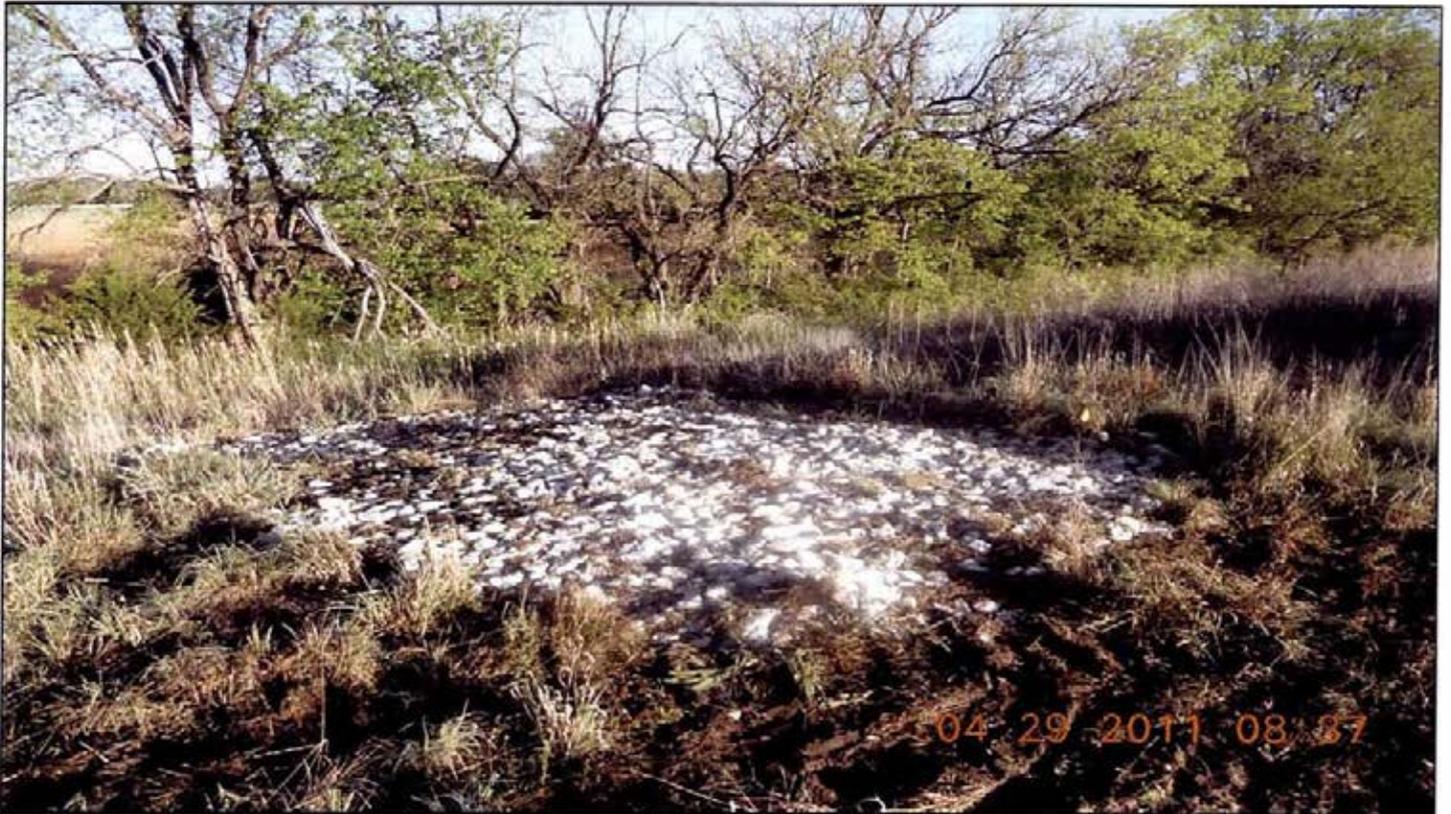
PHOTOGRAPH:	13	PHOTOGRAPHER:	RR
DATE:	29-Apr-11	TIME:	837
PROJECT:	8-Acre Cap Repair Work Cherryvale Kansas April-May 2011		
SUBJECT:	Repair of erosional rills and installation of rip rap on western slope of ODA

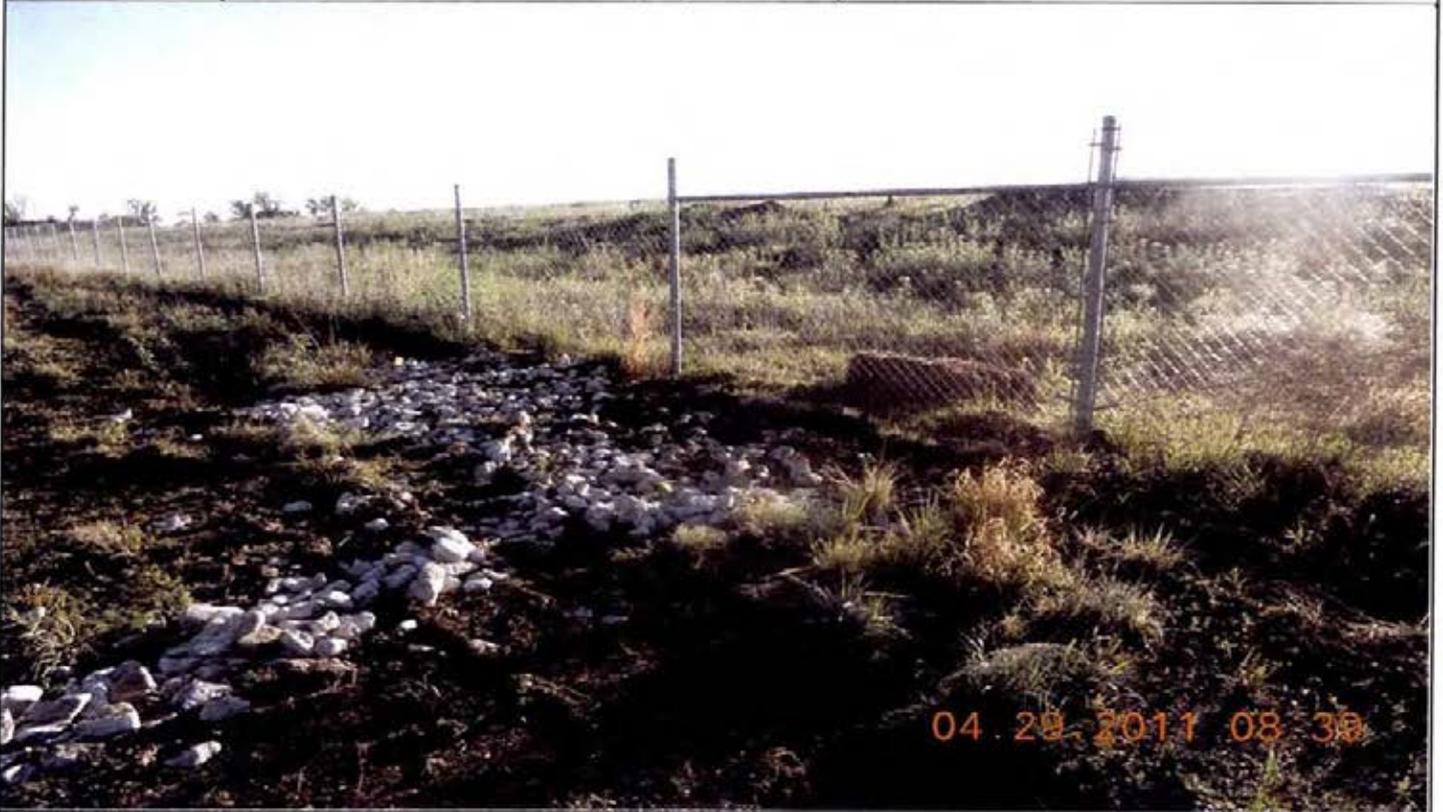
PHOTOGRAPH:	14	PHOTOGRAPHER:	RR
DATE/TIME:	29-Apr-11	TIME:	839
PROJECT:	8-Acre Cap Repair Work Cherryvale Kansas April-May 2011		
SUBJECT:	Repair of erosional rills and installation of rip rap on western slope of ODA

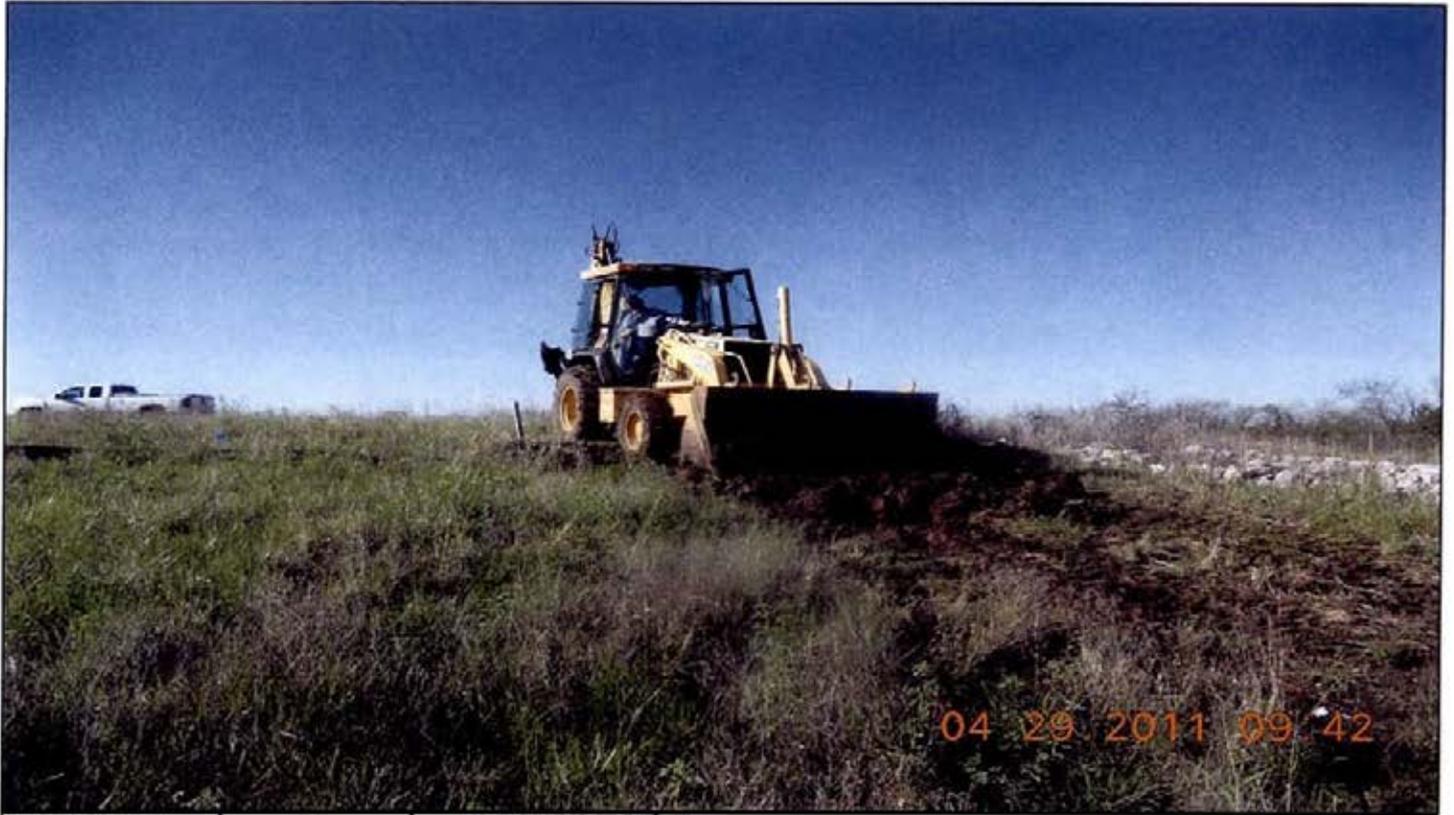
PHOTOGRAPH:	15	PHOTOGRAPHER:	RR
DATE:	29-Apr-11	TIME:	942
PROJECT:	8-Acre Cap Repair Work Cherryvale Kansas April-May 2011		
SUBJECT:	Repair of erosional rills on north side of ODA

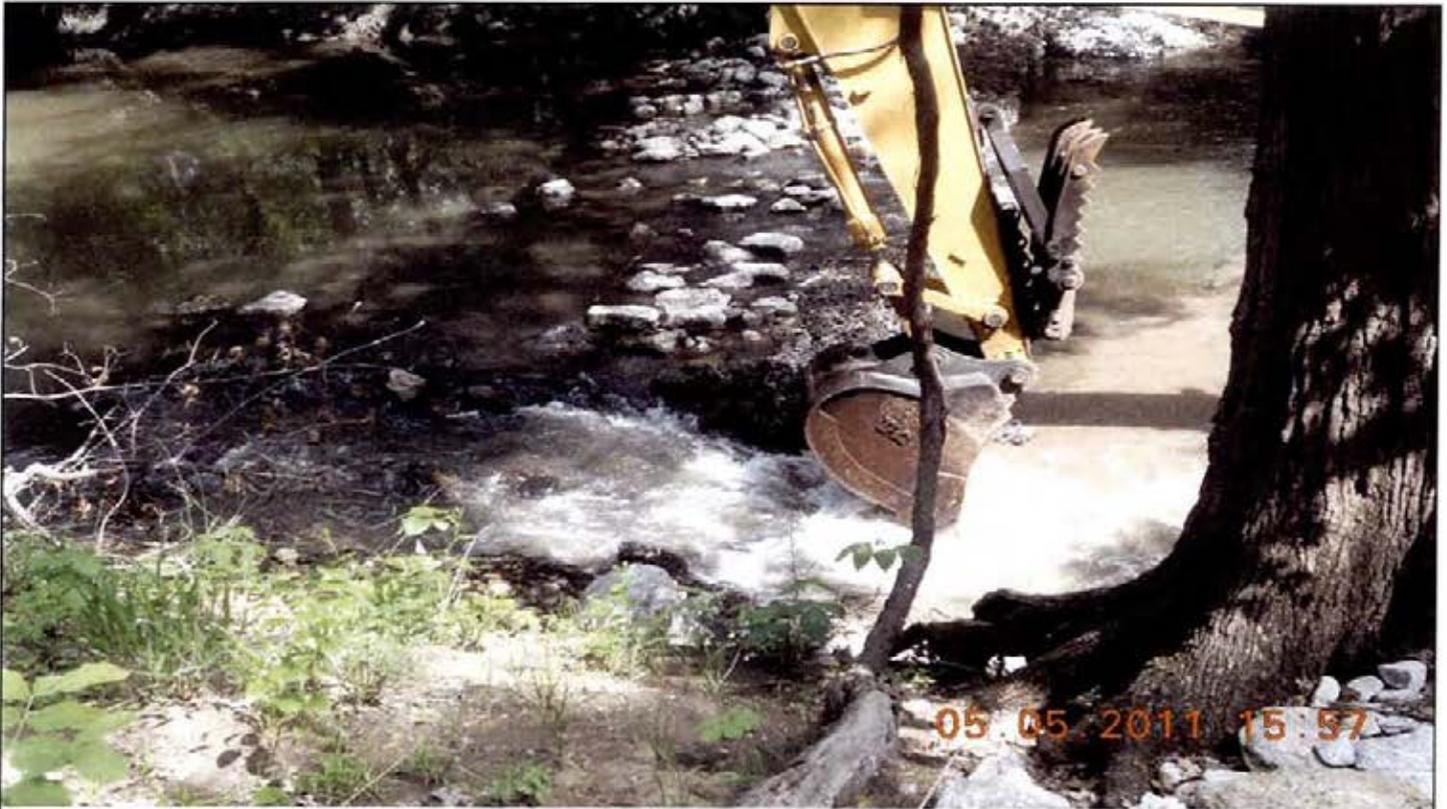
PHOTOGRAPH:	25	PHOTOGRAPHER:	RR
DATE:	5-May-11	TIME:	1557
PROJECT:	8-Acre Cap Repair Work Cherryvale Kansas April-May 2011		
SUBJECT:	Repair of upstream dike of CDS

The gabion basket installation of the Catchment Dike System (CDS) installed in the fall of 2010, appears to be working well. As noted in the Respondents letter dated April 8, 2011, the upstream dike of the CDS located in Drum Creek was in need of minor repair. During the current mobilization, the upstream dike was repaired and tied into the western bank of Drum Creek. Three gabion baskets were installed along the west bank of the upstream dike and filled the previously approved rip rap source having a predominant size of 6.5 inches (average 4 inches).

Prior to the installation of the gabions, loose material and all foreign matter were removed from the creek bed. The gabions were carefully filled with rock, by machine and hand methods, maintaining alignment, avoiding bulges, and providing a compact mass that minimizes voids. Basket lids were stretched tight over the rock until it met the perimeter edges of the front and end panels and secured. Gabion walls were re-constructed to coincide with the top elevations of the dike and tied into the slope of Drum Creek. Reclaimed rip rap was utilized to fill in the void spaces between the toe of the reconstructed dike and the face of the gabion reinforcement wall.

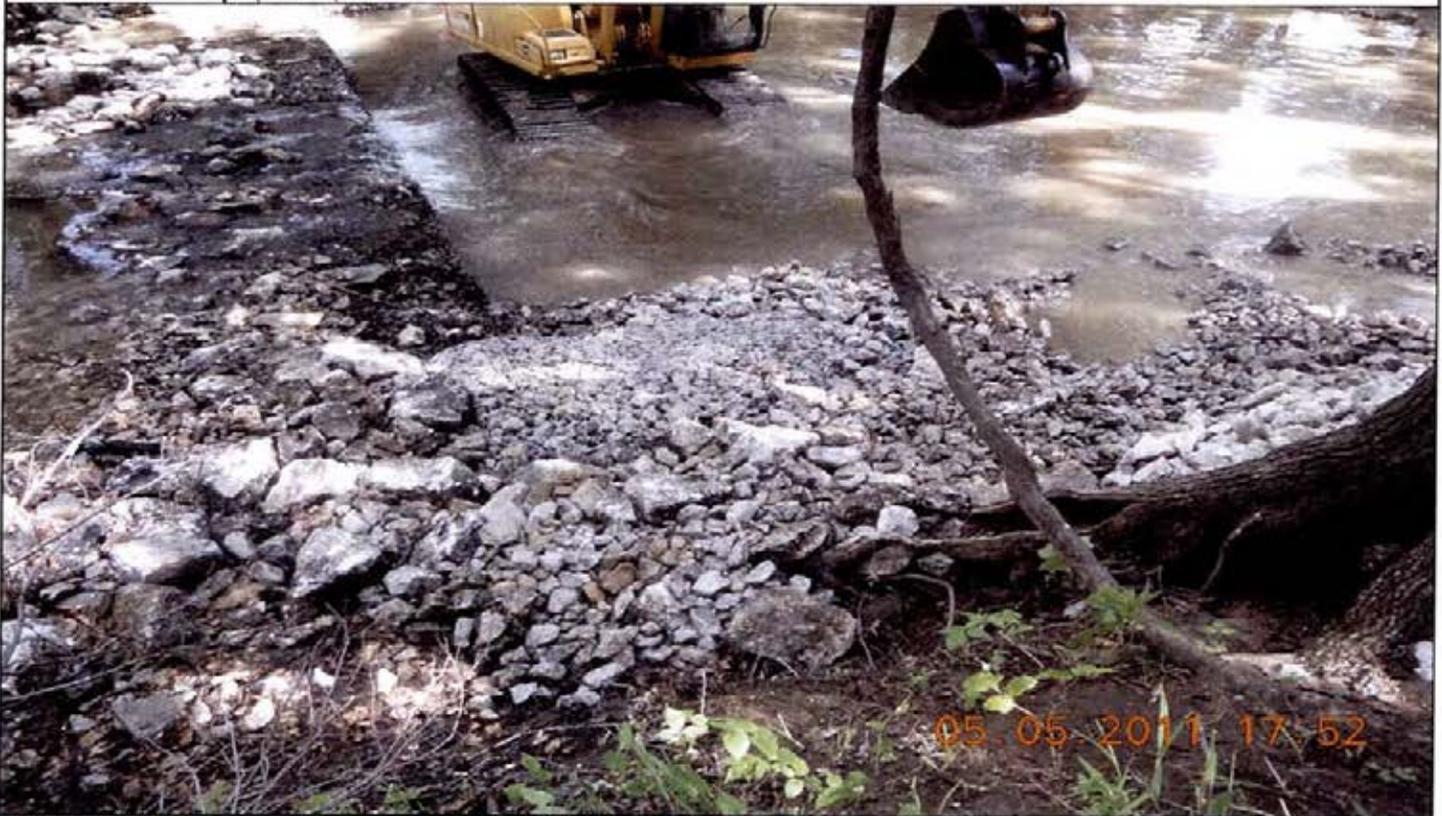
PHOTOGRAPH:	26	PHOTOGRAPHER:	RR
DATE/TIME:	5-May-11	TIME:	1752
PROJECT:	8-Acre Cap Repair Work Cherryvale Kansas April-May 2011		
SUBJECT:	Repair of upstream dike of CDS

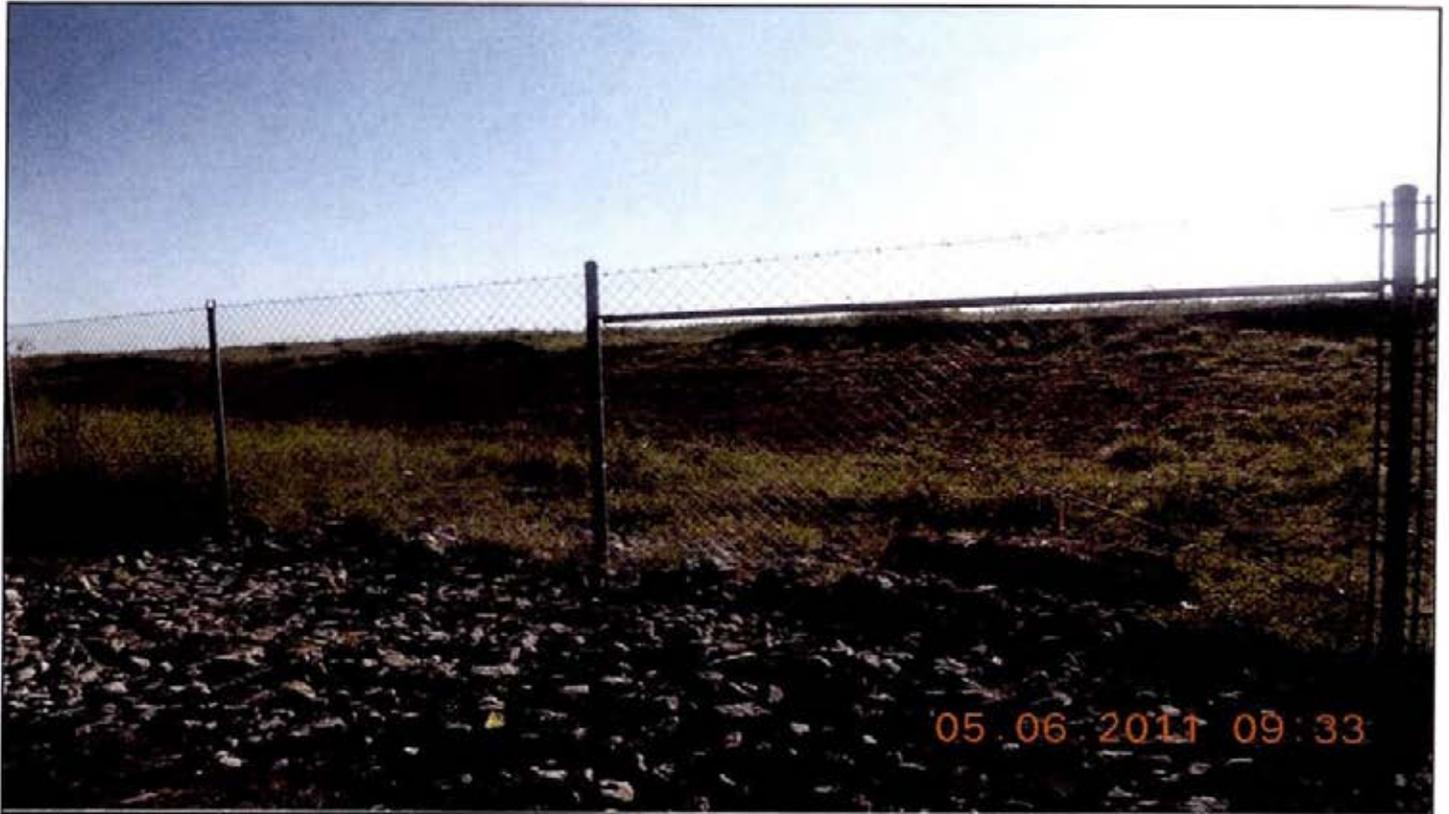
PHOTOGRAPH:	27	PHOTOGRAPHER:	RR
DATE:	6-May-11	TIME:	933
PROJECT:	8-Acre Cap Repair Work Cherryvale Kansas April-May 2011		
SUBJECT:	Repair of erosional rills west slope of ODA

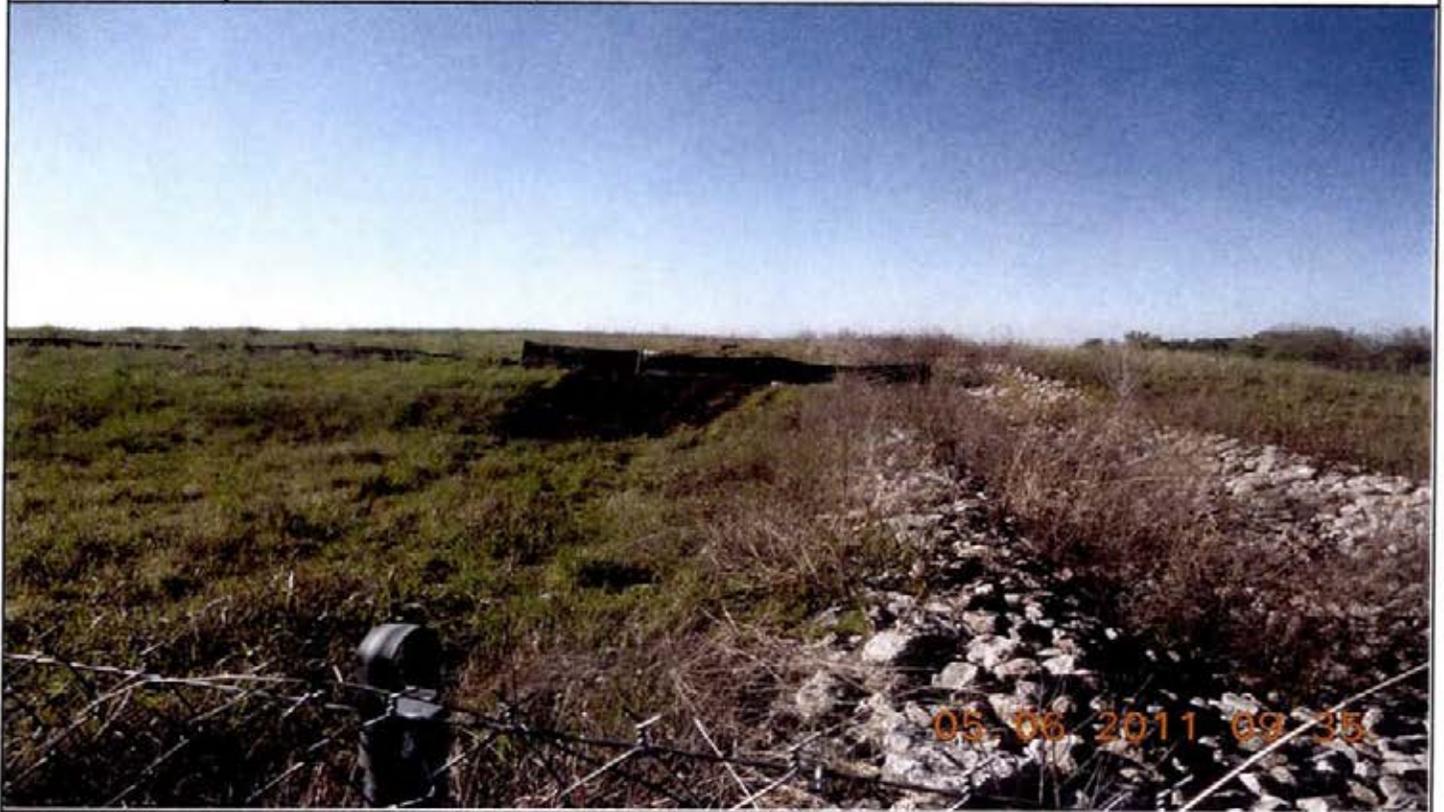
PHOTOGRAPH:	28	PHOTOGRAPHER:	RR
DATE/TIME:	6-May-11	TIME:	935
PROJECT:	8-Acre Cap Repair Work Cherryvale Kansas April-May 2011		
SUBJECT:	Repair of erosional rills north slope of ODA
