June 8, 2011

ENT-LTR-7011-62

**Re: Summary Report for 8-Acre Cap and Site Problem Areas
National Zinc Company Site, Montgomery County, Kansas
KDHE Project #C3-063-00026
Consent Order: 03-E-0022**

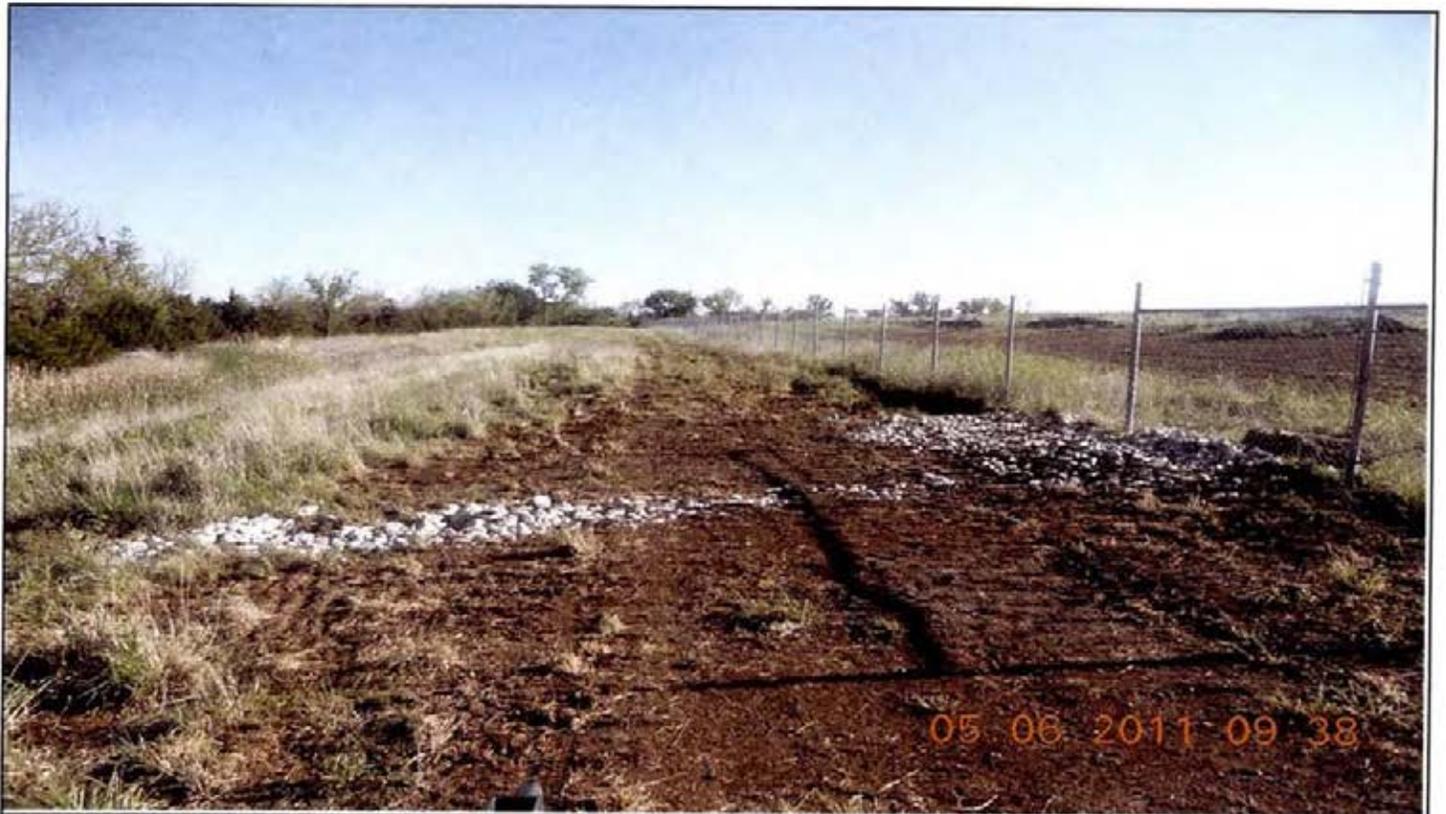
PHOTOGRAPH:	29	PHOTOGRAPHER:	RR
DATE:	6-May-11	TIME:	938
PROJECT:	8-Acre Cap Repair Work Cherryvale Kansas April-May 2011		
SUBJECT:	Repair of erosional rills west slope of ODA-outside fence

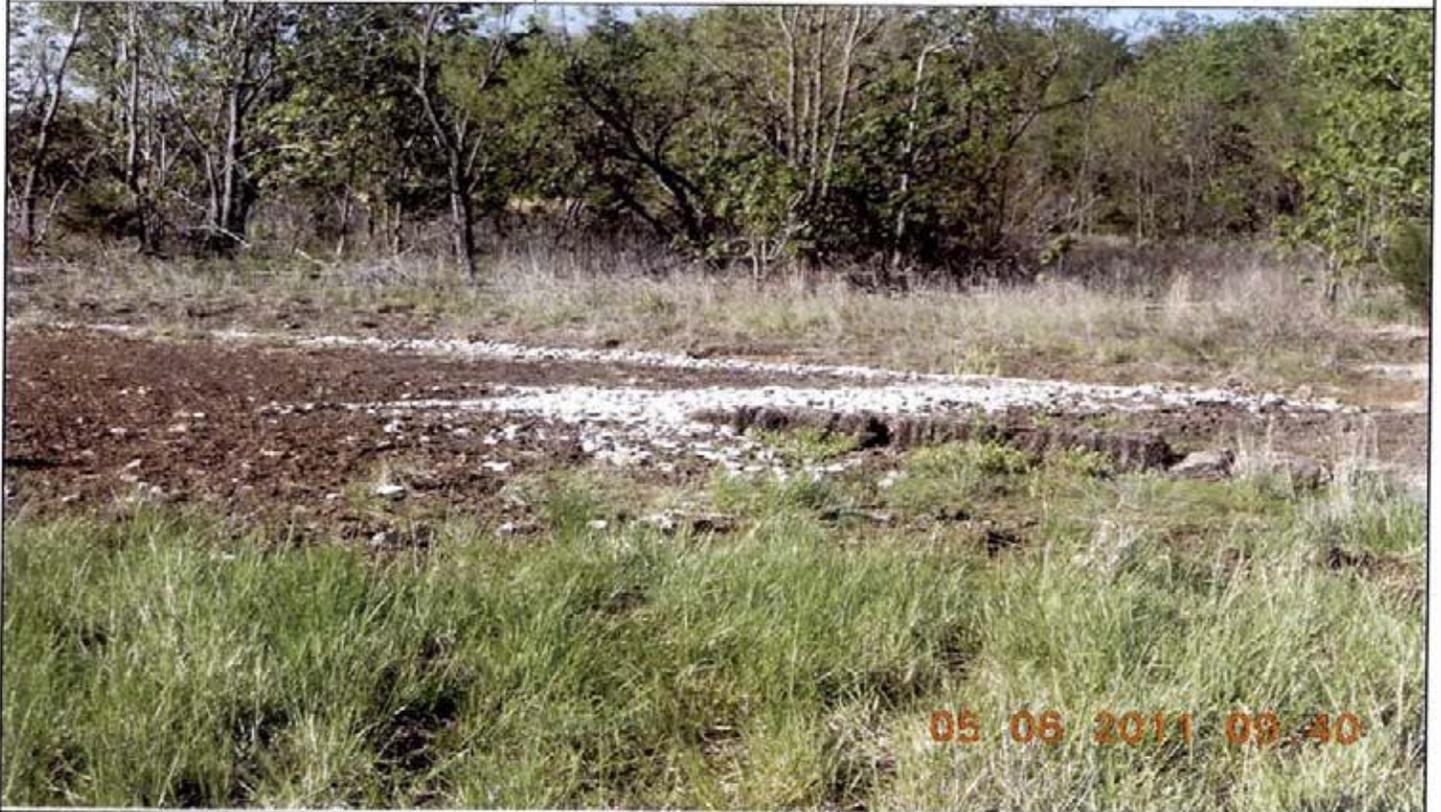
PHOTOGRAPH:	30	PHOTOGRAPHER:	RR
DATE/TIME:	6-May-11	TIME:	940
PROJECT:	8-Acre Cap Repair Work Cherryvale Kansas April-May 2011		
SUBJECT:	Repair of erosion southwest corner of ODA-outside fence at southern drainage swale

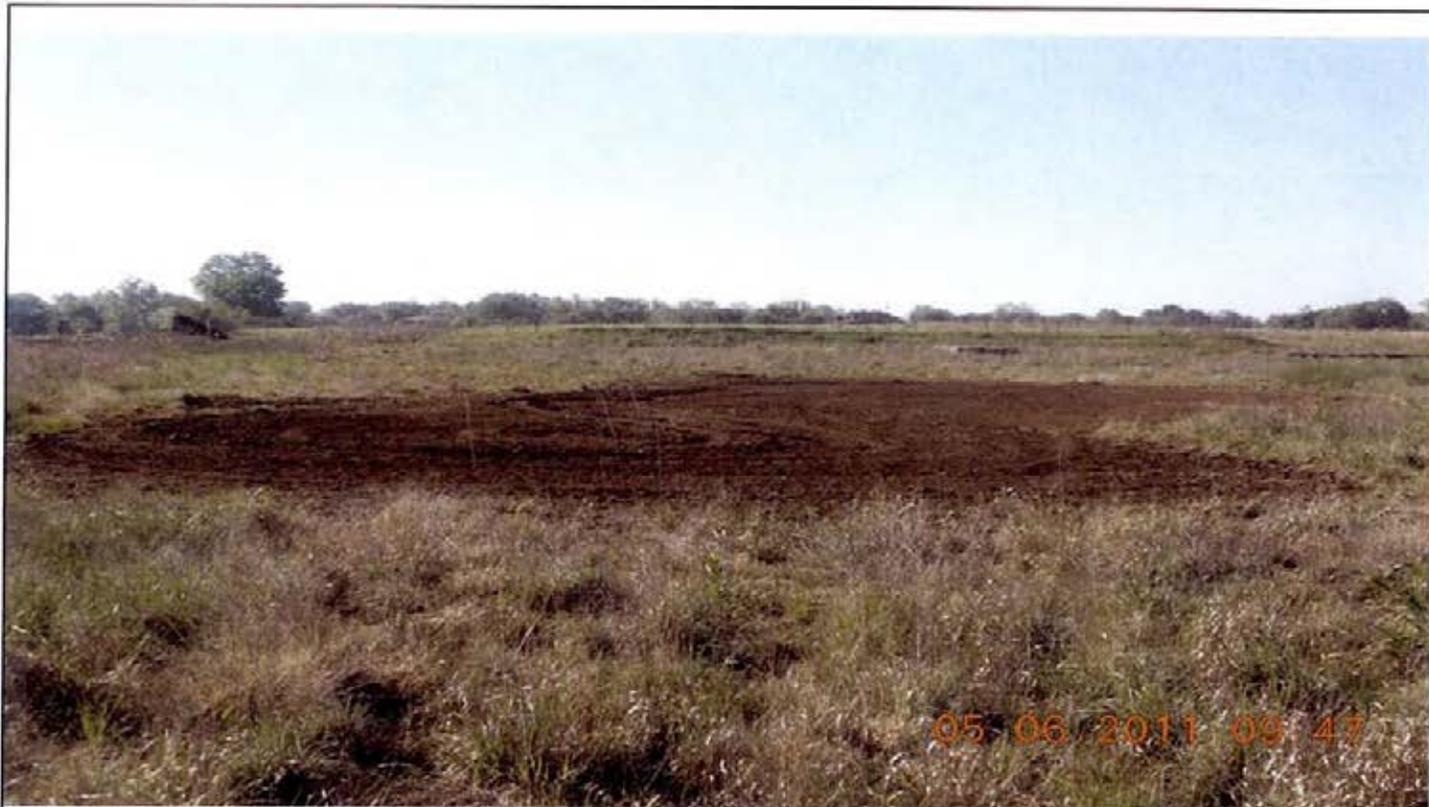
PHOTOGRAPH:	35	PHOTOGRAPHER:	RR
DATE:	6-May-11	TIME:	947
PROJECT:	8-Acre Cap Repair Work Cherryvale Kansas April-May 2011		
SUBJECT:	Topsoil applied to area north of EPA Repository with sparse vegetation

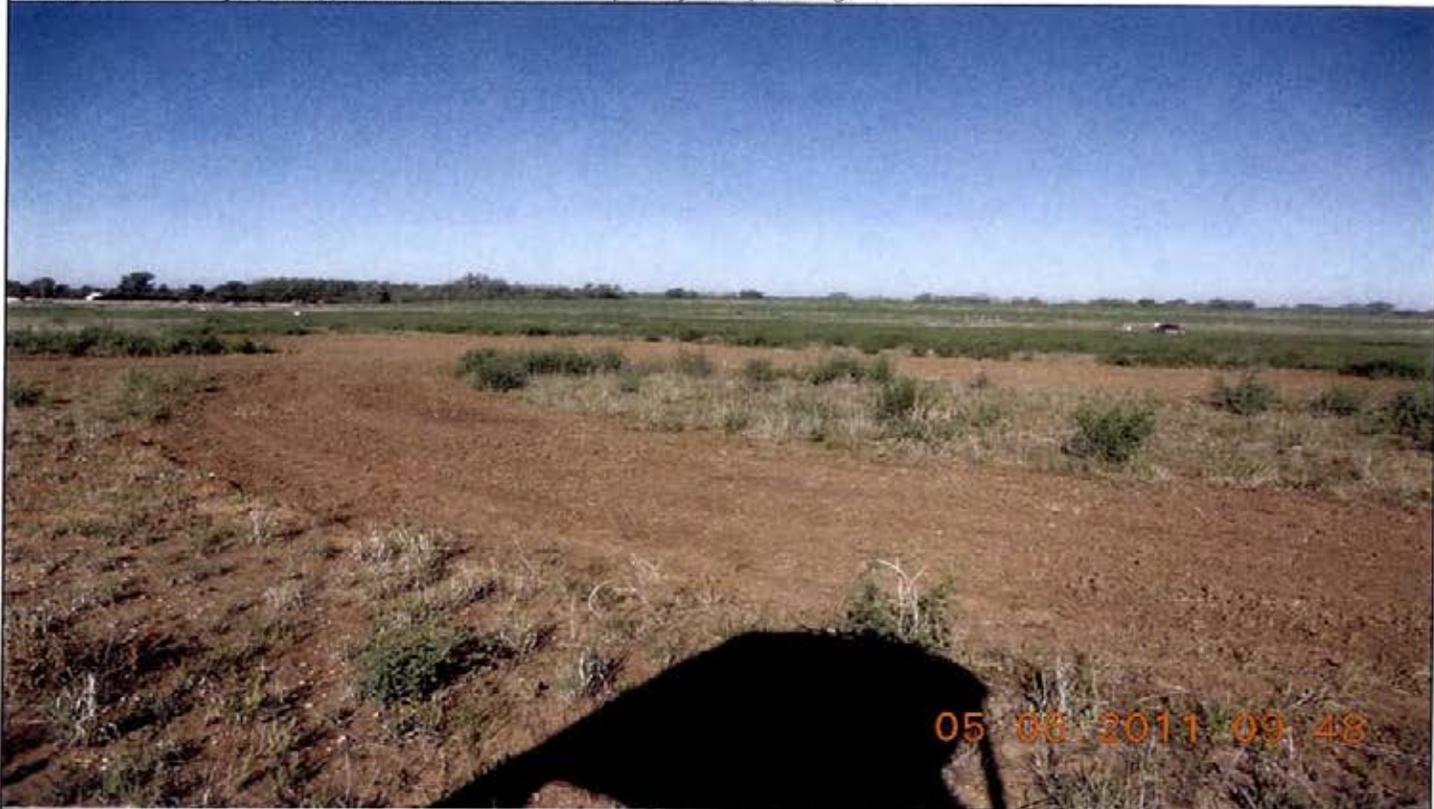
PHOTOGRAPH:	36	PHOTOGRAPHER:	RR
DATE/TIME:	6-May-11	TIME:	948
PROJECT:	8-Acre Cap Repair Work Cherryvale Kansas April-May 2011		
SUBJECT:	Topsoil applied to area north of EPA Repository with sparse vegetation

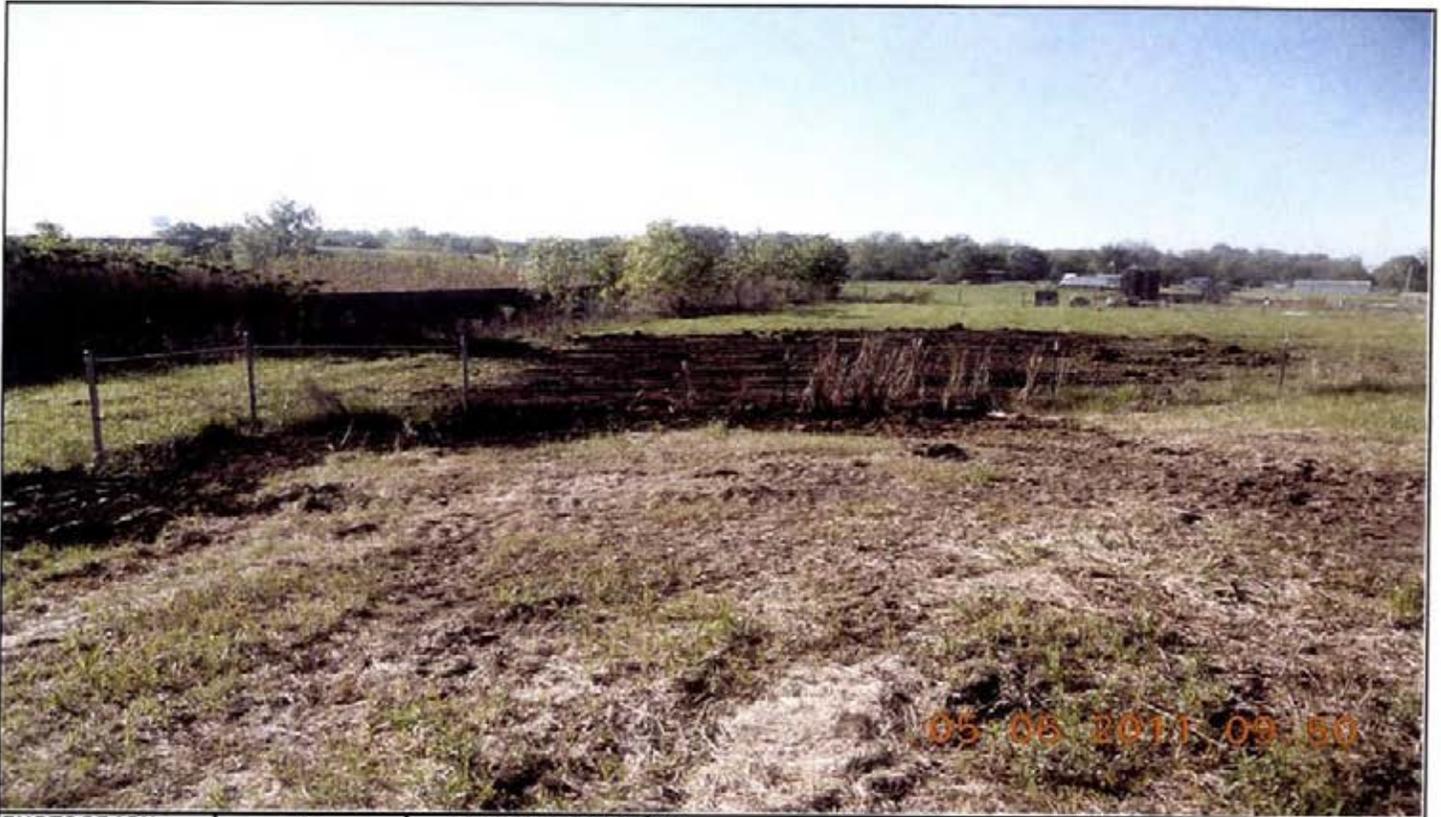
PHOTOGRAPH:	37	PHOTOGRAPHER:	RR
DATE:	6-May-11	TIME:	950
PROJECT:	8-Acre Cap Repair Work Cherryvale Kansas April-May 2011		
SUBJECT:	Repairs being made to Wedge area

Standing water was prevalent in the Wedge Area and along the fenceline where surface water drained from the southeast corner of the EPA Repository (Area E, Figure 2). The existing soil was graded to allow the standing water to drain. When the area was dry enough to proceed, soil was imported to fill the area and graded to allow sheet flow from the EPA Repository to continue to drain to the southeast. After grading activities were complete, the Wedge area was re-seeded and mulched.
