GEOLOGIC AND SOIL ENGINEERING REPORT
LAGOON EMBANKMENT EVALUATION
CHERRYVALE, KANSAS

NATIONAL ZINC COMPANY
BARTLESVILLE, OKLAHOMA 74003

June 9, 1978

WICHITA TESTING LABORATORIES
810 EAST MURDOCK
WICHITA, KANSAS 67214

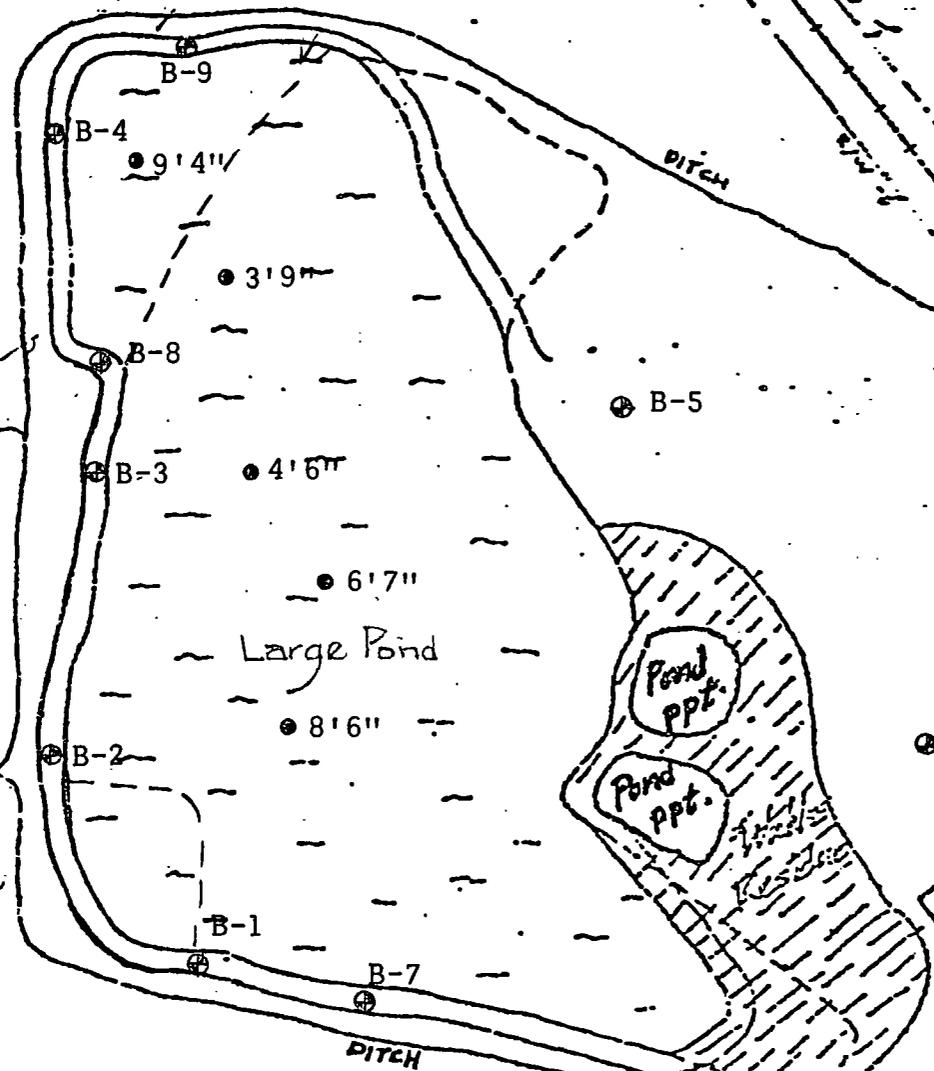
Figure 1

The boring locations are shown on the enclosed Figure No. 1. The boring logs (Figures 2 through 10) present data obtained in this exploration. The logs include the surface elevation; depths and elevations of major changes in the character of the subsurface materials; visual descriptions of the materials in accordance with the Unified Soil Classification System; groundwater data; penetration resistance recorded in 0.5 ft. increments of depth; and the location of undisturbed soil samples.

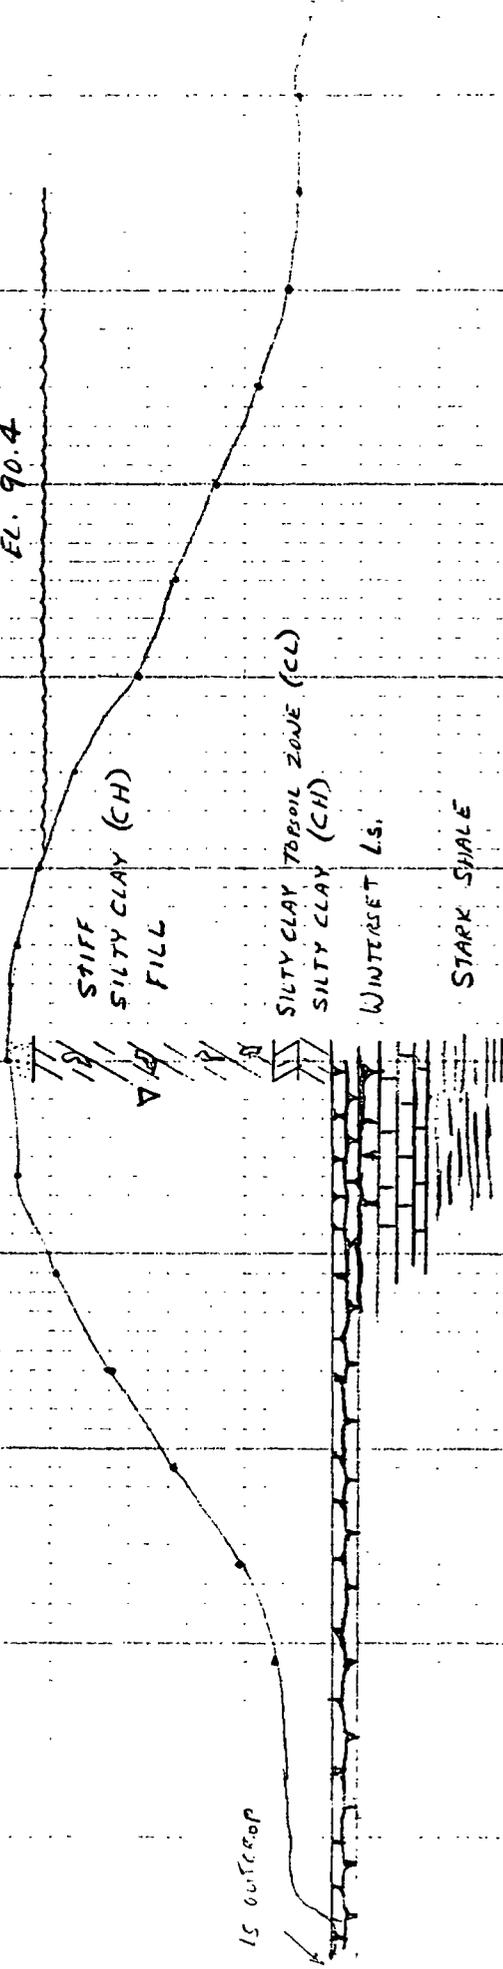
FIGURE 12

The soils encountered in the embankment portion of this site consist of medium and high plasticity (CL & CH) silty clay fill overlying the natural silty clay and sandy clay mantle soils which occur above the Winterset limestone. A thin topsoil zone was encountered below the fill in most borings and the entire embankment is capped with approximately one foot of cinder and brick used as a road bed. At the test hole locations the natural mantle soils, including topsoil zone, vary in thickness from 3 to 10 feet above bedrock. Geologic and Surface Profiles at the locations of Borings 1 through 4 are shown on the enclosed Figure Numbers 11 through 14 respectively.

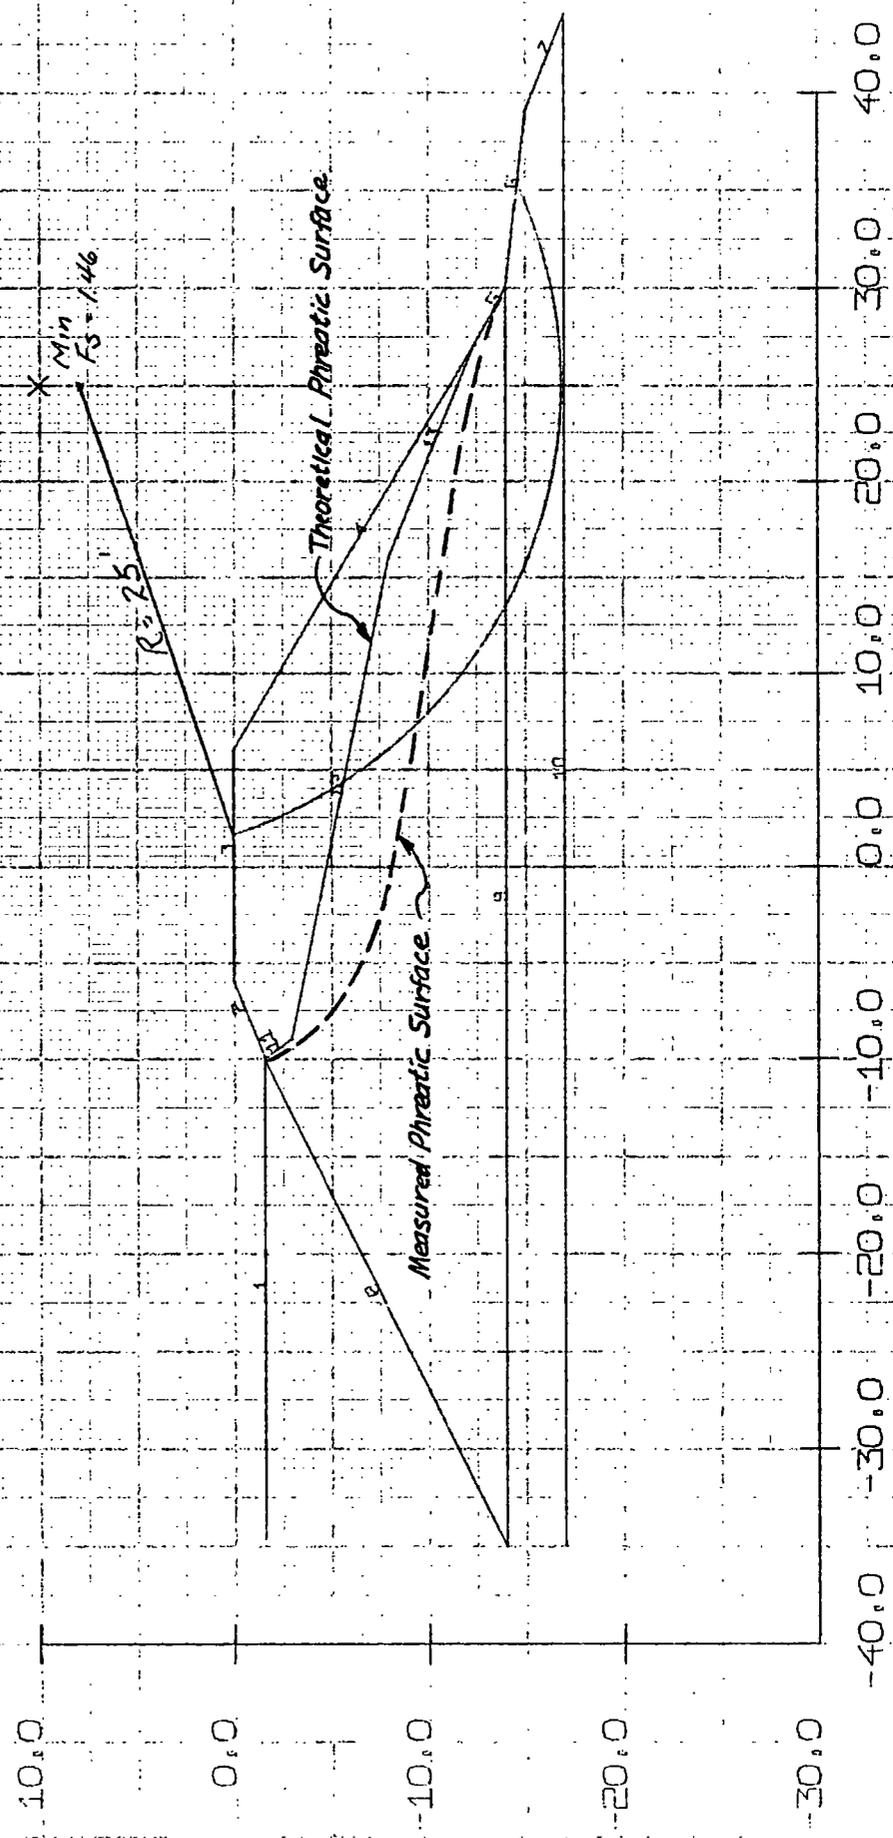
SLOPE STABILITY ANALYSIS
EMBANKMENT CROSS-SECTION

Computer analyses of slope stability were performed using the modified Swedish circle method for steady seepage conditions at the maximum section of the lagoon embankment (near Boring No. 2). In our analyses we assumed a downstream slope of 1.7 from the top of the embankment (about elevation 92.0) to the top of the natural ground surface (about elevation 79.6). The embankment section used in our analyses had a top width of 12 feet. We also used a 2:1 slope for the upstream slope (the side facing the lagoon). We made our analyses assuming that a theoretical phreatic surface would develop at the water level in the lagoon (at elevation 90.4 resulting in 1.6 feet of freeboard) and would extend to the toe of the downstream slope (about elevation 79.6). Effective stress shear parameters (\overline{CU}) were used for steady seepage analysis.

The safety factors for both normal and earthquake conditions were determined for the maximum section as described above. A safety factor of 1.46 was obtained for static conditions using a total of 184 trial arcs. This factor of safety met the 1.4 minimum requirement (SCS, TR-60). A factor of safety of 1.16 was obtained for earthquake conditions in a static analysis, assuming a horizontal acceleration of 0.10 g. This met the 1.0 minimum factor of safety requirement (SCS, TR-60).

The maximum section showing slope configurations, phreatic surface, soil contacts and the theoretical failure surface are shown graphically on the enclosed "Slope Stability Analysis - Embankment Cross-Section".
