REMOVAL ACTION SUMMARY REPORT
NATIONAL ZINC SITE – CHERRYVALE, KANSAS

Superfund Technical Assessment and Response Team (START) 2 Contract

December 17, 2002

Tetra Tech EM Inc.
8030 Flint Street
Lenexa, Kansas 66214
(913) 894-2600

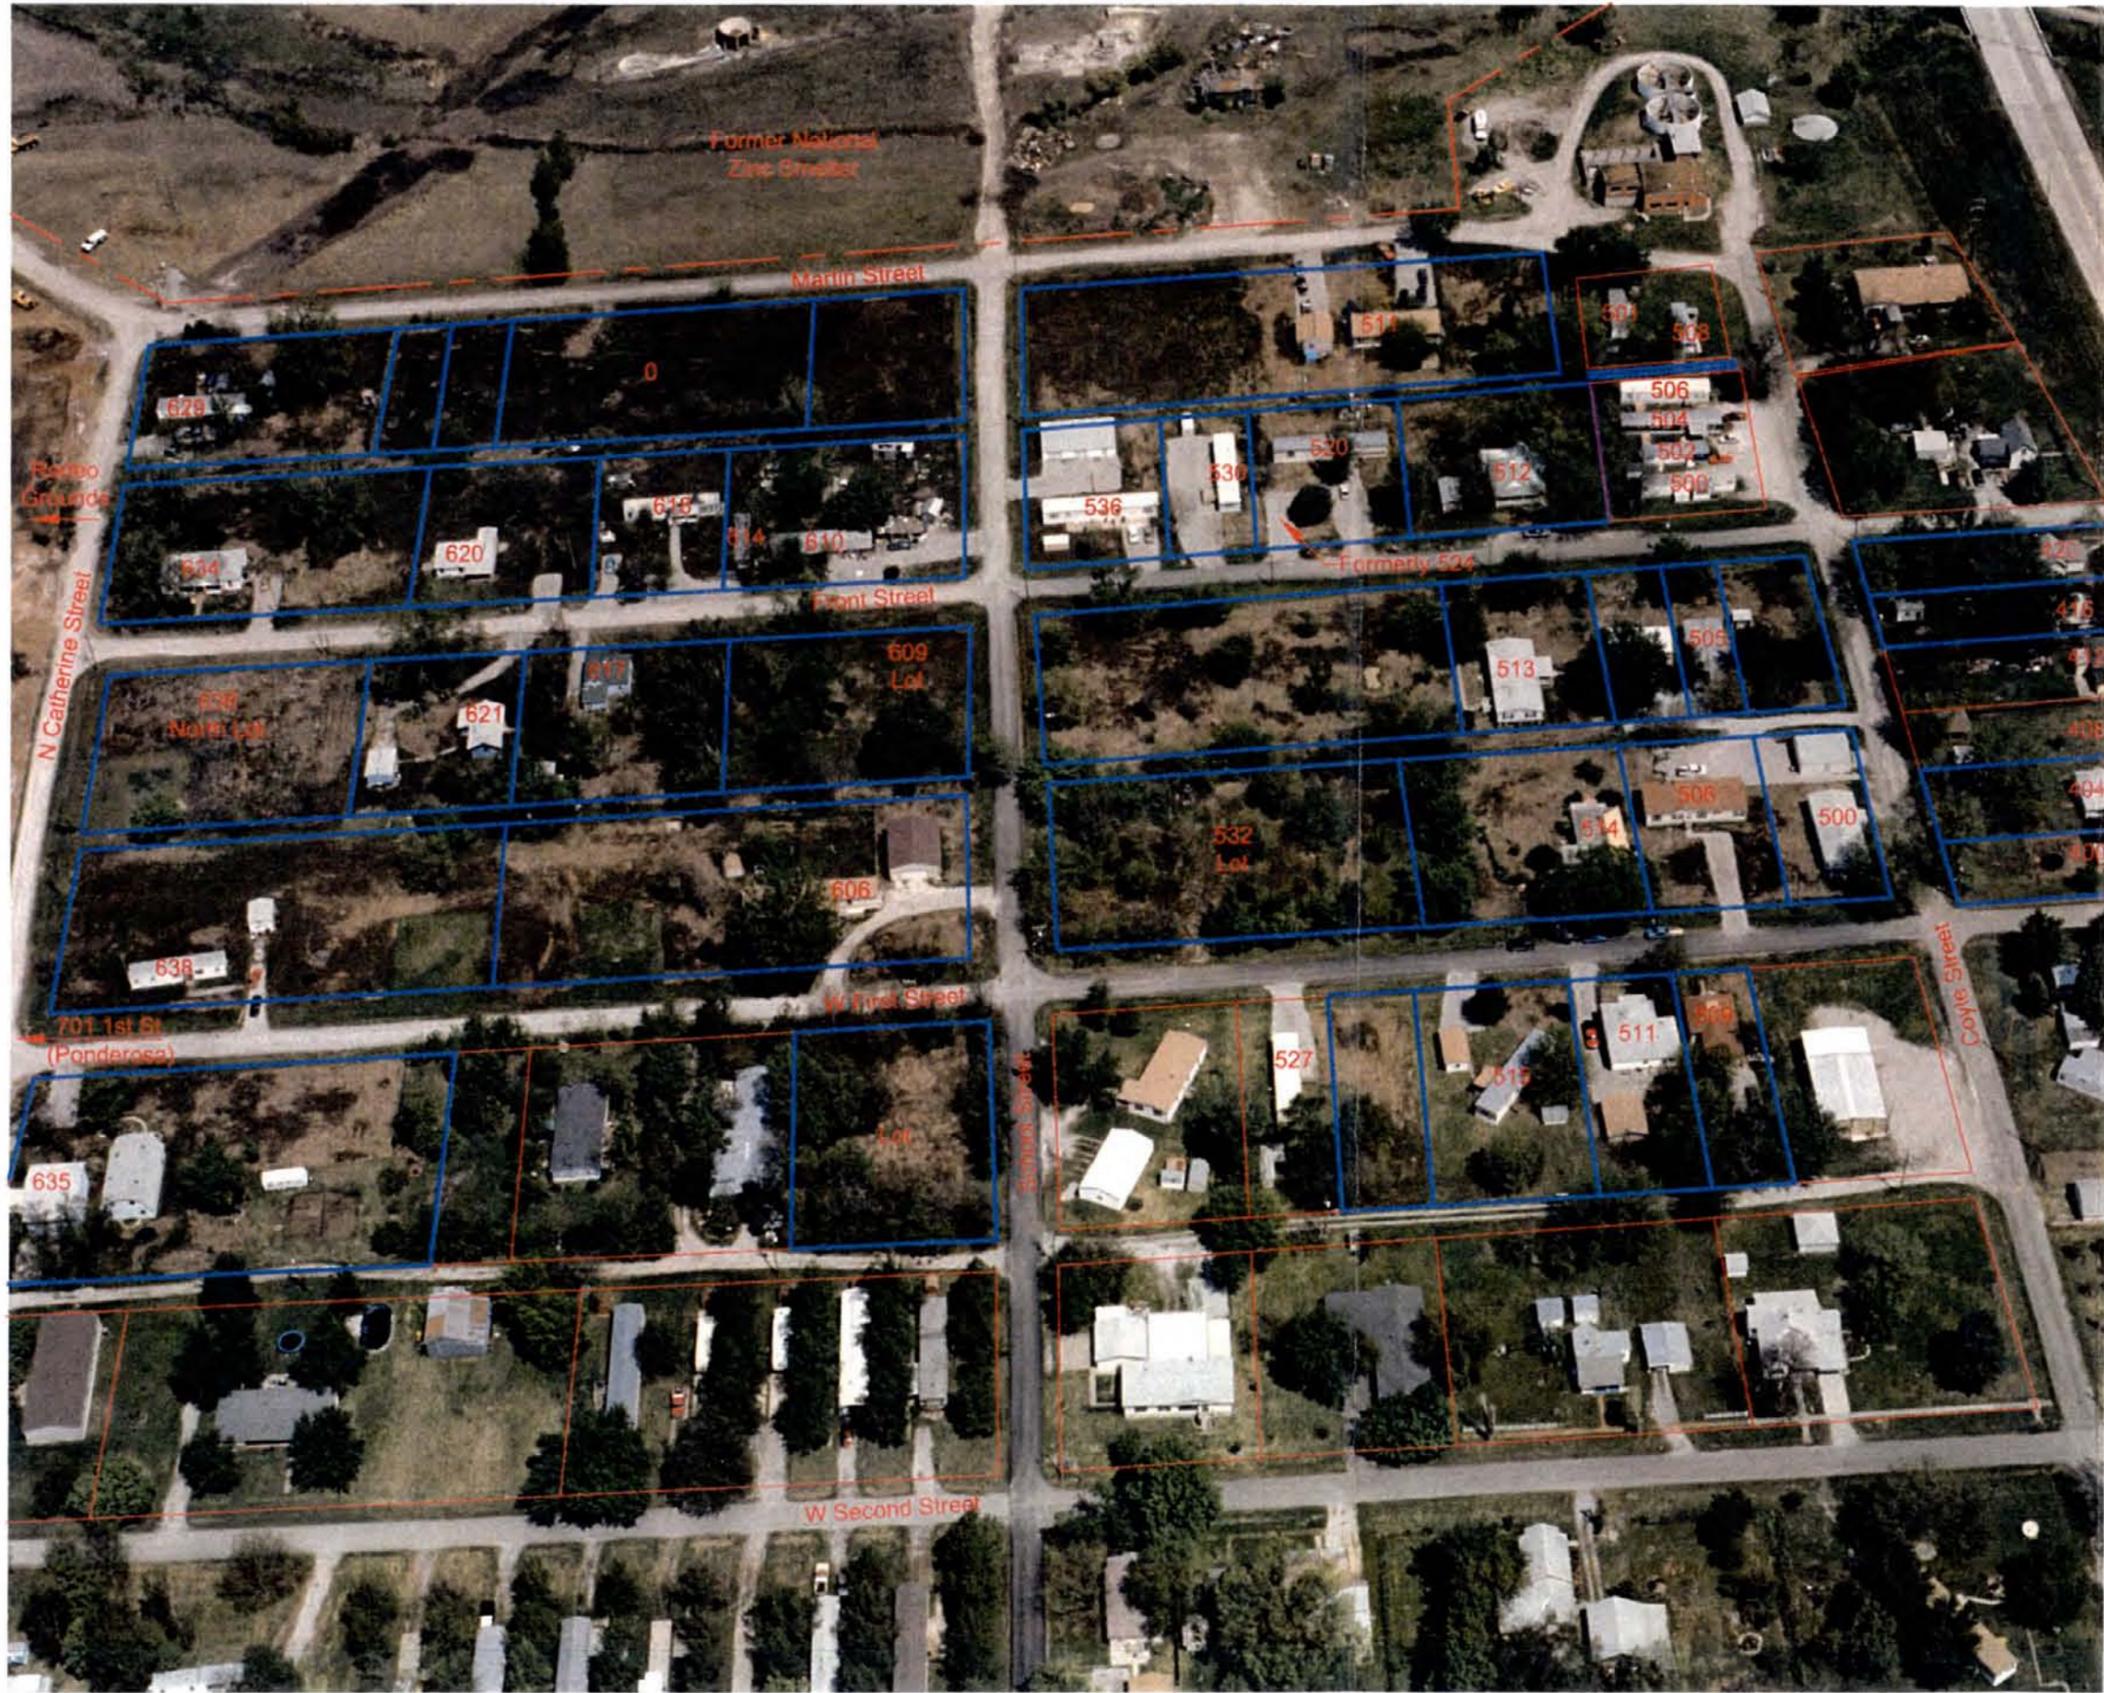
National Zinc Site Cherryvale, Kansas
Figure 2 Cherryvale Residential Property Map
Tetra Tech EM Inc.
Date: 11/27/02 Drawn By: Cain Wilts Project No: G9011.L.02.0063.00

- Legend
- Property Boundary (Not Excavated)
 - Property Boundary (Excavated)
 - 606 Property Address
- Note: Property boundaries are approximate

- XRF screening and excavation were conducted where a trailer had burned during the course of the removal action. The trailer was located at 524 Front Street (see Appendix A, Figure 2). XRF readings were above 400 mg/kg prior to excavation in this area.

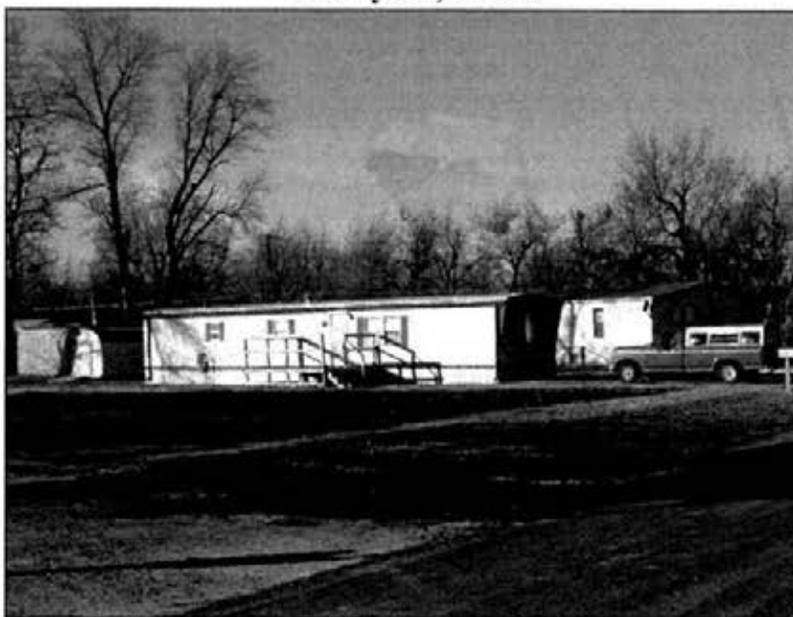
TETRA TECH PROJECT NO. G9011.E.01.0063.00 Direction: Southwest	DESCRIPTION	This photograph shows an excavated yard at 527 West First Street.	1
	CLIENT	U.S. Environmental Protection Agency Region 7	DATE
	PHOTOGRAPHER	Ingrid Davis	12/07/01

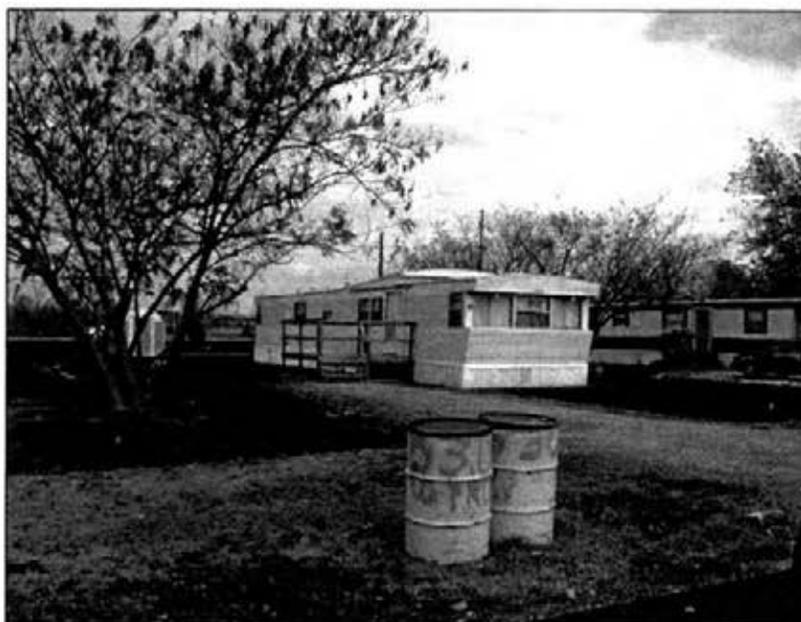
TETRA TECH PROJECT NO. G9011.E.01.0063.00 Direction: Northeast	DESCRIPTION	This photograph shows an excavated yard at 524 and 530 Front Street.	2
	CLIENT	U.S. Environmental Protection Agency Region 7	DATE
	PHOTOGRAPHER	Ingrid Davis	11/12/01

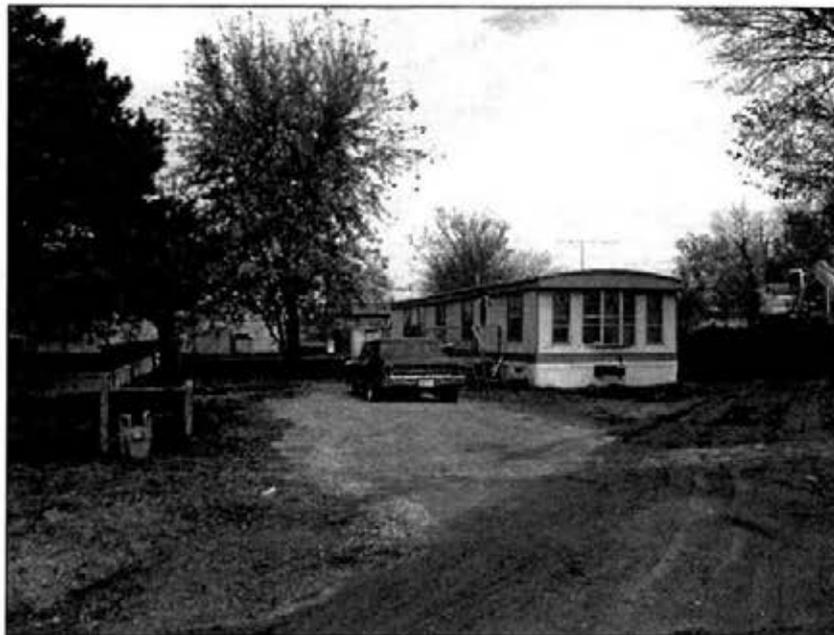
TETRA TECH PROJECT NO. G9011.E.01.0063.00 Direction: Northeast	DESCRIPTION	This photograph shows an excavated yard at 520 Front Street.	4
	CLIENT	U.S. Environmental Protection Agency Region 7	DATE
	PHOTOGRAPHER	Ingrid Davis	11/12/01

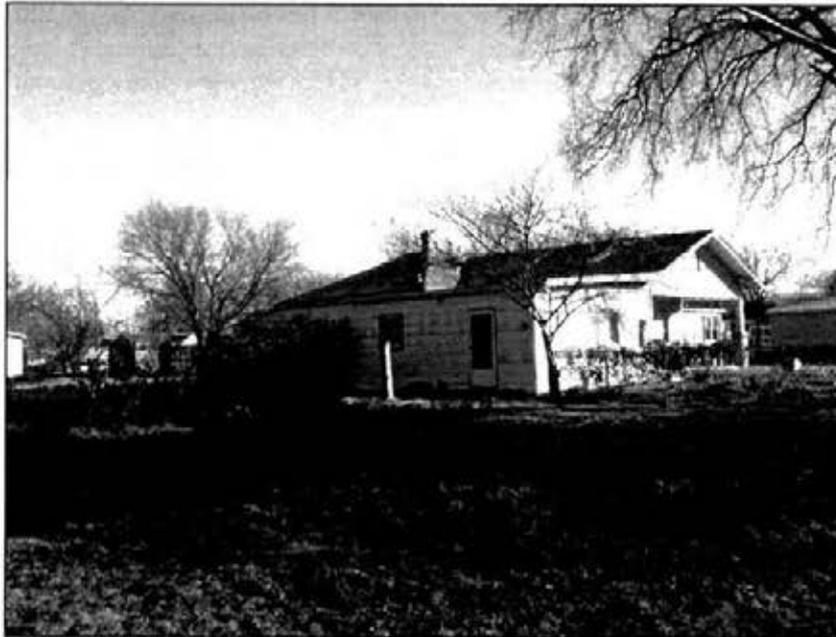
TETRA TECH PROJECT NO. G9011.E.01.0063.00 Direction: Northeast	DESCRIPTION	This photograph shows an excavated yard at 514 West First Street.	5
	CLIENT	U.S. Environmental Protection Agency Region 7	DATE
	PHOTOGRAPHER	Ingrid Davis	12/07/01

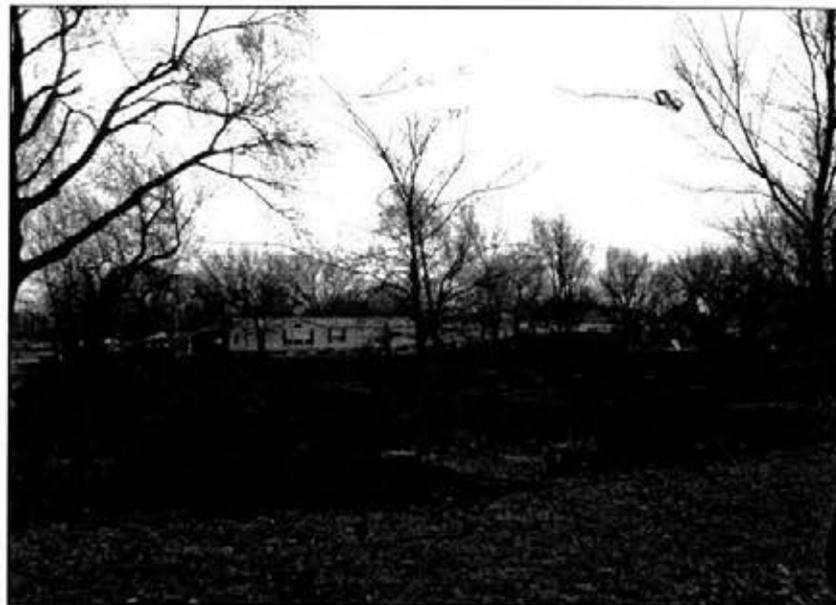
TETRA TECH PROJECT NO. G9011.E.01.0063.00 Direction: Southeast	DESCRIPTION	This photograph shows an excavated lot west of 513 Front Street.	6
	CLIENT	U.S. Environmental Protection Agency Region 7	DATE
	PHOTOGRAPHER	Ingrid Davis	12/05/01

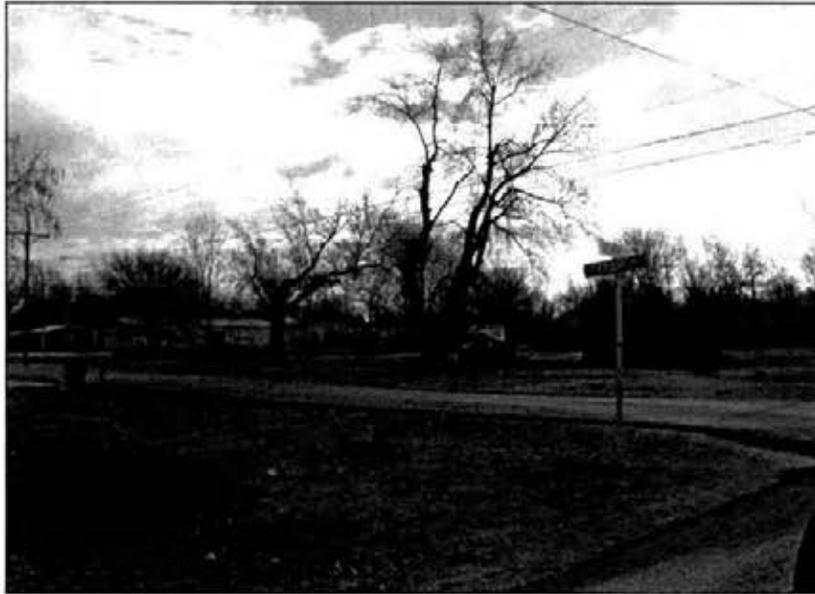
TETRA TECH PROJECT NO. G9011.E.01.0063.00 Direction: Southeast	DESCRIPTION	This photograph shows a yard during excavation at 513 Front Street.	7
	CLIENT	U.S. Environmental Protection Agency Region 7	DATE
	PHOTOGRAPHER	Ingrid Davis	12/05/01

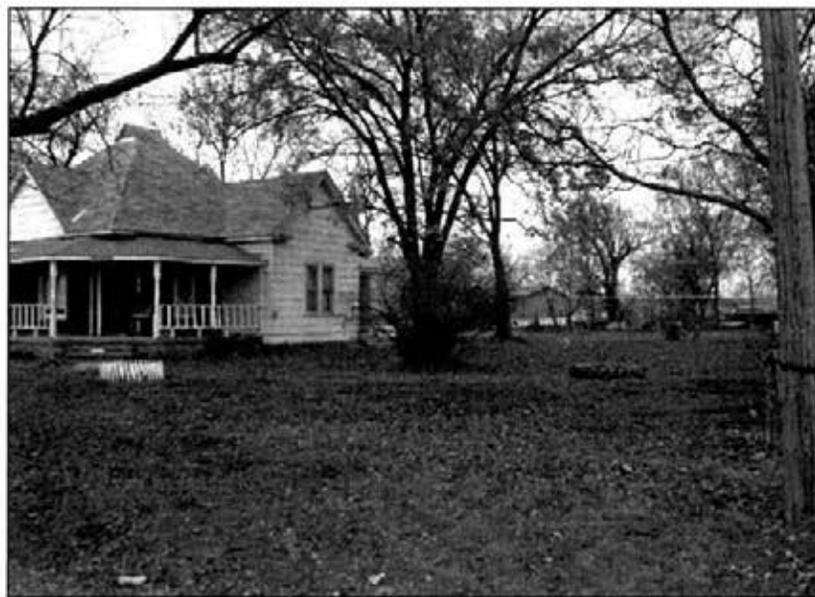
TETRA TECH PROJECT NO. G9011.E.01.0063.00 Direction: Northwest	DESCRIPTION	This photograph shows a pre-excavation at 512 Front Street.	8
	CLIENT	U.S. Environmental Protection Agency Region 7	DATE
	PHOTOGRAPHER	Ingrid Davis	11/08/01

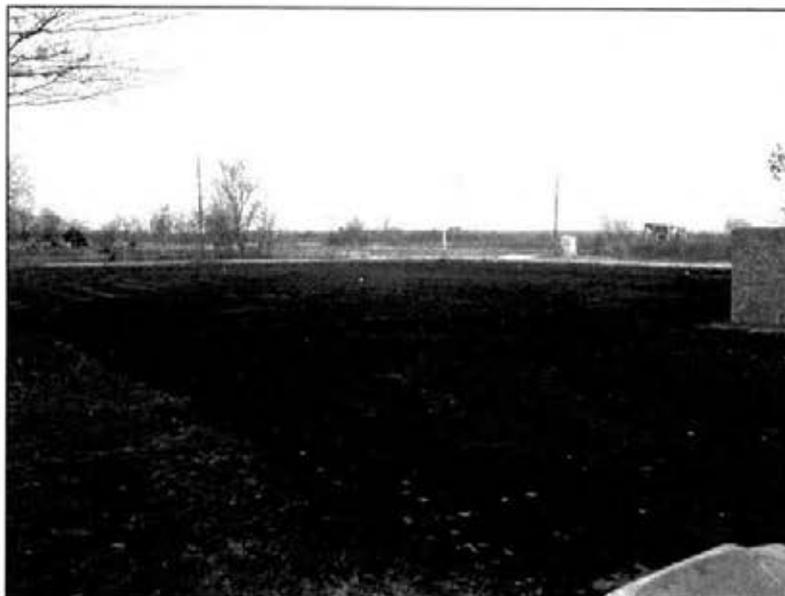
TETRA TECH PROJECT NO. G9011.E.01.0063.00 Direction: Northwest	DESCRIPTION	This photograph shows an excavated lot west of a residence at 511 Martin Street.	9
	CLIENT	U.S. Environmental Protection Agency Region 7	DATE
	PHOTOGRAPHER	Ingrid Davis	11/08/01

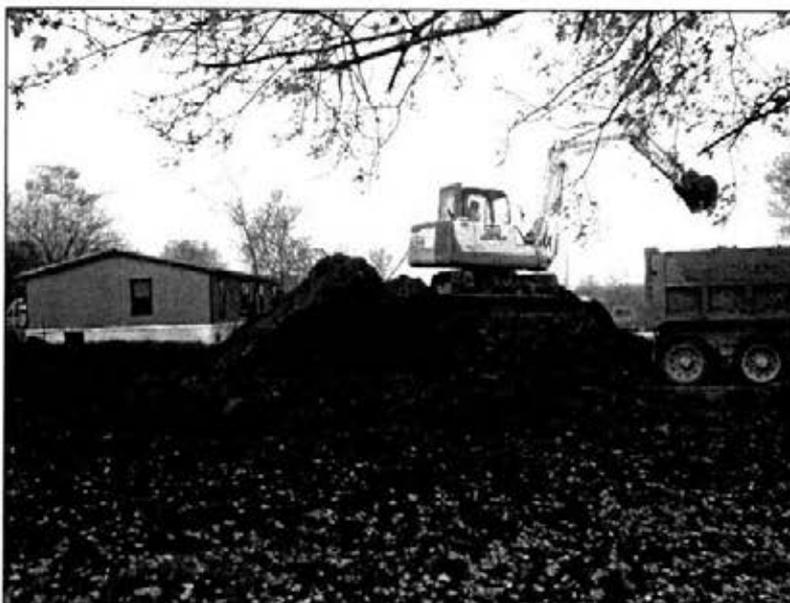
TETRA TECH PROJECT NO. G9011.E.01.0063.00 Direction: West	DESCRIPTION	This photograph shows a stockpile at 511 Martin Street.	10
	CLIENT	U.S. Environmental Protection Agency Region 7	DATE
	PHOTOGRAPHER	Ingrid Davis	11/08/01

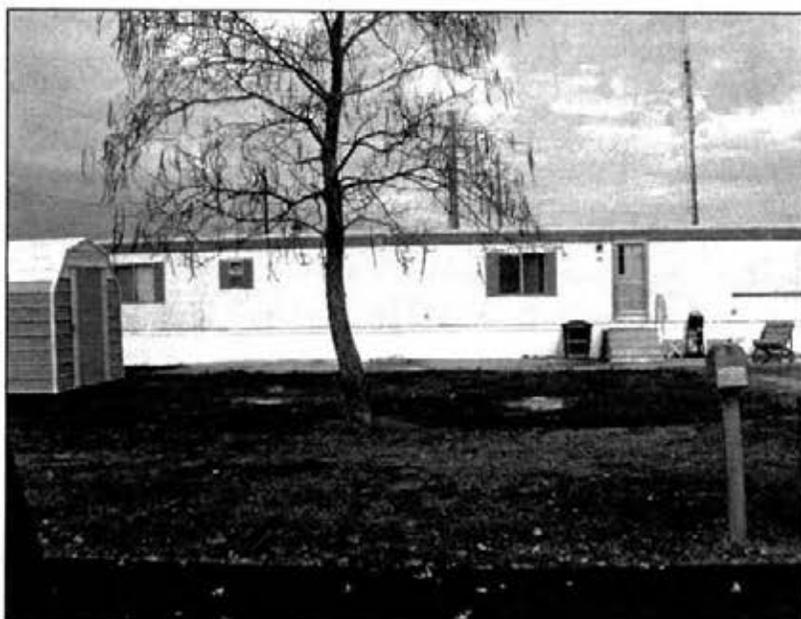
TETRA TECH PROJECT NO. G9011.E.01.0063.00 Direction: North	DESCRIPTION	This photograph shows a residence at post-excavation located at 536 Front Street.	11
	CLIENT	U.S. Environmental Protection Agency Region 7	DATE
	PHOTOGRAPHER	Ingrid Davis	11/12/01

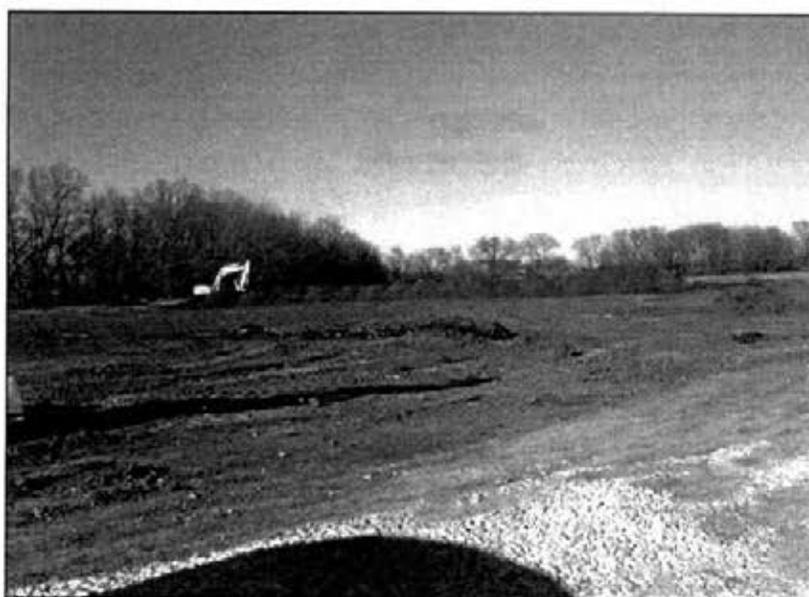
TETRA TECH PROJECT NO. G9011.E.01.0063.00 Direction: Northeast	DESCRIPTION	This photograph shows a borrow pit at Cherryvale, Kansas.	12
	CLIENT	U.S. Environmental Protection Agency Region 7	DATE
	PHOTOGRAPHER	Ingrid Davis	01/03/02

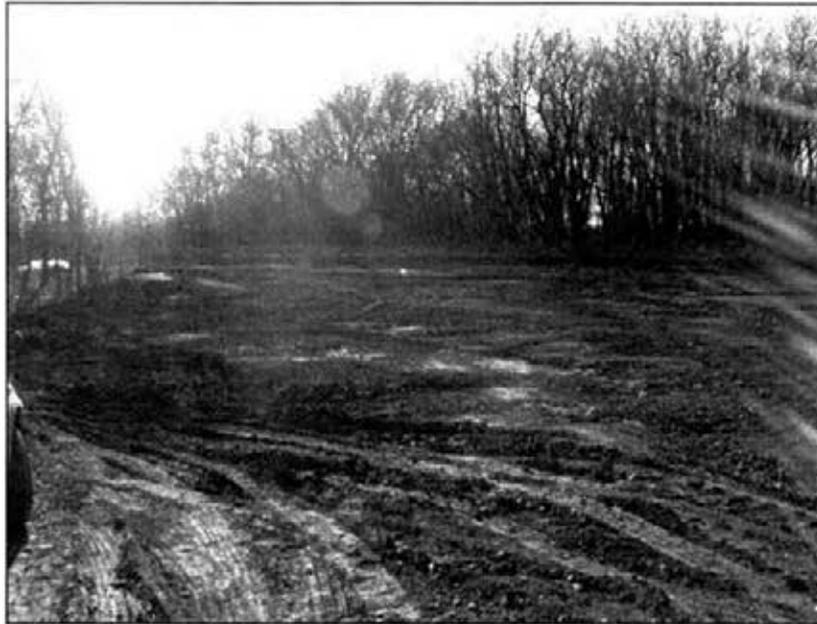
TETRA TECH PROJECT NO. G9011.E.01.0063.00 Direction: Northwest	DESCRIPTION	This photograph shows a borrow pit at Cherryvale, Kansas.	13
	CLIENT	U.S. Environmental Protection Agency Region 7	DATE
	PHOTOGRAPHER	Ingrid Davis	01/03/02

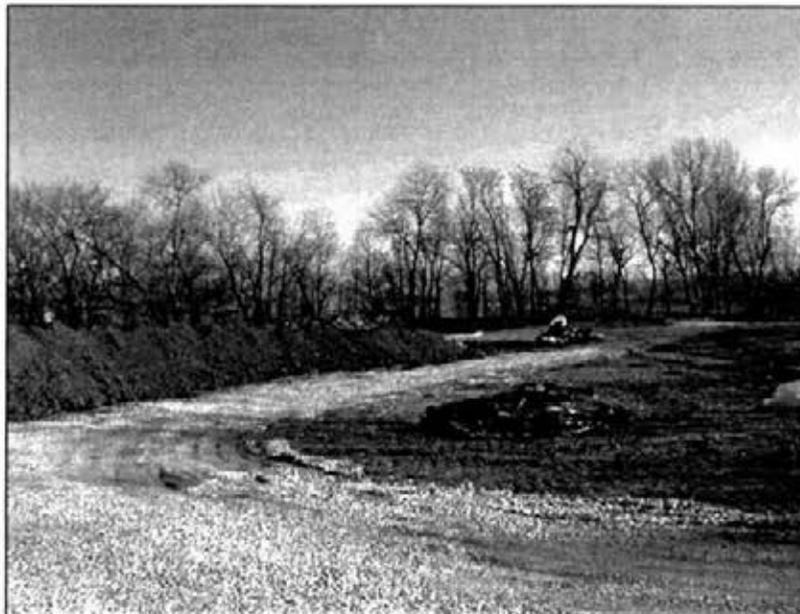
TETRA TECH PROJECT NO. G9011.E.01.0063.00 Direction: Southeast	DESCRIPTION	This photograph shows a borrow pit at Cherryvale, Kansas.	14
	CLIENT	U.S. Environmental Protection Agency Region 7	DATE
	PHOTOGRAPHER	Ingrid Davis	01/03/02

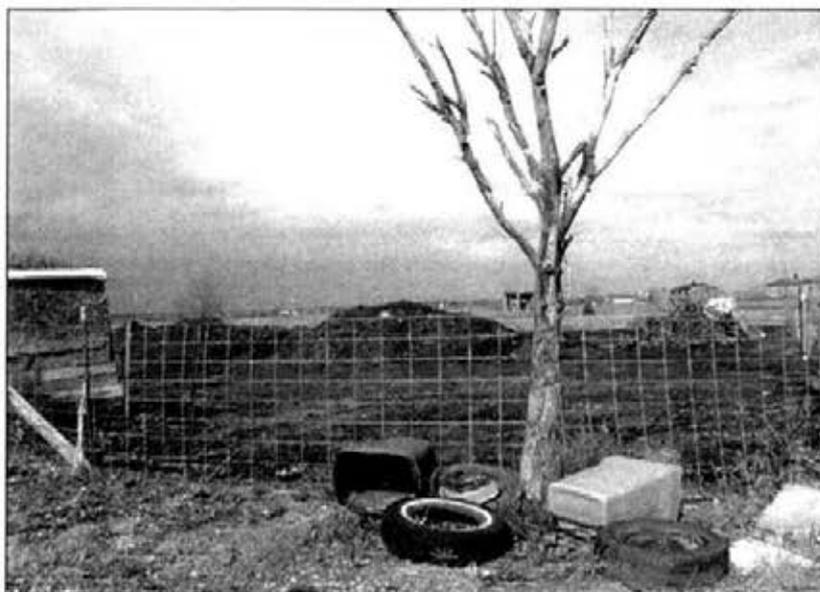
TETRA TECH PROJECT NO. G9011.E.01.0063.00 Direction: Northwest	DESCRIPTION	This photograph shows a horse pen and stockpile at 610 Front Street.	15
	CLIENT	U.S. Environmental Protection Agency Region 7	DATE
	PHOTOGRAPHER	Ingrid Davis	11/12/01

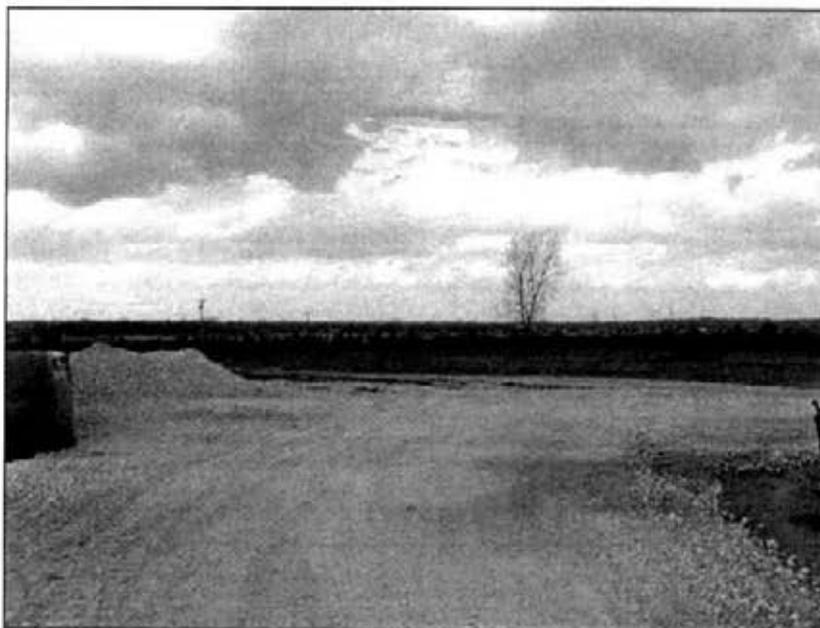
TETRA TECH PROJECT NO. G9011.E.01.0063.00 Direction: Northwest	DESCRIPTION	This photograph shows the repository at Cherryvale, Kansas.	16
	CLIENT	U.S. Environmental Protection Agency Region 7	DATE
	PHOTOGRAPHER	Ingrid Davis	12/05/01

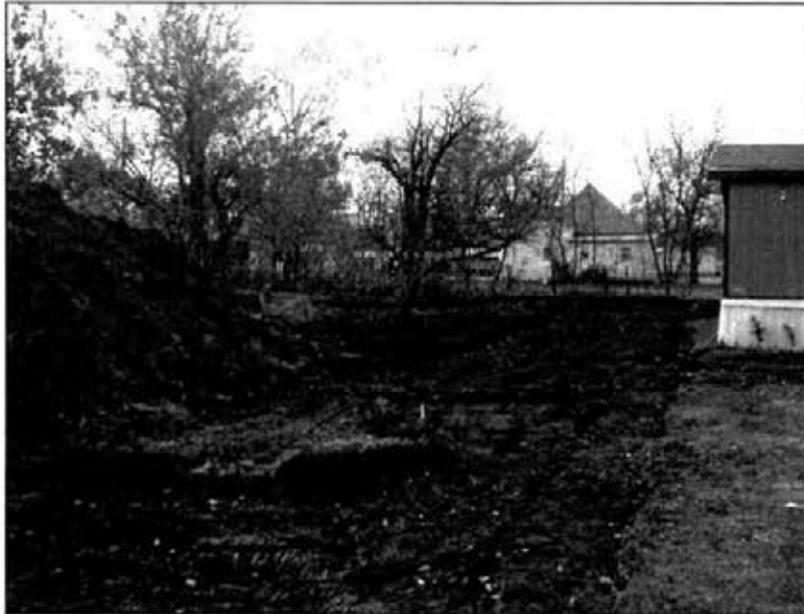
TETRA TECH PROJECT NO. G9011.E.01.0063.00 Direction: South	DESCRIPTION	This photograph shows the eastern part of the yard and stockpile at 511 Martin Street.	17
	CLIENT	U.S. Environmental Protection Agency Region 7	DATE
	PHOTOGRAPHER	Ingrid Davis	11/08/01

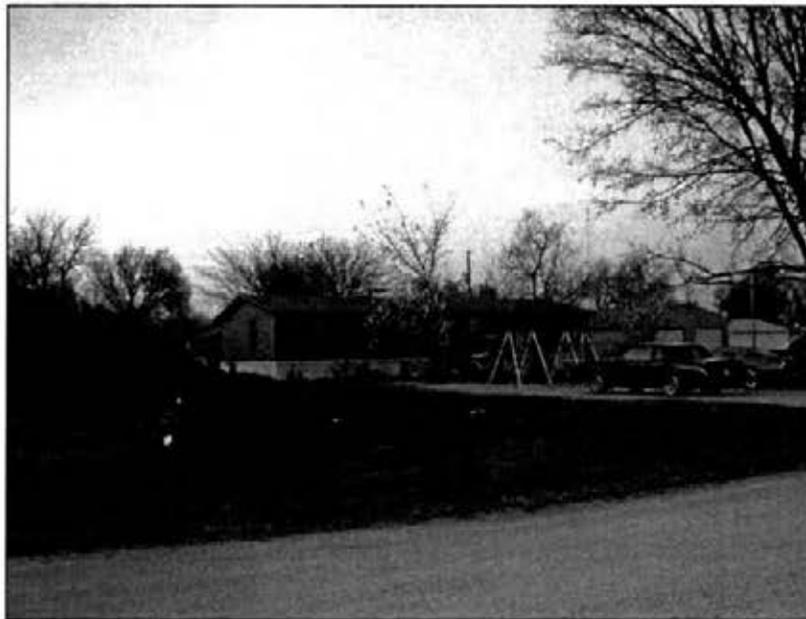
TETRA TECH PROJECT NO. G9011.E.01.0063.00 Direction: Southwest	DESCRIPTION	This photograph shows the front yard at 511 Martin Street during excavation.	18
	CLIENT	U.S. Environmental Protection Agency Region 7	DATE
	PHOTOGRAPHER	Ingrid Davis	11/08/01
