**RE: National Zinc – Cherryvale Removal Site Evaluation - Phase I Data Report
Former National Zinc Site, Cherryvale, Kansas KDHE Project Code #C3-063-00026;
Consent Order Case #03-E-0022. Response to Comments.**

**Cherryvale, Kansas Bioavailability Sample Screening and Collection
Field Note Transcript**

Sample Locations – Cherryvale, Kansas Bioavailability Sampling

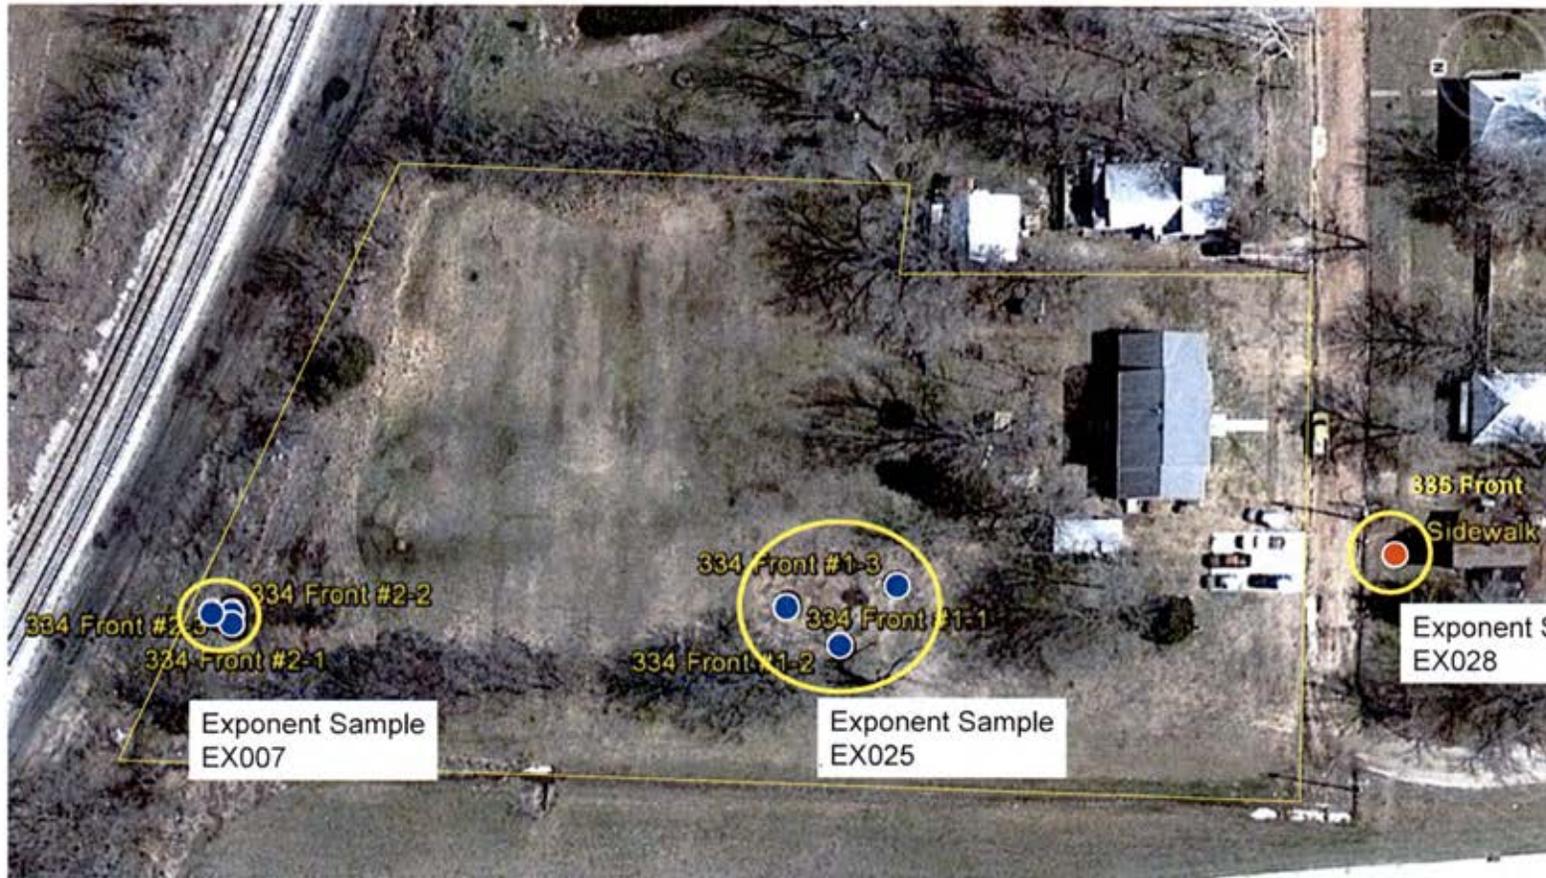
Figure 2 of 19

Start 3:20 PM: 334 Front Street. Schaper Property. Locate sample areas. Three locations sampled. Zn, Pb elevated at each point composite from back yard. Area of thin grass with soil containing irregularly distributed 0.25-0.1.5 cm sized black colored slag dull to glassy, some vesicular with white inclusions. Occasional brick fragments. Composite 1, surface sample from dark soil with sparse slag. Exponent composite sample EX025. Sample 2 from wet area north property boundary south of railroad tracks. Bare wet area with surface material containing 0.25 to 2.5 cm sized black dull to glassy slag fragments, some vesicular. Brick, glass and metal fragments present. Exponent composite sample EX007. Material from sample 1 and 2 all similar in appearance.

Sample Locations – 334 Front St. Cherryvale, KS

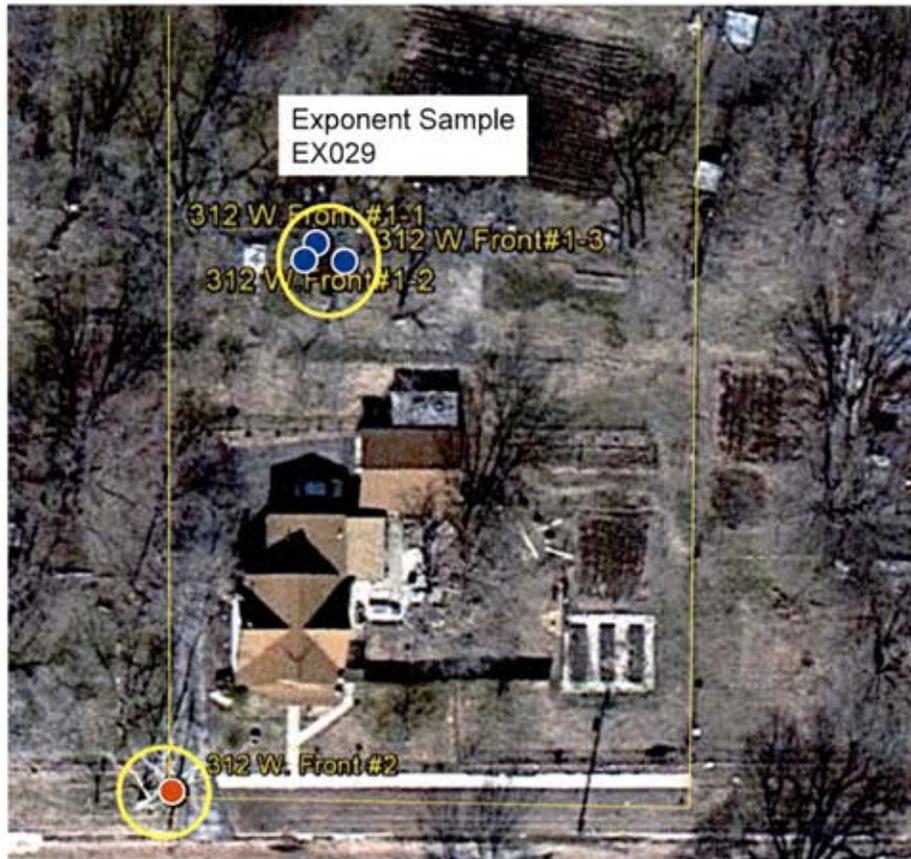
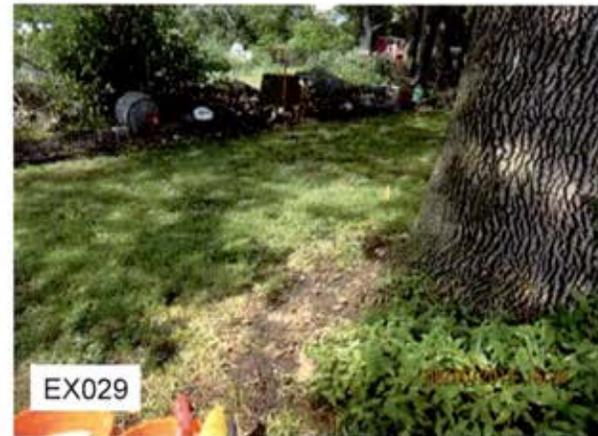
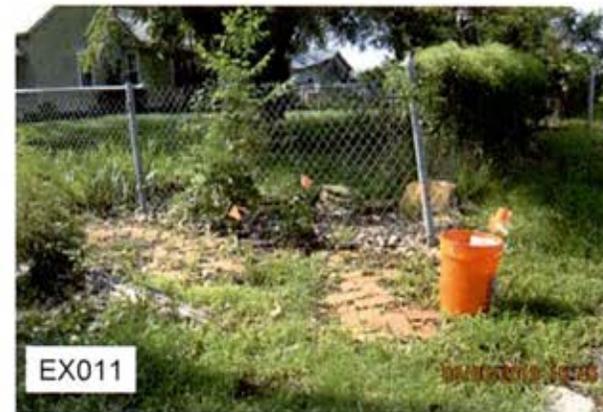
Figure 4 of 19

4:20 PM Gill property sampling 312 Front St. Sample from back between large tree and fence. Surface 0-2 cm depth sample with sparse 0.25 to 0.75 cm sized black slag fragments. Brick and rock fragments noted near base of tree and along garden fence. XRF screen soil, select samples and composite. Collect three point composite sample near storm shelter and between fence and trees. Exponent composite sample EX029. Back of property note abundant green colored broken glass fragments in soil.

4:40 PM: 312 Front St. sample 2 from near brick sidewalk west of driveway. Surface sample of soil with black colored coarse sand 0.1-2.5 cm sized slag fragments. Exponent composite sample EX011.

Exponent Sample
EX011

312 Front #1

312 Front #2

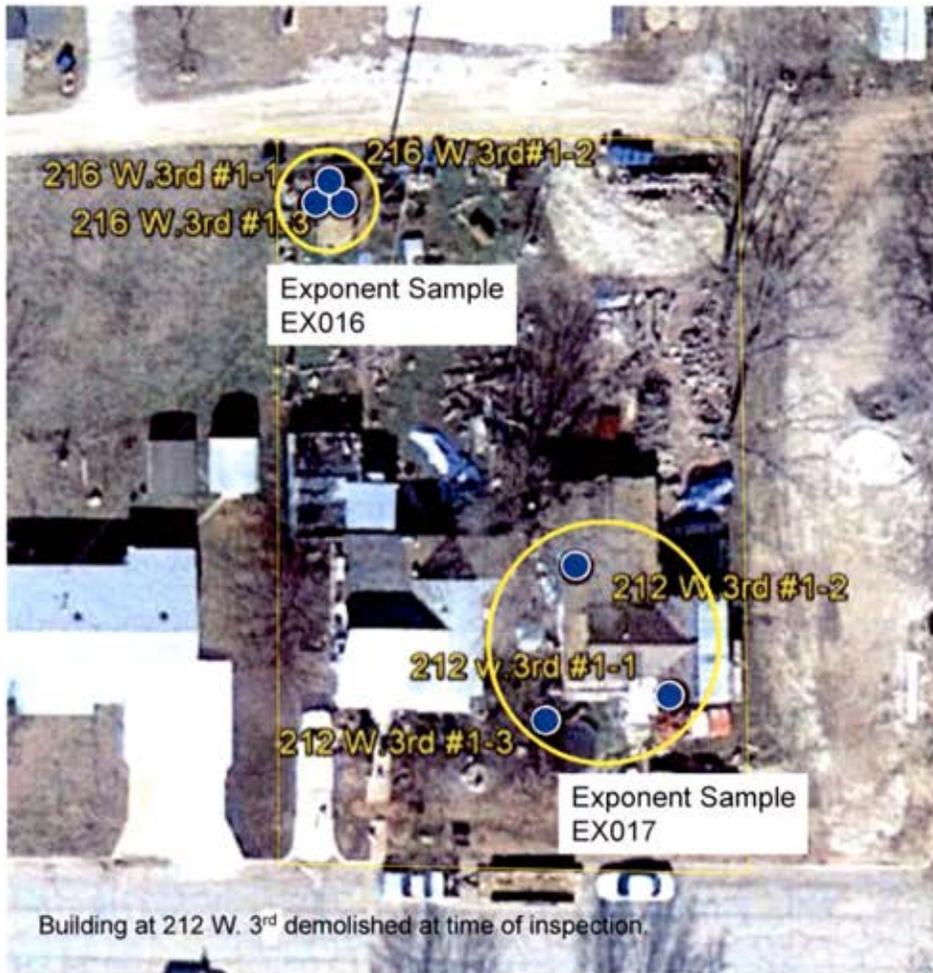
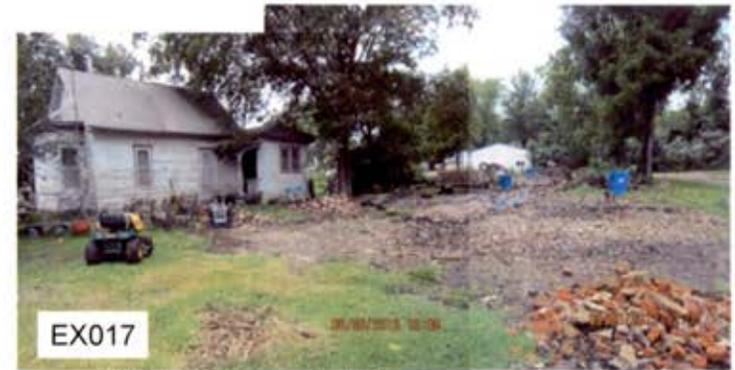
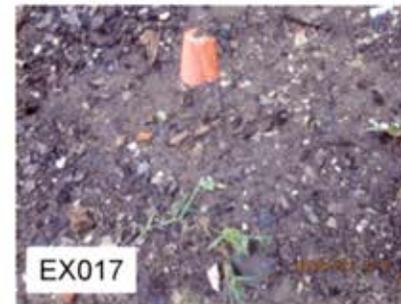
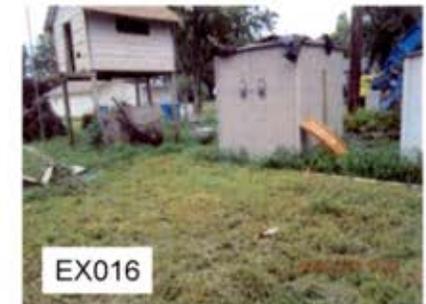
Figure 5 of 19

11:20 AM: Brooks property, 212 to 216 W 3rd. Speak with Brooks' daughter notify for access. Sample 1, collected from surface soils at 212 demolished residence with apparent demolition debris burn pile. Dark gray soil, remnant burned material, glass fragments, nails, wood, red brick, concrete block, roofing material and plastic "debris" at location. Irregularly distributed black vesicular slag fragments up to several (5-8) cm in size observed. Possible mixed source material from lead paint, slag fragments and old building materials. Peeling white paint chips noted on residence at 216. XRF screen sample points. Three point composite of soils at 212 location 0-2 cm in depth. Exponent composite sample EX017. Meet Brooks' son at property 12:14 PM, discuss sampling. Collect 2nd sample from back of 216 W 3rd near play area. No slag fragments noted. 0-2 cm depth surface soil composite from below grass layer near play area south and east of fence. Exponent composite sample EX016. Burke (KDHE) leave 12:15 PM.

212 W. 3rd Towards 216

212 W. 3rd Slag Residue

216 W. 3rd #1

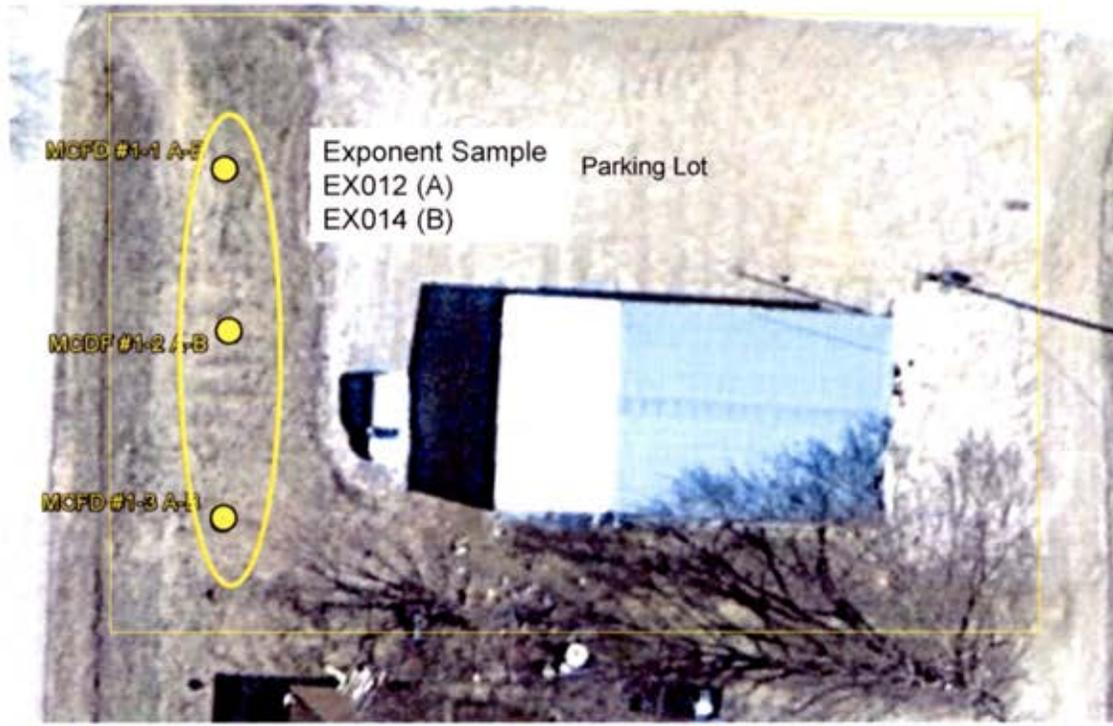
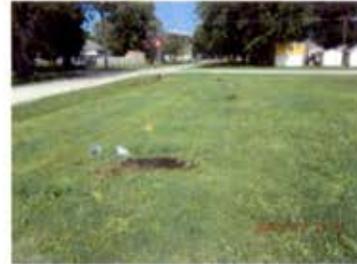
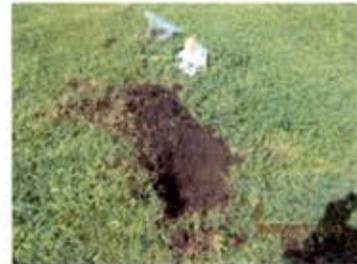
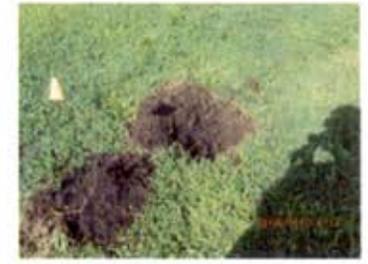
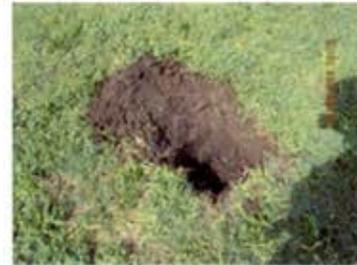
Figure 6 of 19

3:30 PM: First and Coyle Montgomery County Fire Department location (MCFD). North side of property in grassy area north of gravel driveway. Soil appears to be graded over and composed of imported topsoil. Three points selected along north side of property. Successive scrape in each sample point below surface grass layer in 5 cm increments until elevated XRF metal readings encountered. Samples divided into layers composite intervals A and B. (A) layer at 2 cm below grass layer and includes soil entrained in grass consisting of brown to dark brown soil with roots and organic fragments. No slag noted. Exponent composite sample EX012. (B) Sample of darker brown organic soil with roots collected between 13-15 cm below surface. Exponent composite sample EX014.

MCFD View East

MCFD Location #1-1

MCFD Location #1-2

MCFD Location #1-3

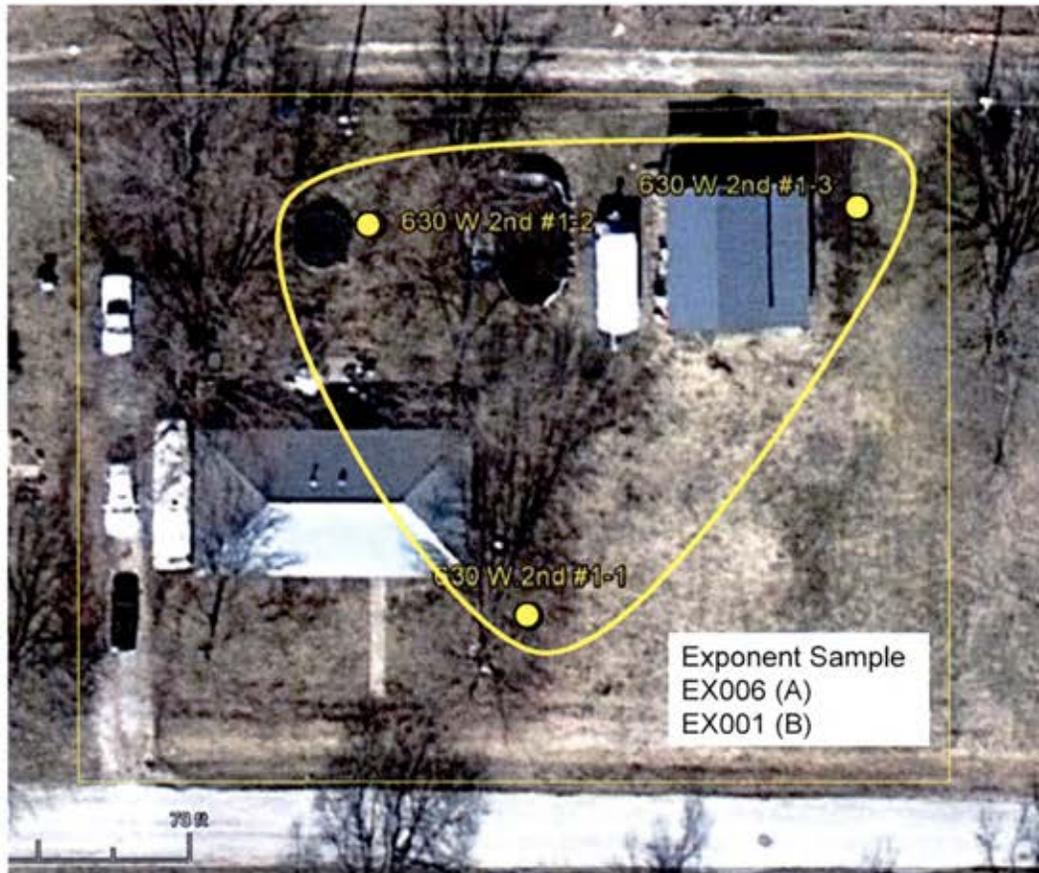
Figure 7 of 19

9:40 AM: Ward property 630 W. 2nd. Flat yard appears graded in front. Three sample locations (1), front east of house. Wet, dark brown soil, glass, brick fragments, (debris) noted in surface layer under grass; no smelter residue observed. (2) Back yard by play area. Dark brown soil, debris, glass fragments, brick fragments, tar paper at 5-7 cm below surface grass irregular; no smelter residue observed. (3) Back yard east of outbuilding. Flat surface, abundant small wood pieces, brick fragments and nails, limestone gravel, occasional retort fragment. Thin vegetation. (A) composite 0-2 cm below surface. Exponent composite sample EX006. (B) composite 13-18 cm below ground surface. Exponent composite sample EX001.

630 W. 2nd #1-3
Debris Layer (arrow)

Slag and debris fragments

630 W. 2nd #1-3 Detail

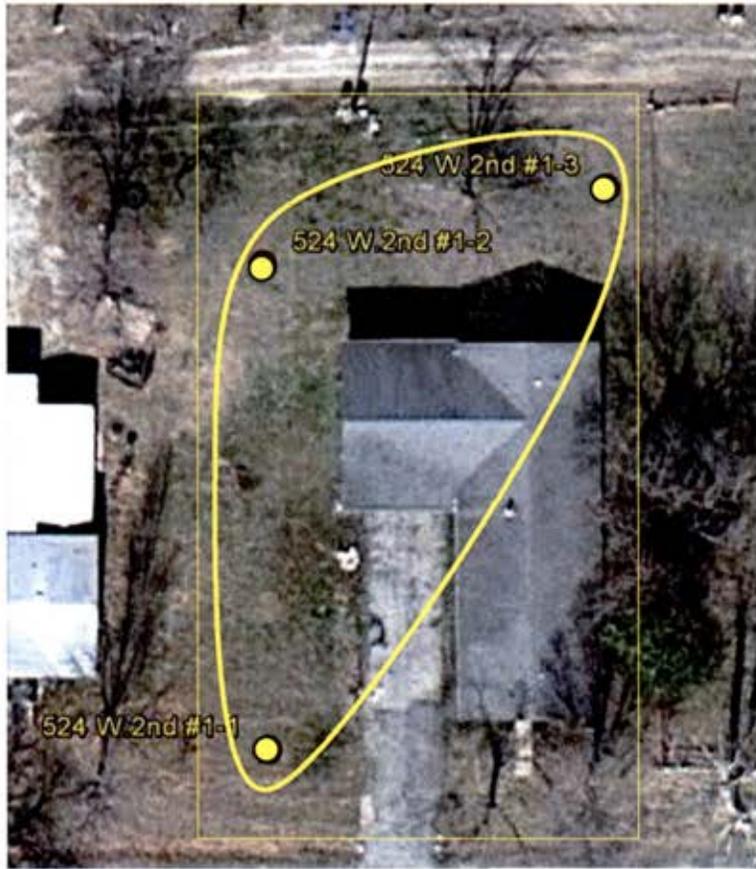
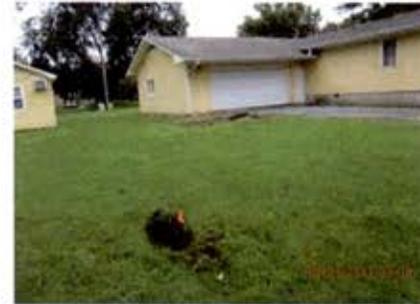
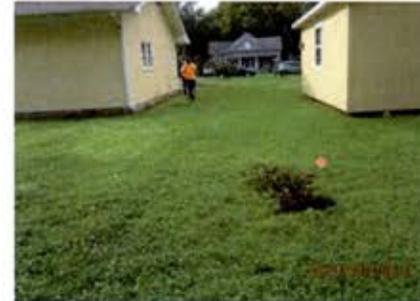
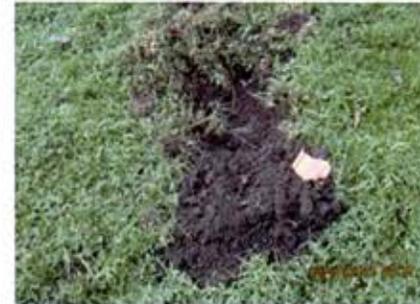
Figure 8 of 19

9:00 AM: Booe property 524 W. 2nd. Three sample points selected, front yard west of driveway. Back yard northeast, by fence. Central yard west side. XRF screen for all samples. Successive scrape from surface in 2 cm increments. (A) sample 0-2 cm brown soil below grass layer including entrained soil in roots. (B) sample thin dark layer 5 cm below surface. No debris noted. No smelter residue observed. A and B sample composites. (A) Exponent composite sample EX008, (B) Exponent composite sample EX018.

Exponent Sample
EX008 (A)
EX018 (B)

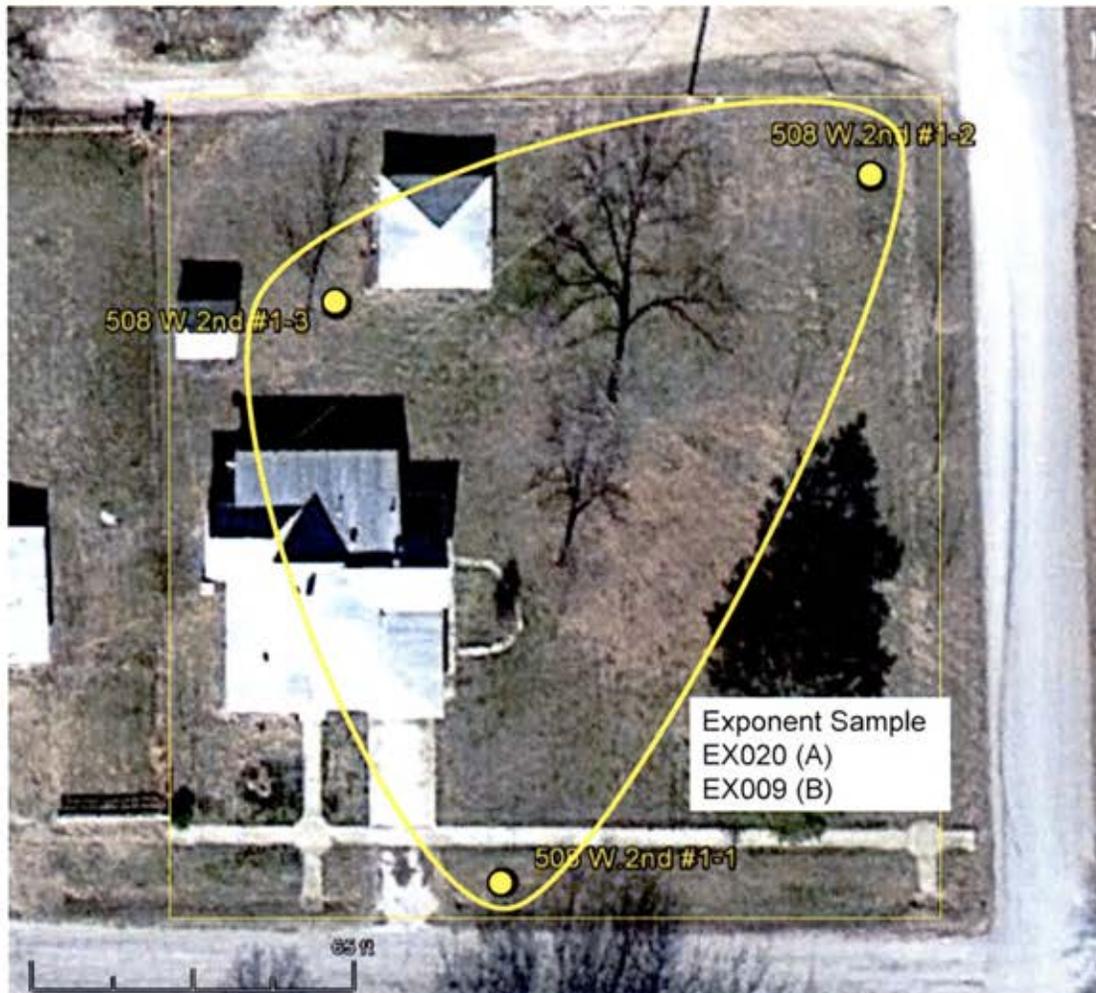
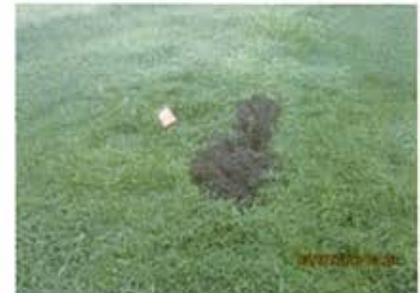
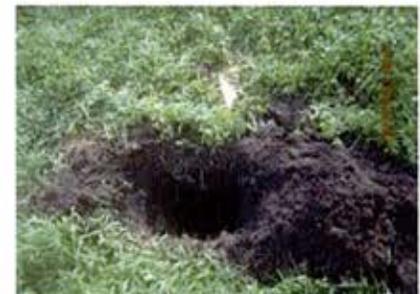
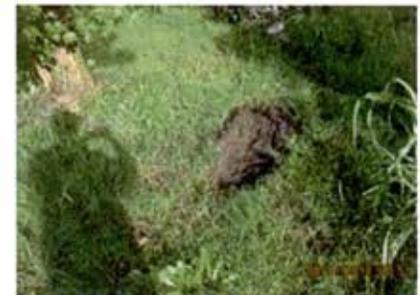
Figure 9 of 19

8:00 AM: Slane property 508 W. 2nd. Three locations selected, front yard east, northeast back yard by fence, central back yard by tree west of outbuilding. XRF screen all sample points. Select surface sample (A) 0-2 cm depth sample below grass layer including soil in roots. Successive 5-cm scrape below surface at each location. Yard soils appear graded over or filled in. No smelter residue observed. Meet property owner. Property owner notes old building demolition on southeast portion of property now graded over. (B) sample approximately 20-25 cm below surface. Sample composite A and B collected. (A) Exponent composite sample EX020, (B) Exponent composite sample EX009.

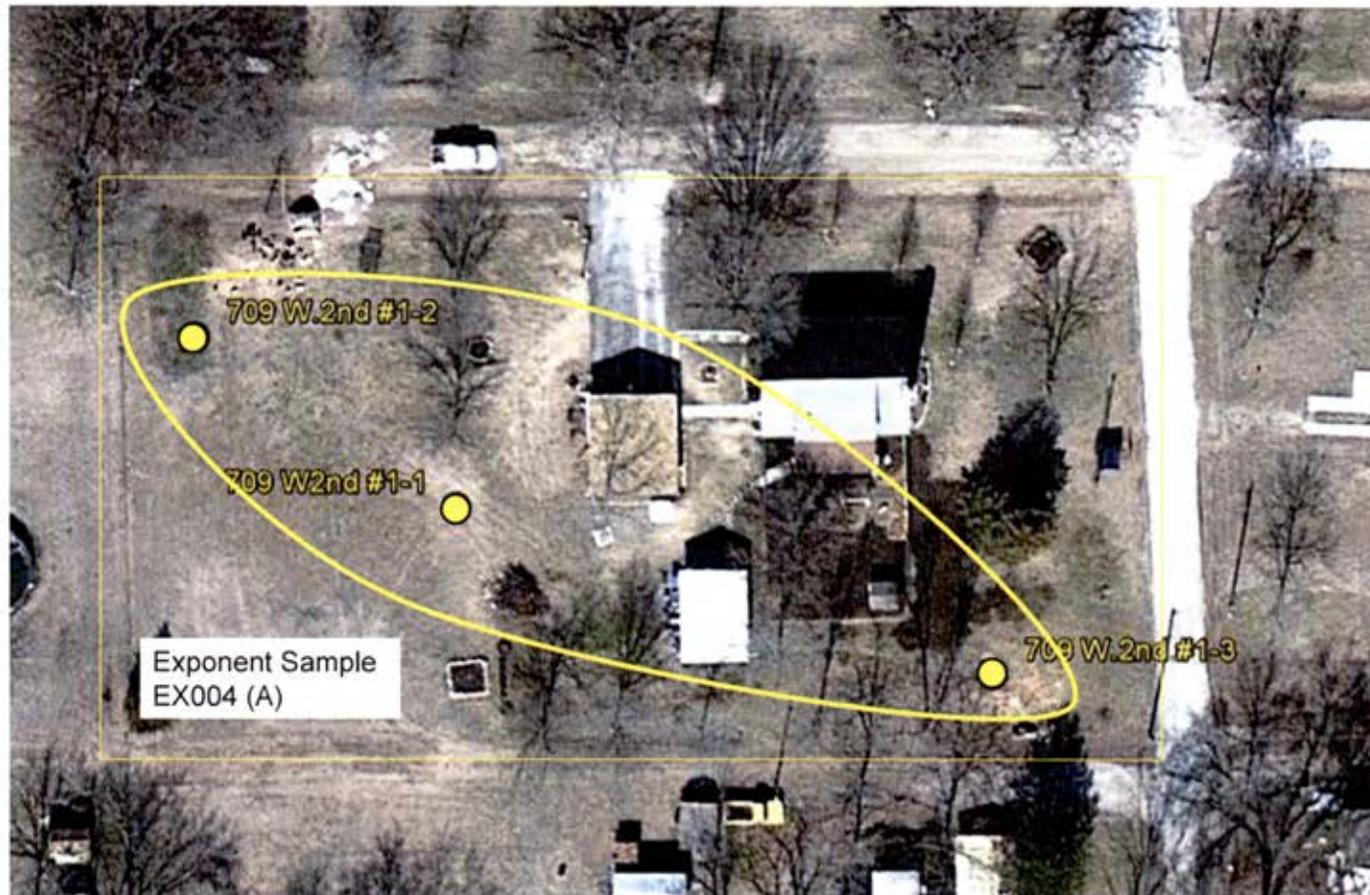
Figure 10 of 19

1:00 PM: Ware property 709 W. 2nd. Far west location south of rodeo grounds. Three sample points. NW property in flat. SW property west of shed on slightly elevated ground. SE of house near right of way. (A) depth sample only. Consistently dark native soil through depth 15-20 cm with no distinct layer noted. No smelter residue observed. Exponent composite sample EX004.

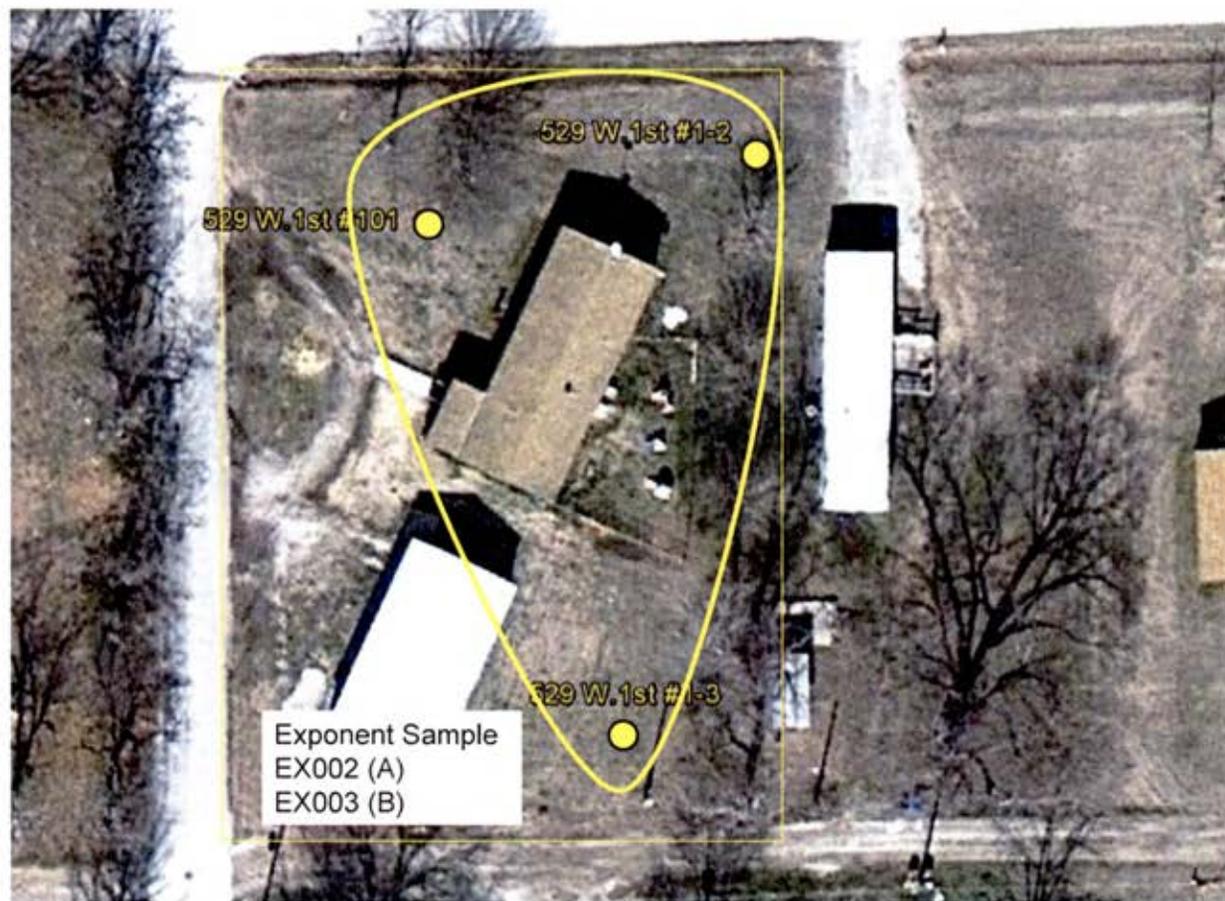
Figure 11 of 19

10:40 AM: Valverde property 529 W. 1st. Thick grass surface cover. (1) Sample front yard northwest by tree. Dark brown organic soil. Small brick fragment debris noted 5 cm below surface. Distinct black colored soil layer at 10-12 cm below surface. (2) sample northeast property. Thick grass, possible surface fill or reworked soil uniform to 20 cm. (3) sample southeast property near phone pole. No clearly defined layer below surface. Soil uniform. No smelter residue observed. Three sample composite from A and B layer. (A) composite Exponent sample EX002. (B) composite Exponent sample EX003.

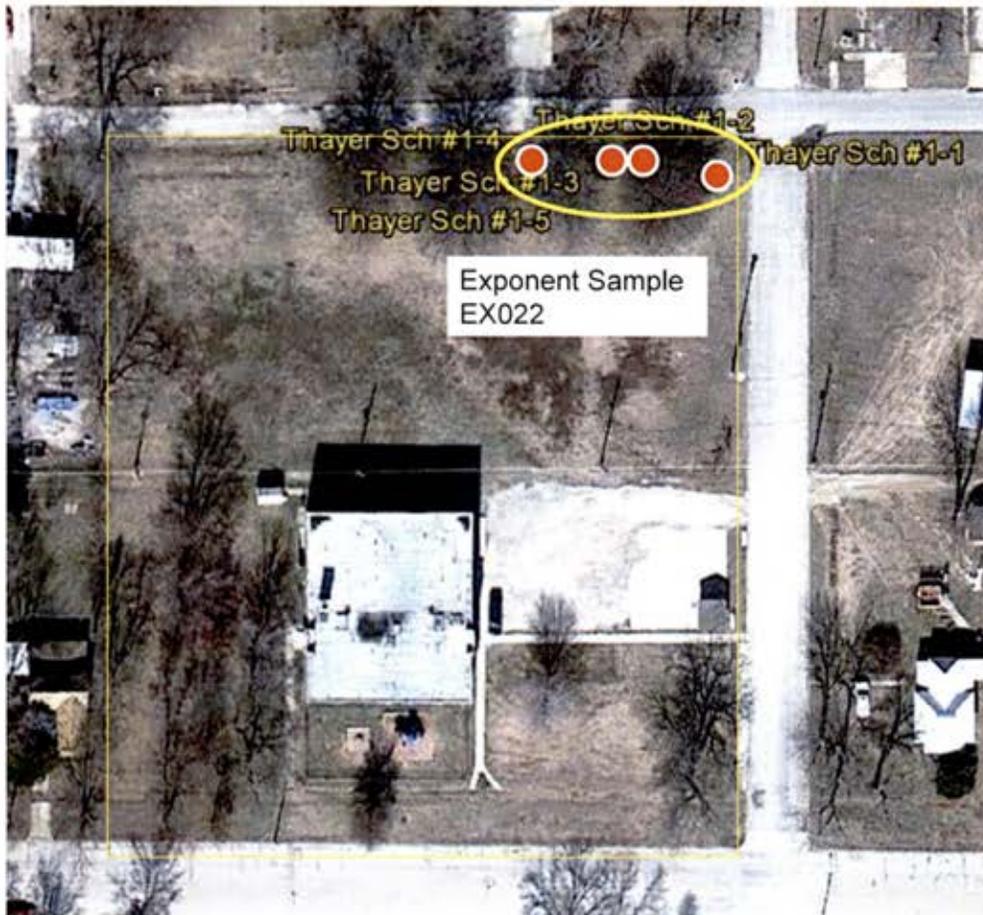
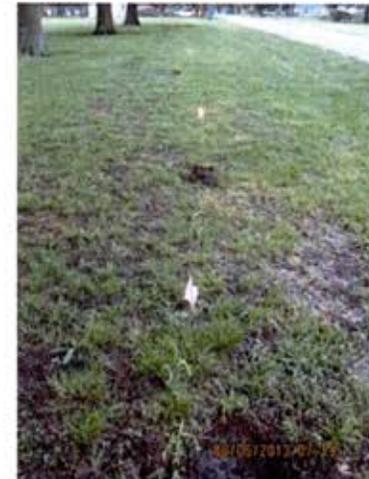
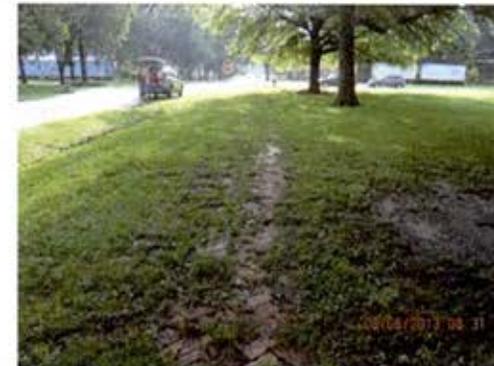
Figure 12 of 19

7:45 AM: Thayer School sidewalk. Investigate location, establish location of brick sidewalk and select sample points. Five point composite from soils near sidewalk on north and south side. Composite for Thayer School sample 1. Surface soils 0-2 cm deep, dark gray to black color, occasional 0.25 cm black slag fragment, fragment approximately 0.25-2.5 cm noted near trees south of sample location. Sample complete 8:35 AM. Exponent composite sample EX022.

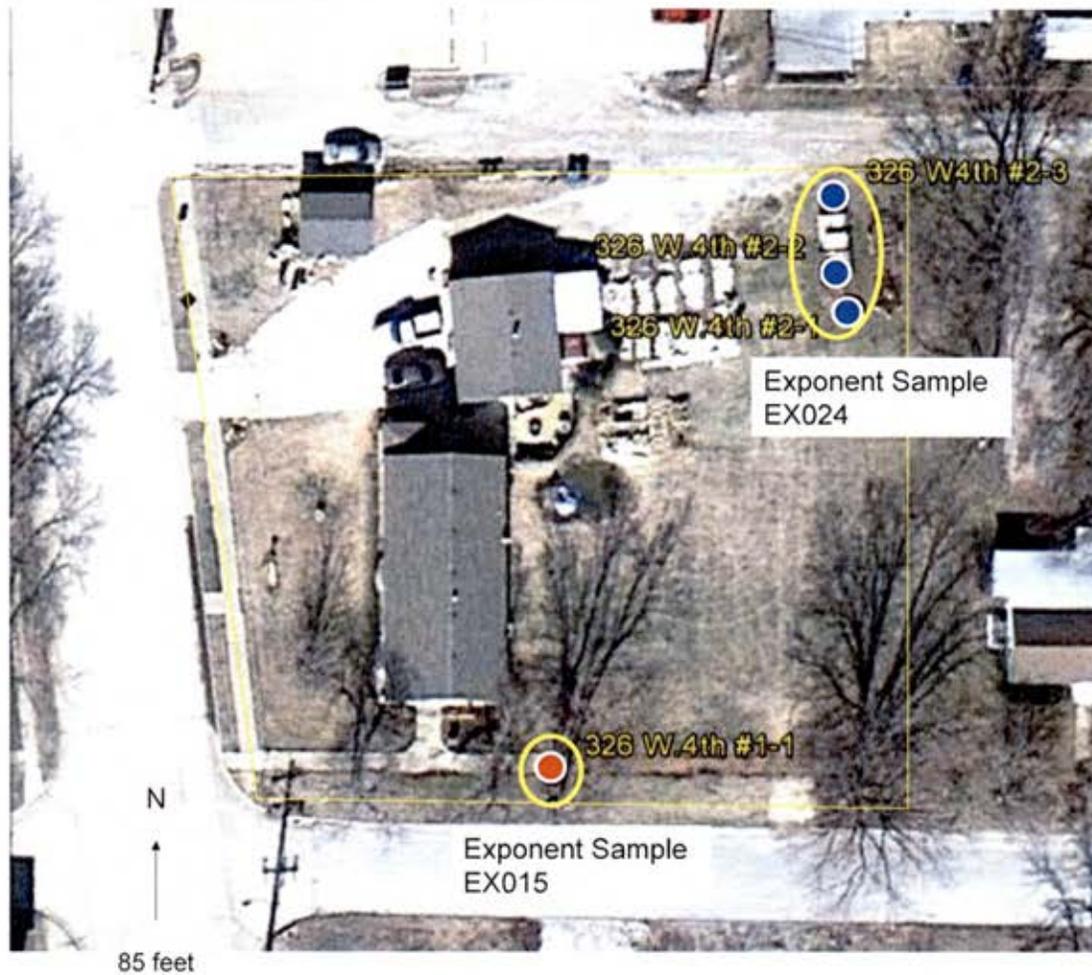
Figure 13 of 19

1:15 PM: Jewitt property 326 W. 4th. Sidewalk noted south side of property, irregular. Sample 1, single point from adjacent to brick sidewalk near southeast corner of residence where concrete and brick sidewalk join. XRF screen low lead with limited sample. No significant slag observed at surface. Exponent composite sample EX015. Sample 2 from northeast side of property. Reddish colored granular slag mixed in with 0.25 to 1.5 cm slag fragments under thin black soil used as driveway fill. Slag black to brown at surface, red color below surface with weathered appearance. XRF screen and three point composite from 0-2 cm below surface. Exponent composite sample EX024.

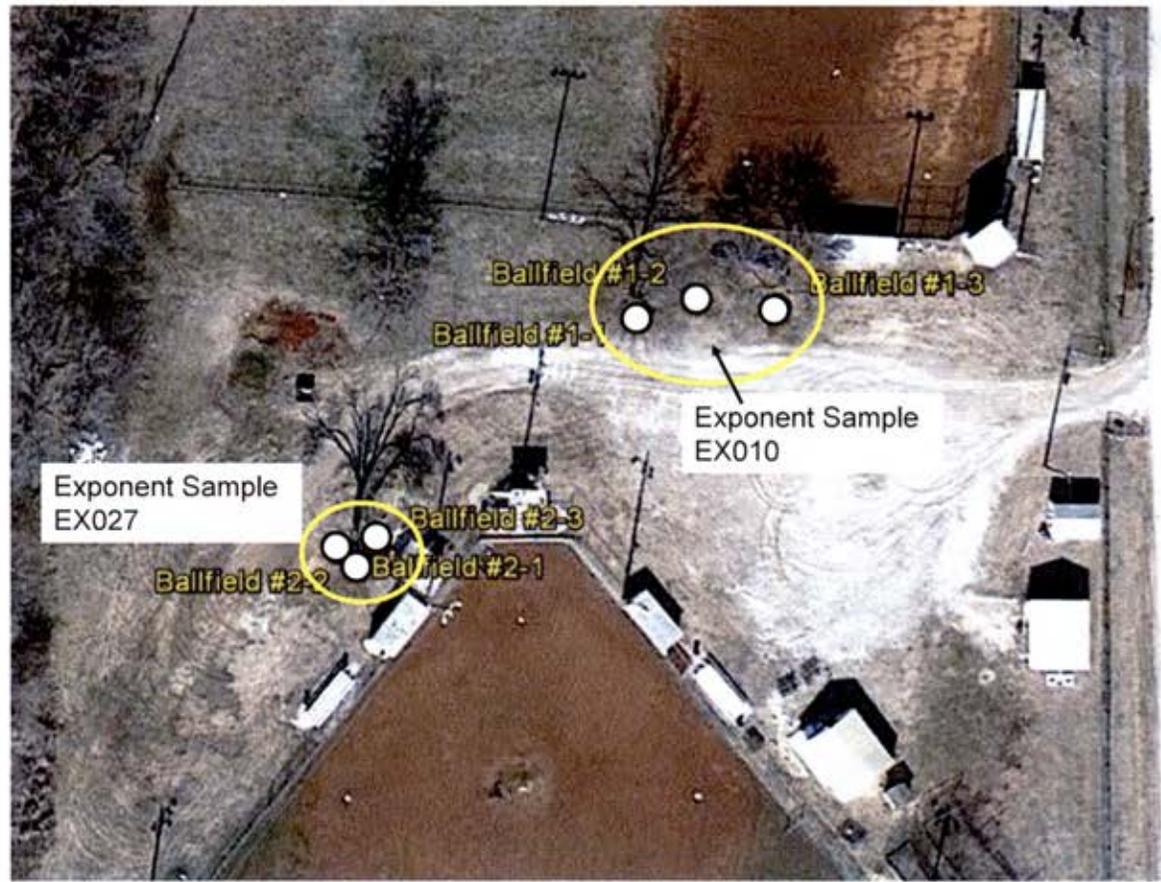
Figure 14 of 19

8:40 AM: Ball Field. North side of entry road near picnic table between bleachers and tree. XRF screen Zn/Pb no As. Bare soil area. Sample composite 1 from three locations approximately 15 feet apart, 0-2 cm below surface. Tan soil with brown to black color angular, vesicular, vitreous slag 0.25 to 0.1.5 cm in size with white inclusions and white limestone fragments from adjacent road. Composite 2. South side of tree and west of buildings south of sample 1. Tan soil with brown to black color, angular, vesicular, vitreous slag 0.25 to 1.25 cm in size with white inclusions. Finer grained well-sorted granular slag below surface. Sample 0-2 cm below surface. Exponent composite sample EX027.

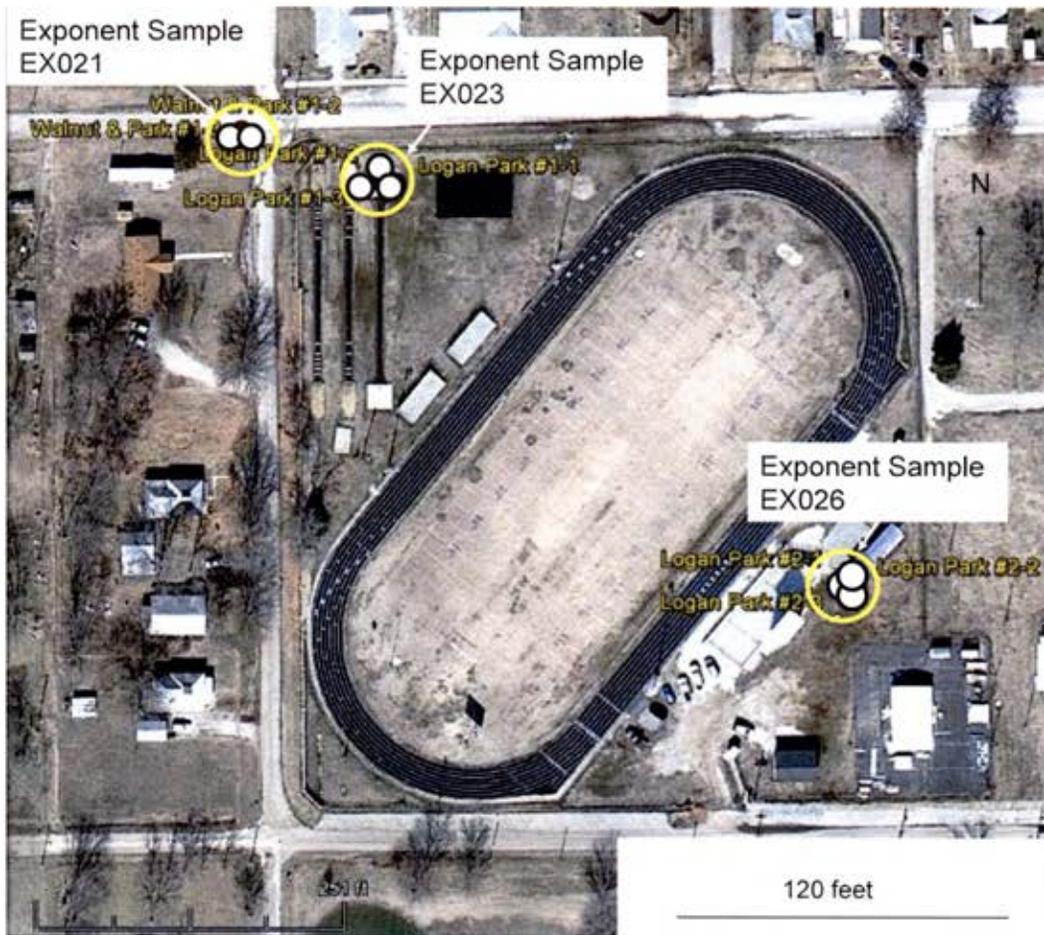
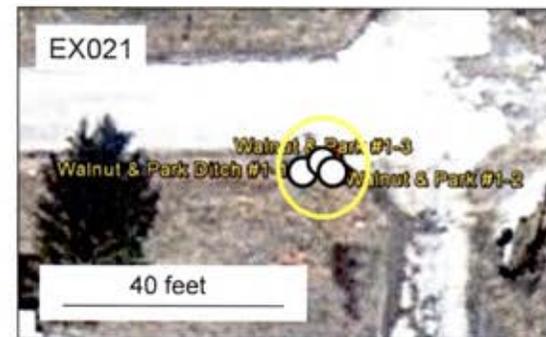
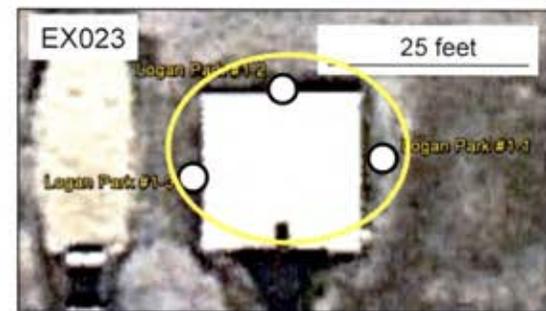
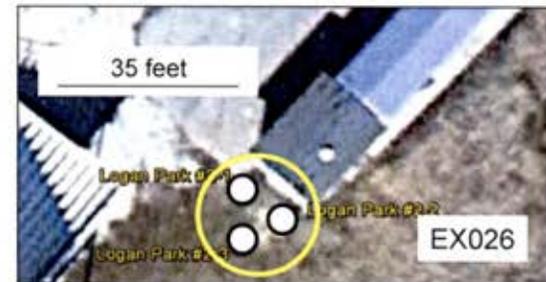
Figure 15 of 19

9:25 AM: Logan Park. Traverse site to northwest side of park to concrete pad on north side of pole vault location. Black colored vitreous and vesicular slag 0.25 to 0.1.25 cm size. Appearance similar to ball field occurrence. Present in soil base surrounding concrete. Sample 1, 0-2 cm deep, three point surface soil composite from base of concrete pad. Exponent composite sample EX023. Move southeast across track to concession area near bleachers. Sample 2, three point composite immediately west of brick building. Bare

10:20 AM: West Walnut and Park ditch. Soil with dark slag fragments up to 3 cm, irregular distribution, with red brick fragments on south side of road. Slag possibly in road base. Shallow ditch nearly filled with sediment. Note stick-up piece of 2-7/8 inch drill pipe nearby. Occasional purple colored retort fragments with vitreous fused and vesicular surface. Chat fragments noted in road and soil. Three point surface soil composite 0-2 cm below surface within 2-3 meter area. Exponent composite sample EX021.

Sample Locations – Logan Park, Walnut & Park St., Cherryvale, KS

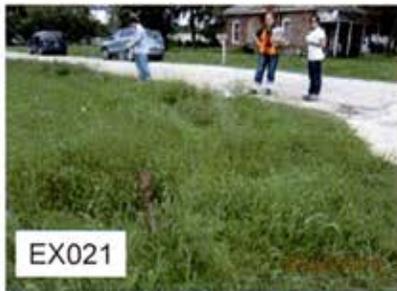
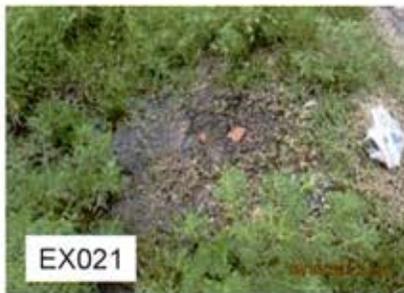
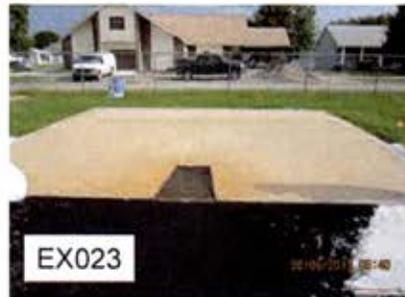
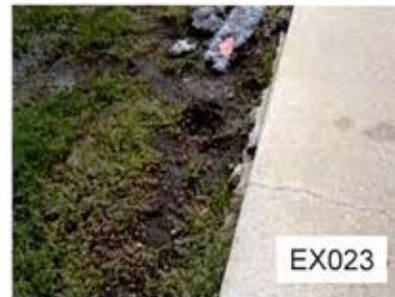
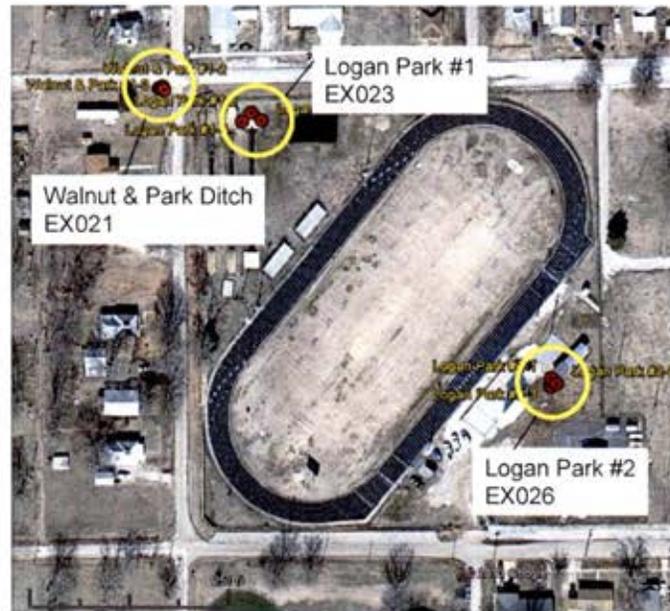
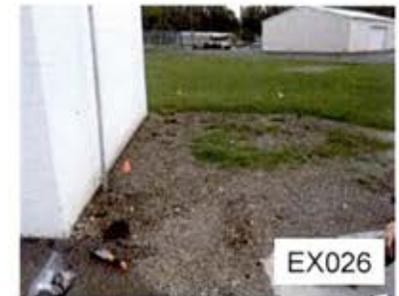
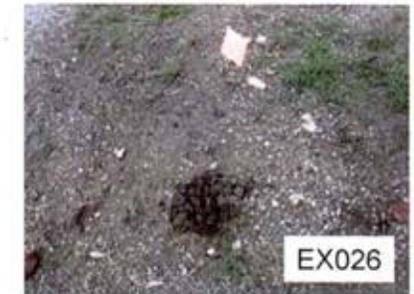
Figure 16 of 19

brown colored soil with white limestone rock fragments, brick and isolated black slag fragments. Exponent composite sample EX026.

Walnut & Park Ditch

Logan Park #1

Logan Park #2

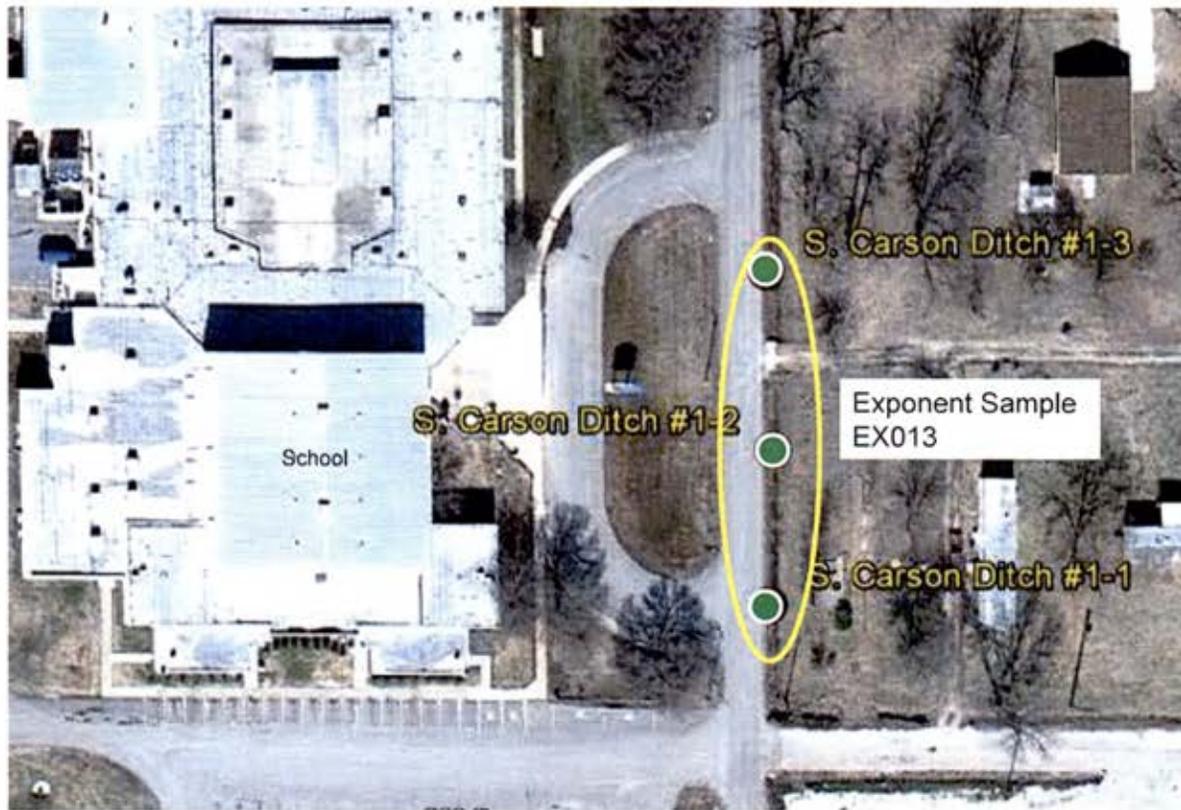
Figure 17 of 19

2:10 PM: S. Carson ditch east of school. Road edge at S. Carson north of 9th. Three locations for composite selected along east edge of road on ditch bank. Ditch 0.4-1 meter deep in areas, water flowing at time of sampling. Dark brown soils with isolated slag fragments, chat fragments, asphalt residue and limestone gravel. Some native limy sandstone ledges noted in ditch bank. Material apparently used as road base under asphalt road and road topping. Large 5-10 cm purple colored ceramic retort fragments with black vitreous fused vesicular surface. Stratified appearance of soil noted in ditch sidewall. XRF screen on soil and slag fragments. 0-2 cm sample of soil below soil surface. Composite for S. Carson ditch sample 1. Exponent composite sample EX013.

Slag Fragments Near Sample 1-2

Slag Fragments Near Sample 1-3

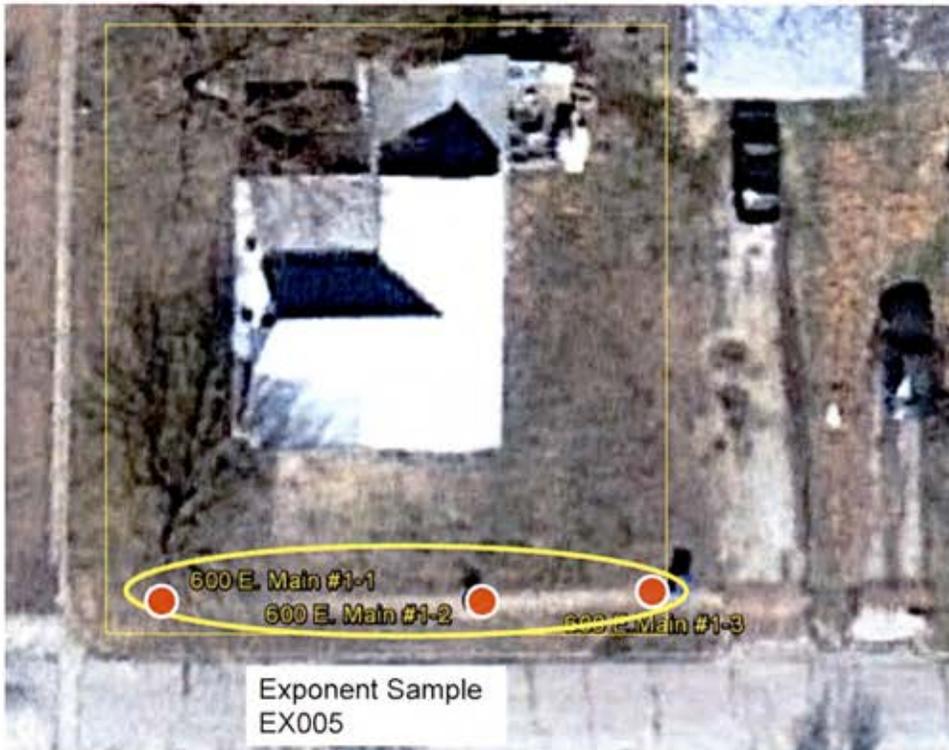
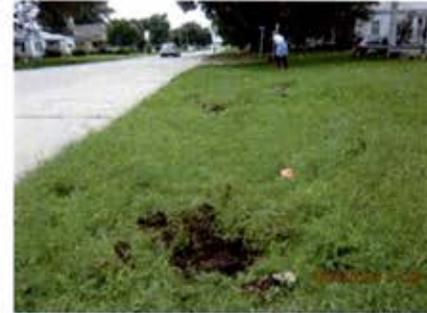
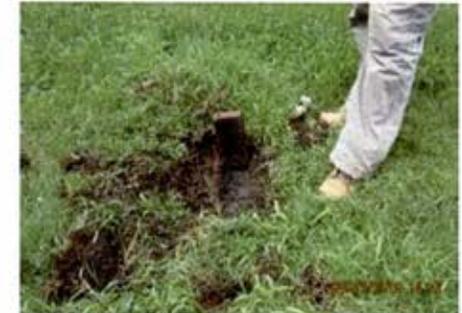
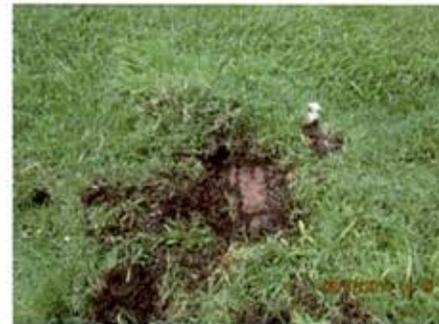
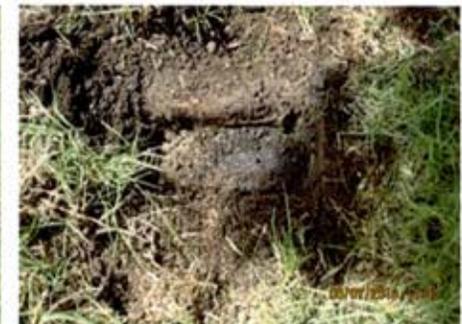
Figure 18 of 19

2:30 PM: 600 E Main sidewalk sample. Initial XRF screen of surface soil adjacent to brick. Remove brick in three locations across front of property. Black colored, sand-sized, compact, well sorted granular slag present beneath each brick. Spot XRF screen. Collect sample 0-2 cm below surface. Exponent composite sample EX005.

Slag Under Brick

Brick Under Grass
