**RE: National Zinc – Cherryvale Removal Site Evaluation - Phase I Data Report
Former National Zinc Site, Cherryvale, Kansas KDHE Project Code #C3-063-00026;
Consent Order Case #03-E-0022. Response to Comments.**

**Cherryvale, Kansas Bioavailability Sample Screening and Collection
Field Note Transcript**

Sample Locations – Cherryvale, Kansas Bioavailability Sampling

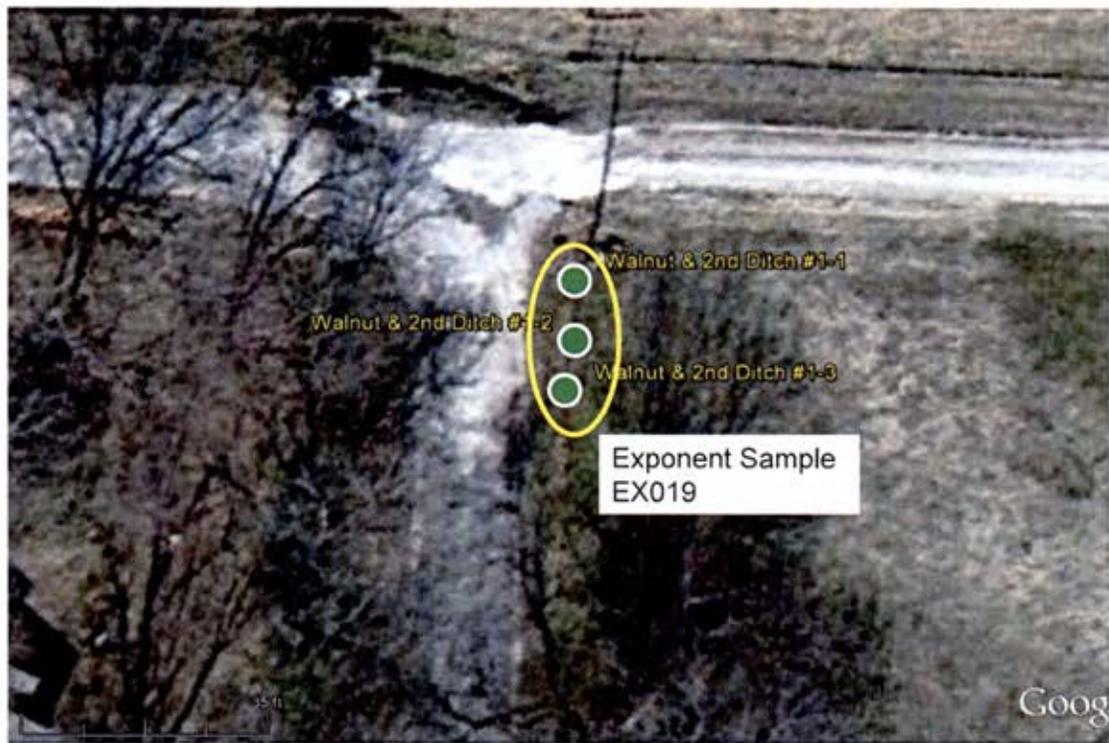
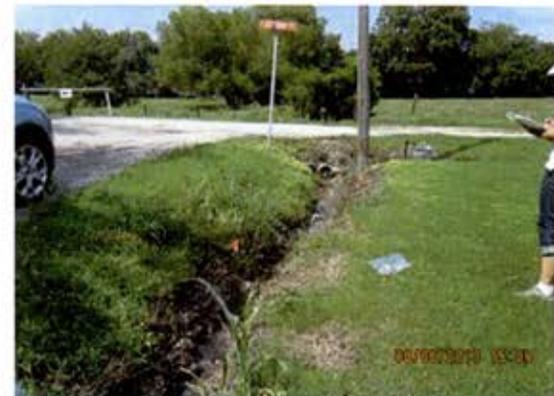
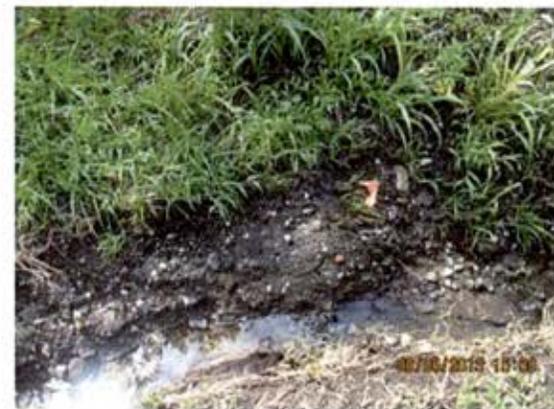
Figure 19 of 19

3:00 PM: E. Walnut and 2nd ditch sample. Isolated slag fragments on east side of road in ditch sidewall with the appearance of road base under asphalt. Slag, brick and native rock fragments noted on east and west side of road. Dark stratified soil layer noted below asphalt on east side by sample point. Tan-brown soil with native rock fragments, brick and slag fragments. Slag fragments variable in size up to 5-8 cm. Purple colored ceramic retort fragments with black vitreous surface. Standing water in ditch at time of sampling. XRF screen of soil adjacent to fragments. Sample composite soil 0-2 cm below surface near retort fragments along 20 foot long length in ditch side wall. Exponent composite sample EX019.

Slag Fragments in Soil
