Golder Associates Inc.

Project No.: 113-81564

Re: REPORT ON DECEMBER 2010 500 RAMP SOURCE EXCAVATION ACTIVITIES

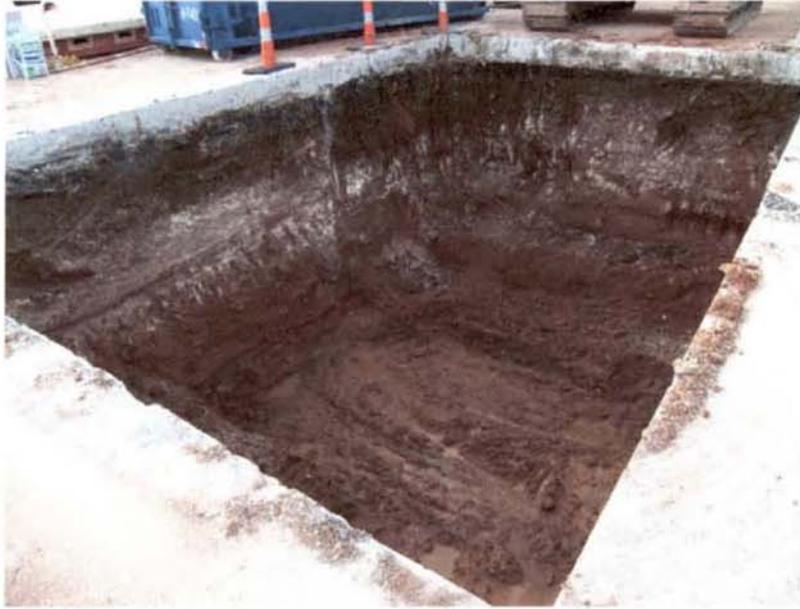
Photograph 1: View of excavation prior to backfilling.

The excavation area began with an area approximately 20 feet by 20 feet, and was subsequently expanded to the west, due to elevated field screening results (above 20 parts per million [ppm]). Based on field screening results, this excavation expansion was extended along the west sidewalls an additional 10 feet. Half of the excavation was completed to approximately 11 to 12 feet below ground surface (ft bgs) and half was completed to approximately 14 ft bgs. The depth of excavation was increased to 14 ft in areas based on the results of field screening. The total volume of concrete removed was approximately 33.3 cubic yards and the total volume of in situ soil removed was approximately 248.1 cubic yards (Photograph 1 in Appendix A).

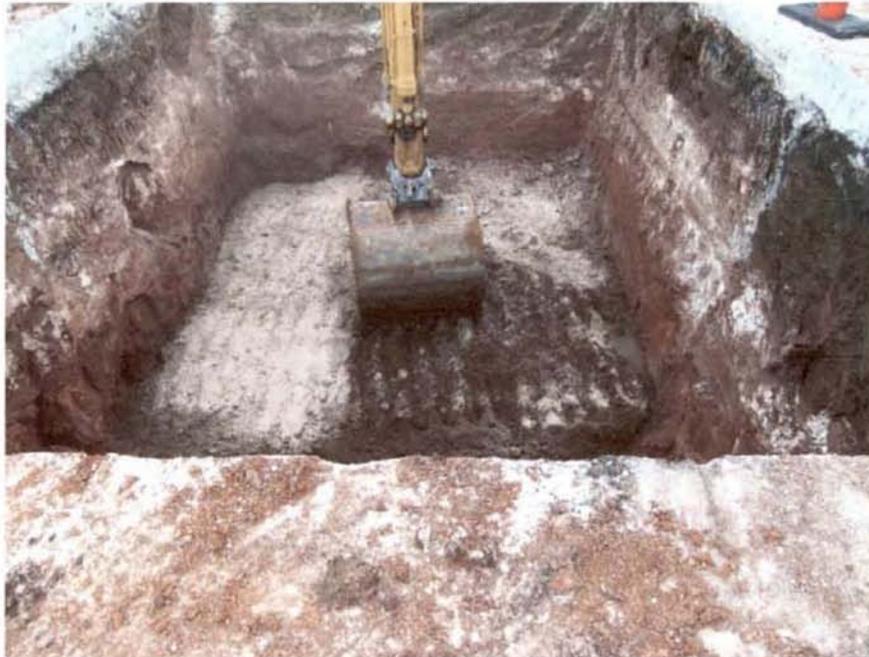
Photograph 2: View of ChitoRem mixing in excavation.

ChitoRem and then another 75 pounds of ChitoRem was spread over the backfilled soil. The excavator operator then used the teeth of the excavator bucket to thoroughly mix the borrow soil and ChitoRem across the lift and, using the bucket, tamp the soil until the depth of the excavation in the area was approximately 13 ft bgs (Photograph 2 in Appendix A). The ChitoRem amendment was included in subsequent lifts of backfill until this material was approximately 8 ft bgs (approximately 400 pounds total ChitoRem).

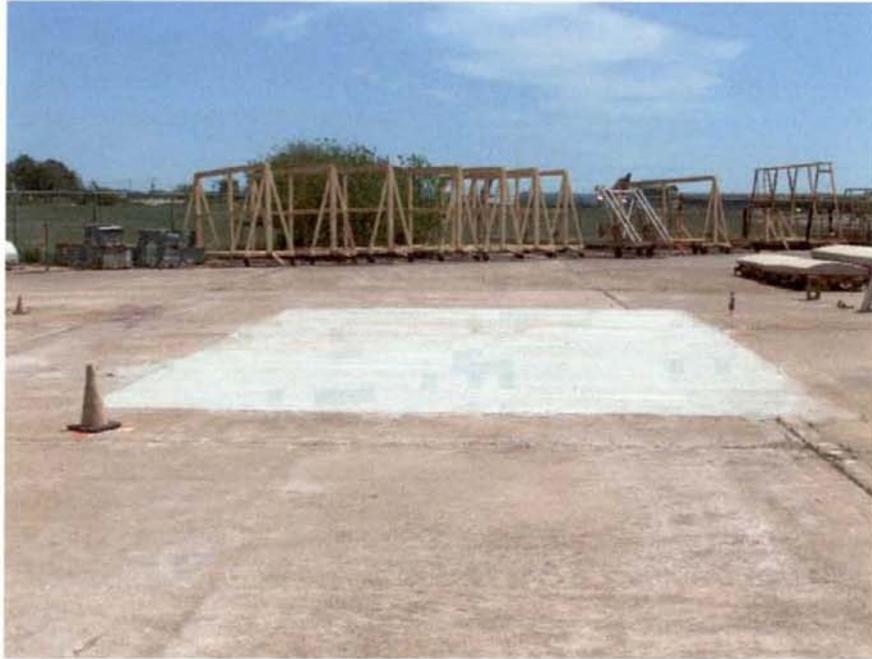
Photograph 3: View of excavation area, completed to match existing conditions.

When the floor of the excavation reached approximately 8 ft bgs, stockpiled soils from the excavation were placed back into the excavation in 1 foot lifts and compacted with a vibratory compactor up to approximately 1.3 ft bgs. The area was then restored to match existing conditions in the area (Photograph 3 in Appendix A). Well BH03-01 was subsequently replaced (after Golder departed from the Site). A log for this replacement well was provided by GSI and is included in Appendix B.
