## Early Phase II Removal Site Evaluation Cherryvale, KS

Soil Sample Results: Cherryvale Unified School District 447  
Former McKinley School, Lincoln Elementary School,  
Cherryvale Middle/High School

Prepared for:  
Kansas Department of Health and Environment

August 2014 revised

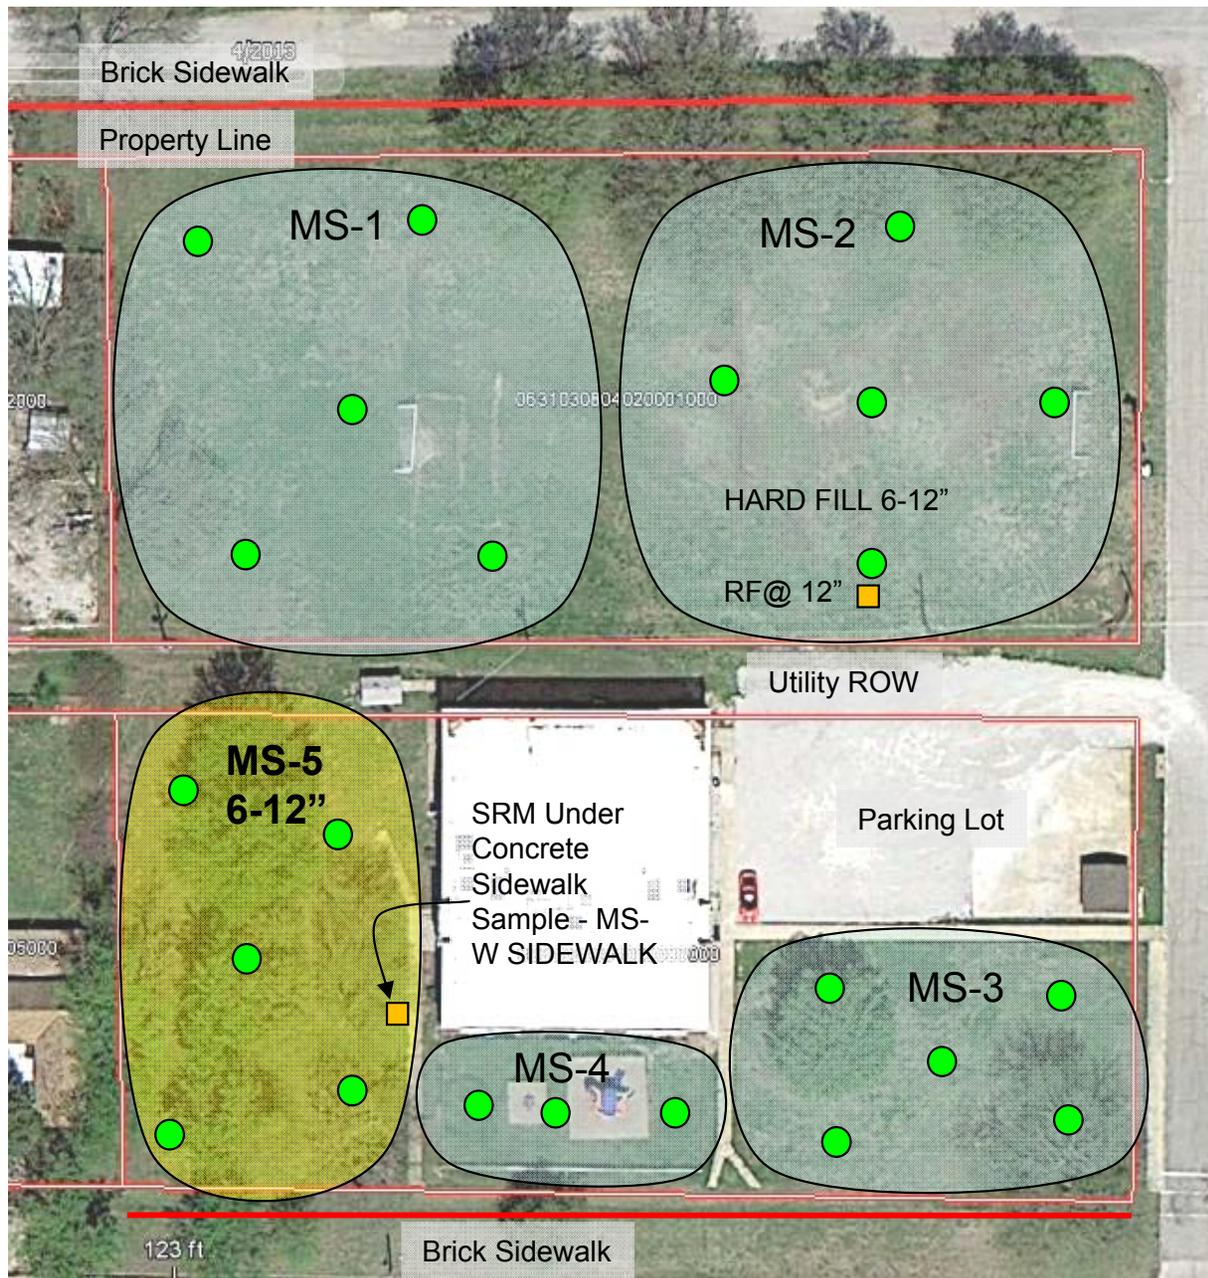
Figure 2

All composites were below the lead screening threshold of 400 mg/kg except for the sample at the southwest quadrant of former McKinley School Sample MS-5B, at a depth of 6-12 inches below ground surface. (Figure 2) Average XRF screening sample results for 4 readings taken on the sieved composite at this location and depth is 445.8 mg/kg lead. This was the only soil composite collected which exceeded the soil screening limit and as noted, this sample was from the 6-12 inch depth, covered by 6 inches of soil that is below the screening threshold.

At the former McKinley School, small area approximately 12 inches in diameter with granular SRM was observed next to the west walkway which was apparently uncovered by a small animal burrow. A grab sample of the granular SRM shows elevated lead which is not representative of average soil concentrations. The location is shown in Figure 2.

Former Mckinley School

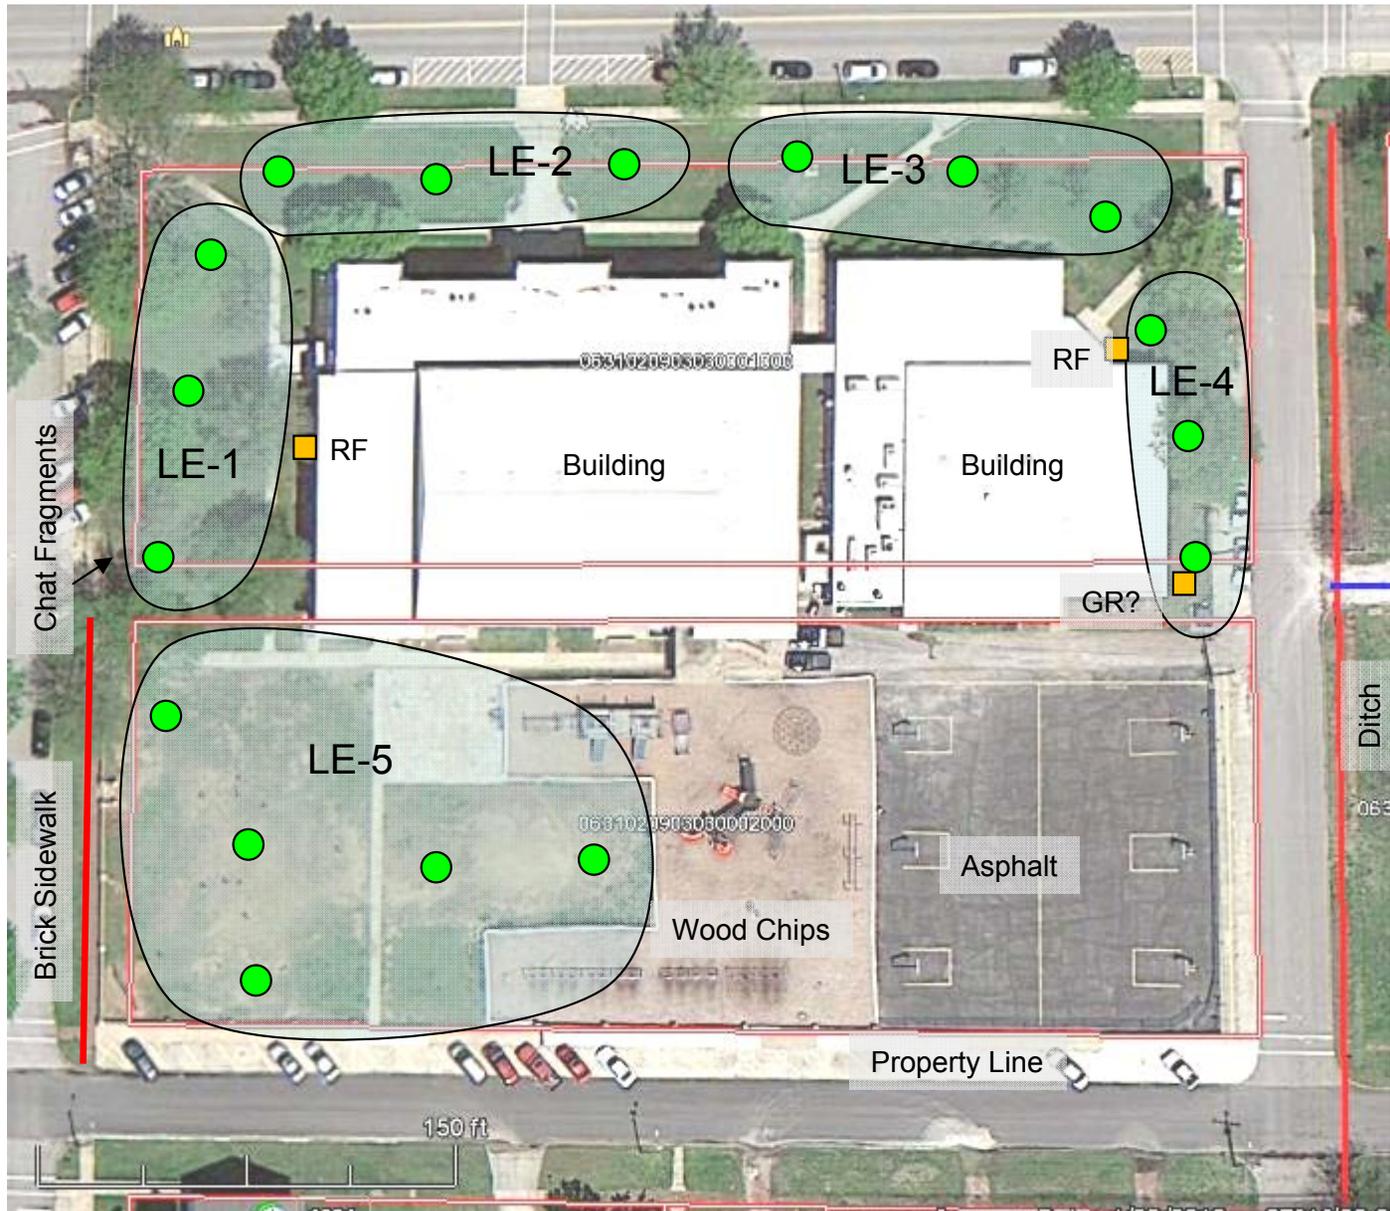
Figure 3

Figures 2 through 5 show the school properties, sample locations, SRM observations and any soil exceedances. Sample results and depth for any composites over the screening limit of 400 mg/kg for lead are highlighted. The individual soil screening data is presented in Table 1.

Lincoln Elementary School

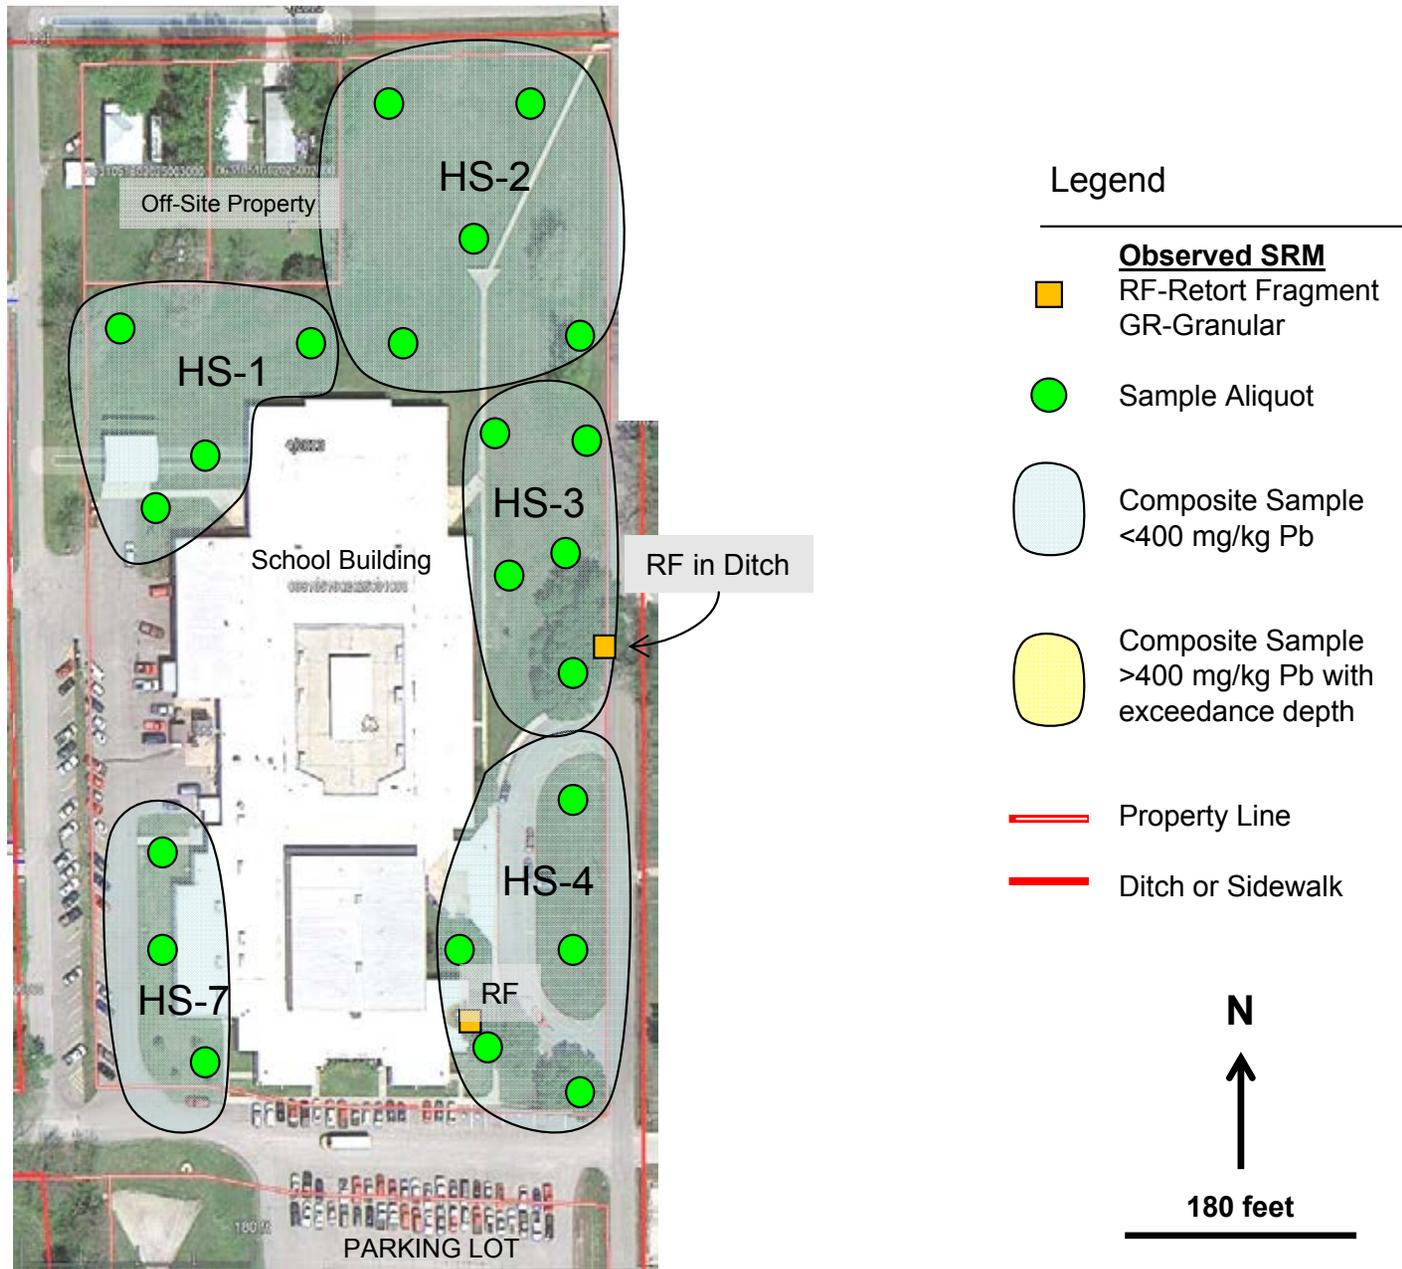
Figure 4

Cherryvale MS/High School (Figures 4 and 5)	Brick with concrete slab, detached outbuilding.	In Use	Grass with landscape northwest, northeast and east. Isolated grass landscape next to building. Asphalt parking lot and grass covered ball field to south. Recent excavation for drainage line north side. Recent radio tower install with concrete footings north side.	Isolated SRM retort fragment southeast corner of building under trees. Isolated SRM fragments in ditch directly north of circular driveway on east side.

Cherryvale High School North Property

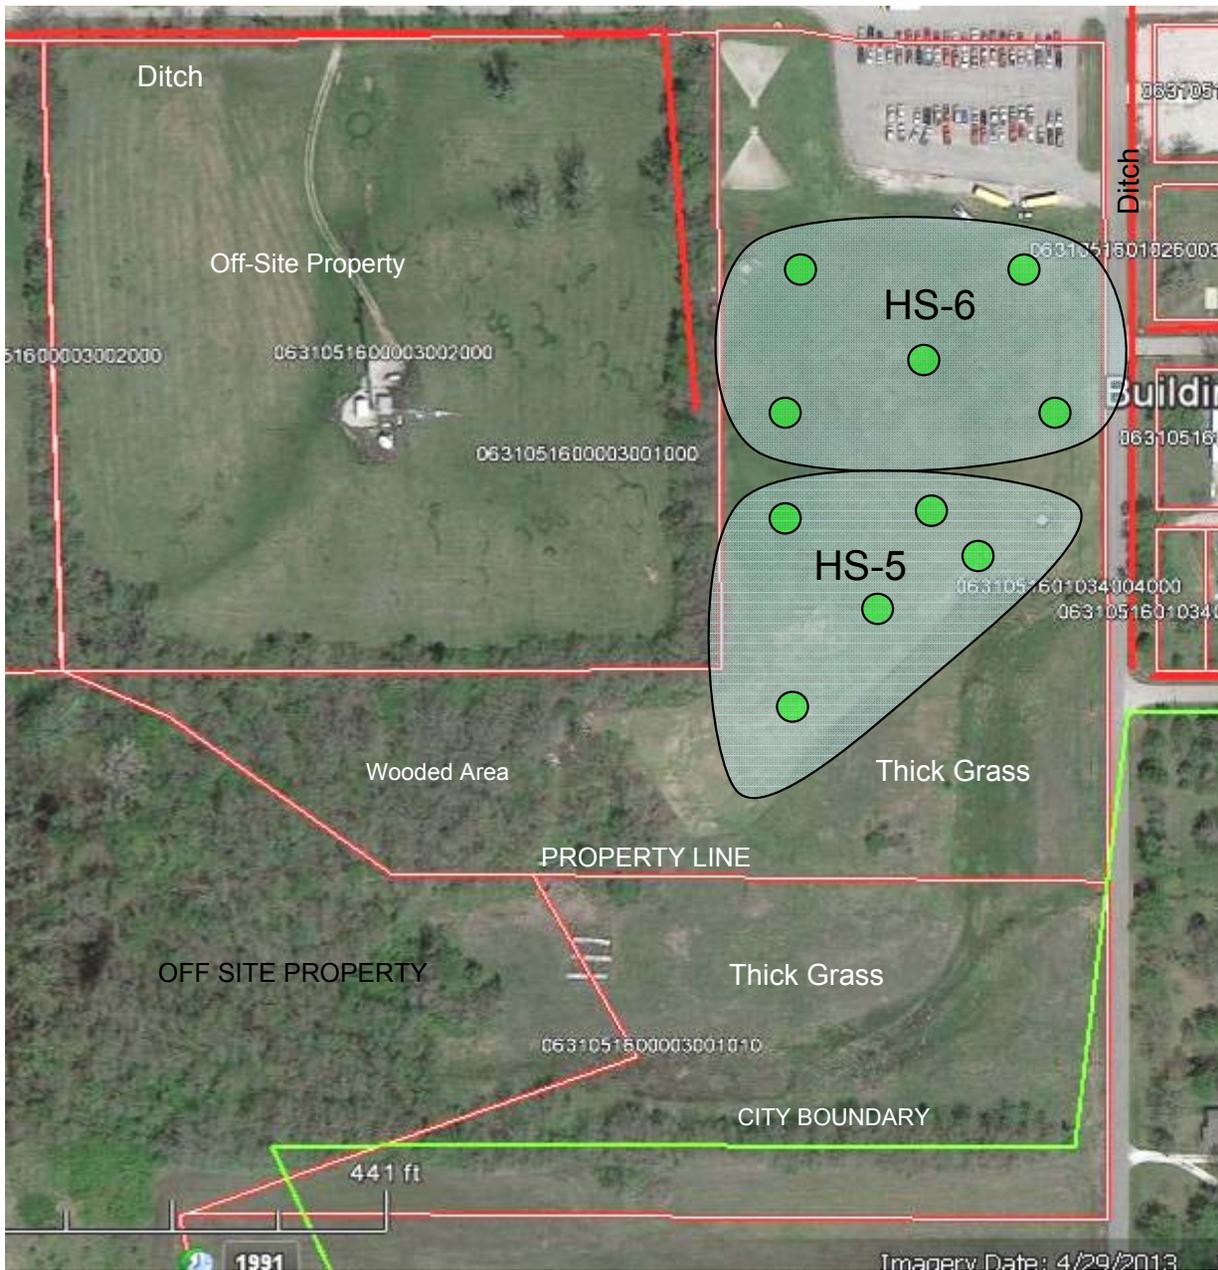
Figure 5

Cherryvale High School South Property
