PRELIMINARY ASSESSMENT
WADE'S ALUMINUM PRODUCTS
FORT SCOTT , KANSAS
CERCLIS Identification Number
KSD087772372

**Wade's Aluminum Products
Fort Scott, Kansas**

Preliminary Assessment

CERCLIS Identification Number
KSD087772372

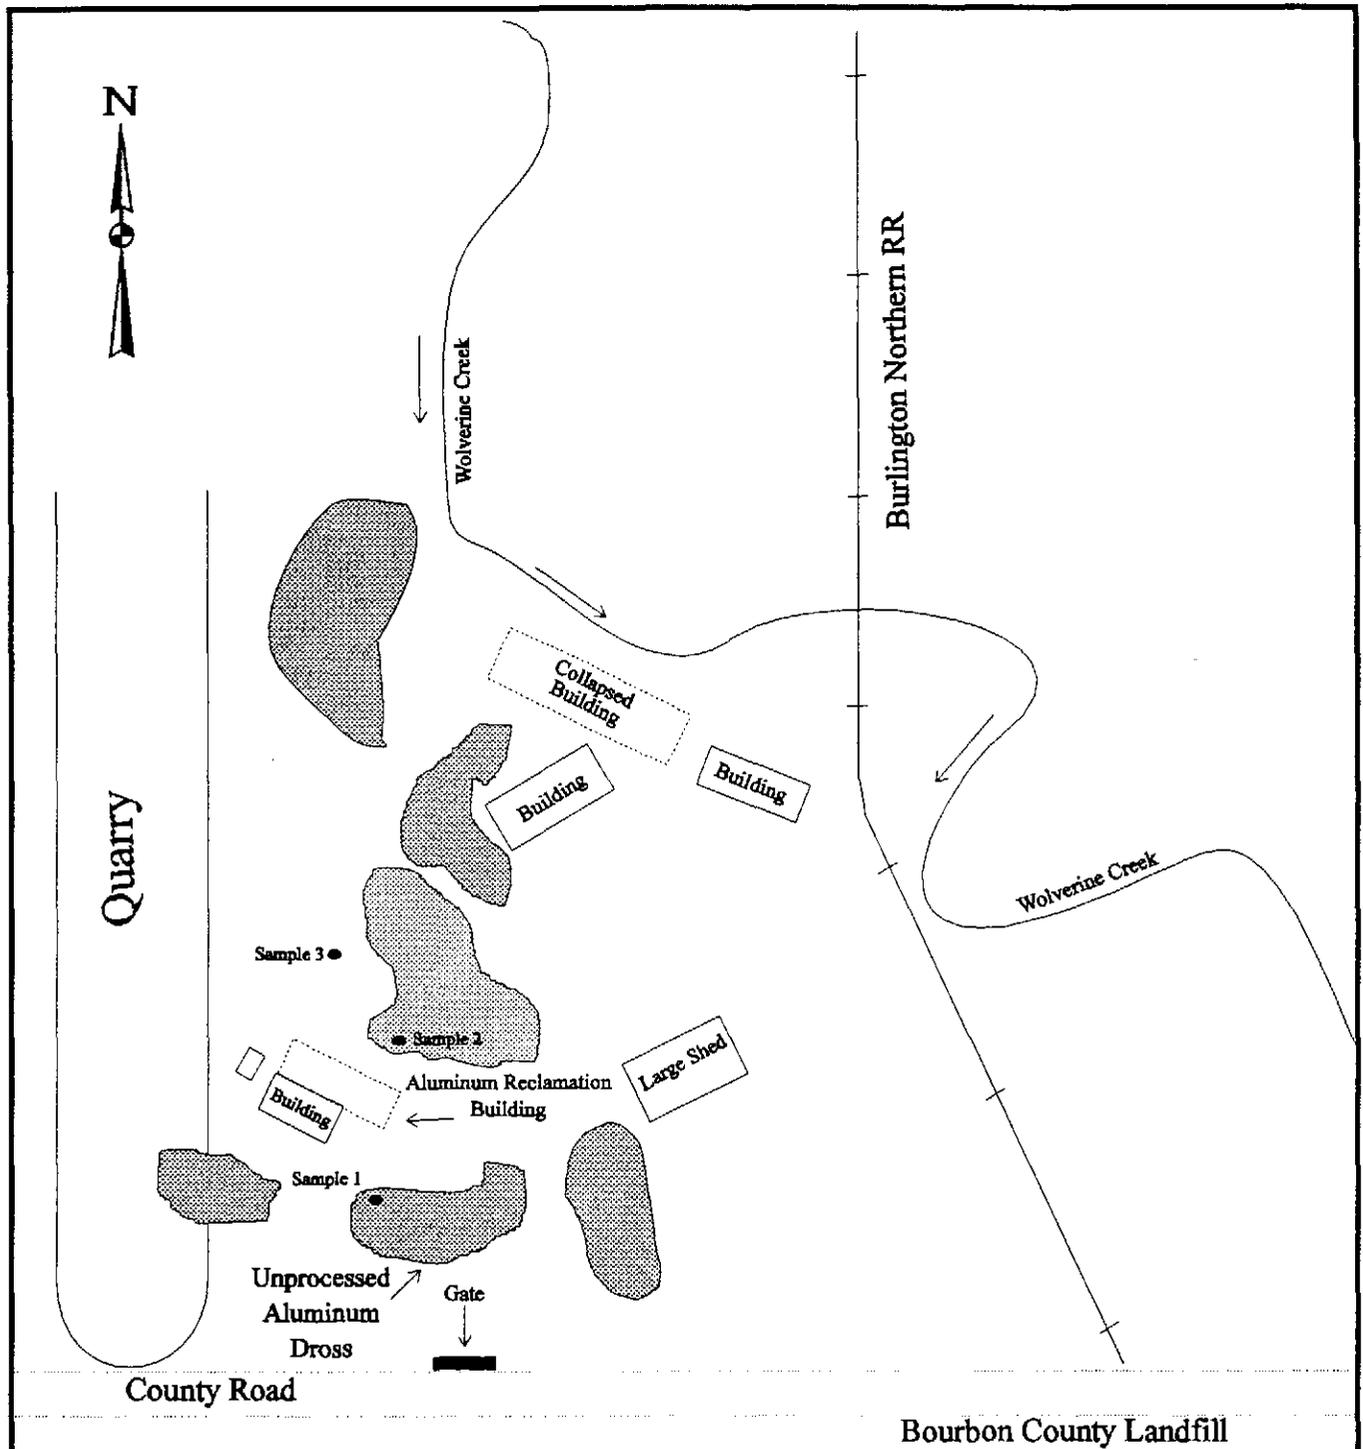
Figure 2
 Site Map
 Wade's Aluminum Products
 Preliminary Assessment

Source: KDHE Site Reconnaissance

Processed Dross Waste Pile

The Wade's Aluminum Products site is an abandoned aluminum reclamation facility located in a rural area (Photo 1 and Figure 2). The facility reclaimed aluminum from dross, which is the waste from primary aluminum plants. The aluminum reclamation building has been removed, leaving only a dross storage shed and a particulate emission filter structure, referred to as a baghouse (Photo 2). The site has several other abandoned buildings that were used during the operation of a cement and concrete block plant. Several drums of processed aluminum dross are stockpiled in some of these buildings (Photo 3). The buildings are in very poor structural condition and one large building has collapsed. Several large piles of processed aluminum dross materials are located throughout the site as well as one area of unprocessed dross. Several rubbish piles are also located throughout the site.

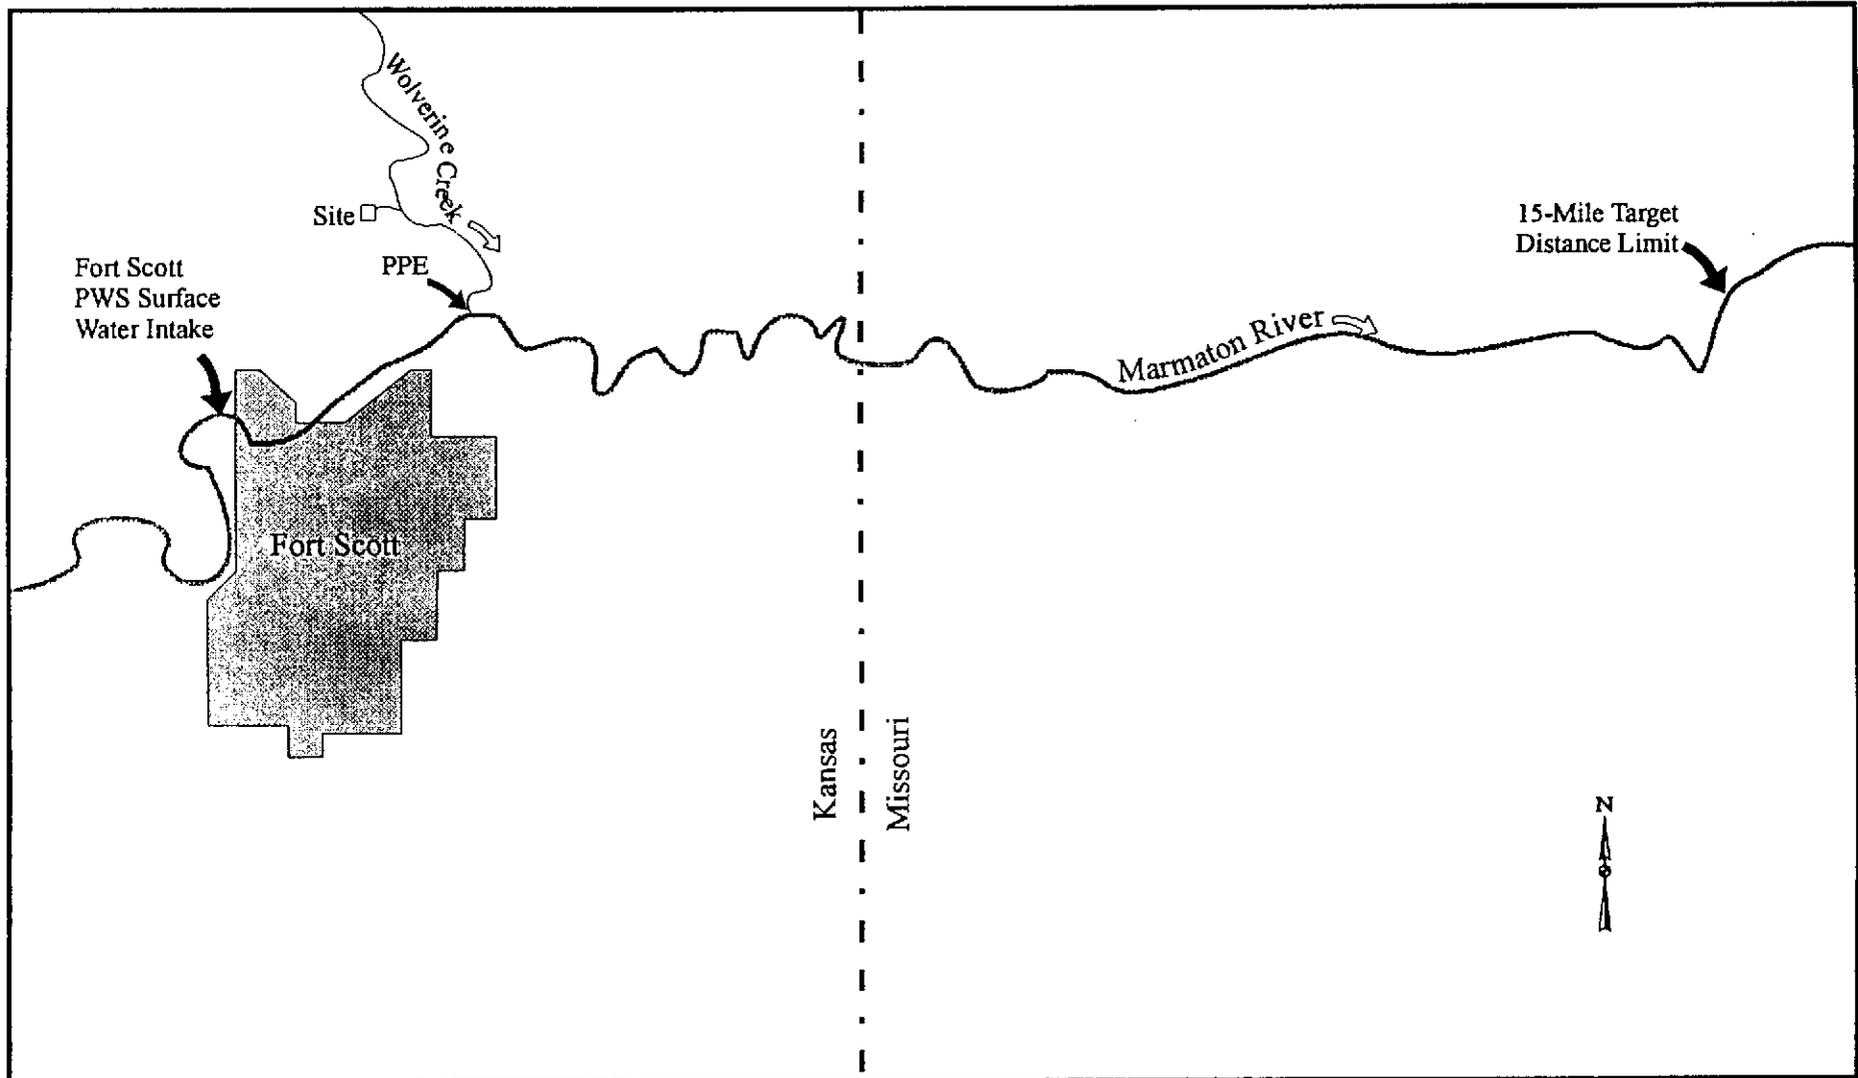
Figure 4
Surface Water Pathway
Wade's Aluminum Products
Preliminary Assessment

The site is located in the Osage River Basin of the Missouri River Basin. Surface drainage from the Wade's Aluminum Products site is to Wolverine Creek. Wolverine Creek is an intermittent stream that flows south-southeast to the Marmaton River, approximately 1/4 mile downstream from the site (Figure 4 and Reference 2). The annual mean discharge of the Marmaton River for the water year 1994 at a gaging station located upstream from the site was 387 cubic feet per second (cfs) (Reference 11). The site lies above the 100 year flood plain of Wolverine Creek (Reference 2). Approximately 9 miles of the in-water surface water segment occurs in Missouri.

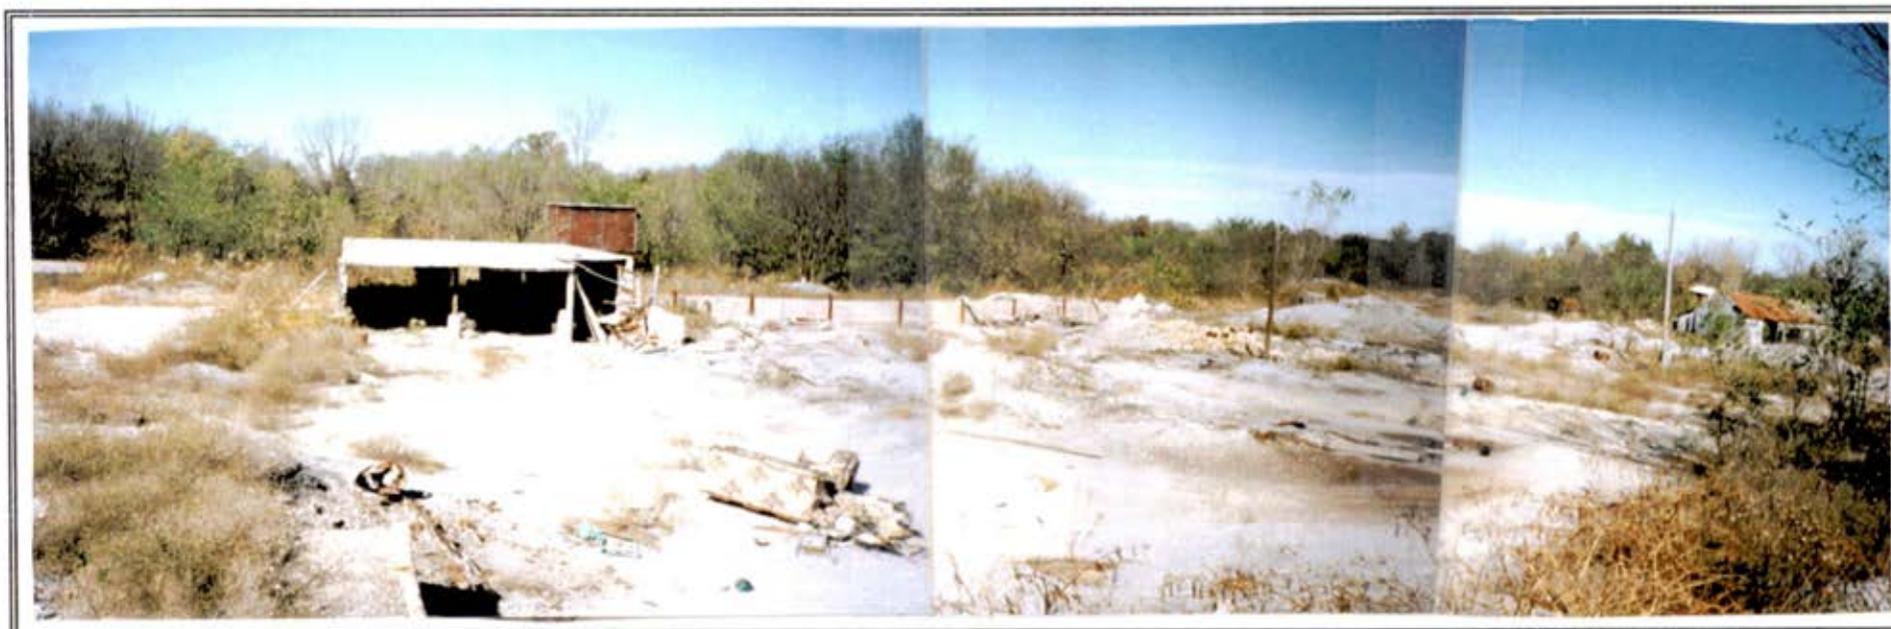
PHOTO #1

Date: October 24, 1995
Location: Wade's Aluminum Site,
Ft. Scott, Kansas
Direction: Viewing Northwest
Photographer: Travis Kogl, KDHE/BER

Comments: Former aluminum reclamation facility. Dross storage shed on left. Former process building location in center. Former cement plant building on right. Waste piles in center background.

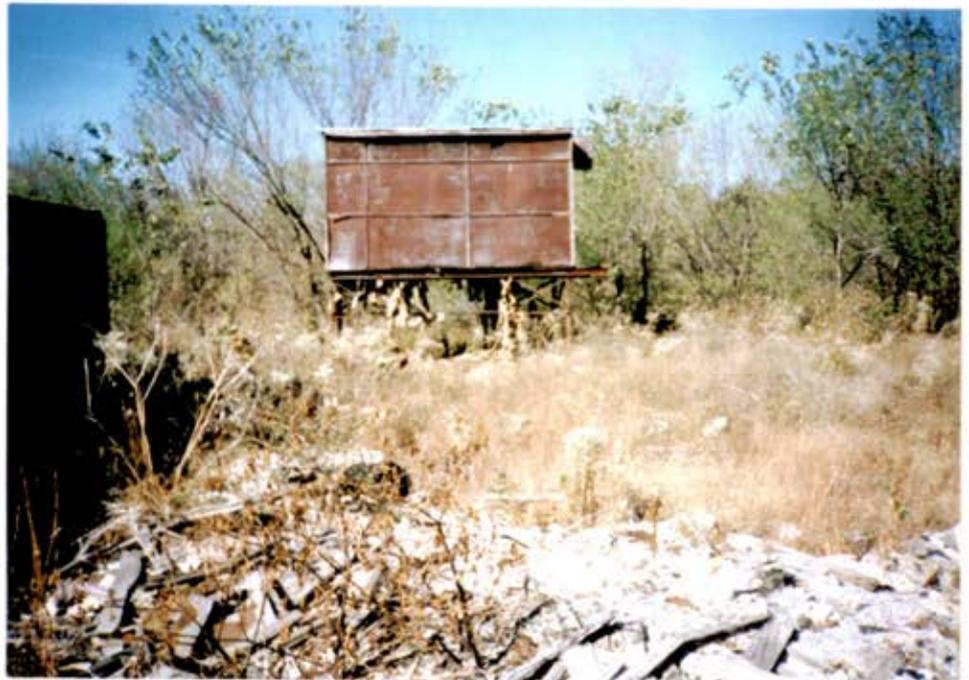
PHOTO #2

Date: October 24, 1995
Location: Wade's Aluminum Site
Ft. Scott, Kansas
Direction: Viewing west
Photographer: Travis Kogl, KDHE

Comments: "Baghouse" particulate
emission control structure.

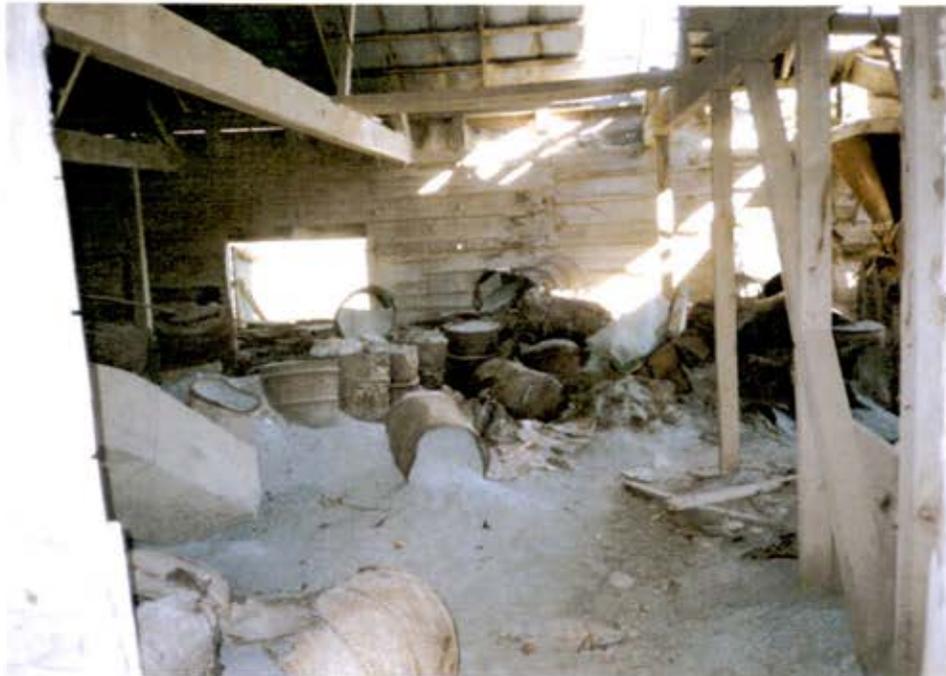
PHOTO #3

Date: October 24, 1995
Location: Wade's Aluminum Site
Ft. Scott, Kansas
Direction: Viewing north
Photographer: Travis Kogl, KDHE

Comments: Waste dross
stockpiled in former cement plant
building.

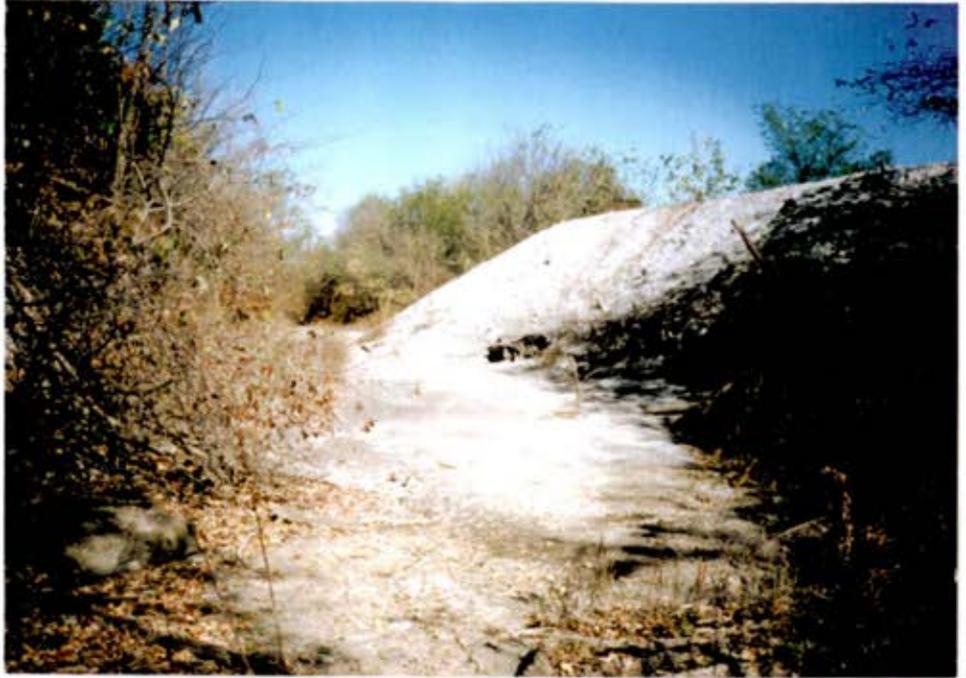
PHOTO #4

Date: October 24, 1995
Location: Wade's Aluminum Site
Ft. Scott, Kansas
Direction: Viewing north
Photographer: Travis Kogl, KDHE

Comments: Quarry partially filled
with waste material. This quarry is
located on the west part of the site.

The Bourbon County Landfill is located south of the site, across a county road. The Burlington Northern railroad borders the site on the east, and agricultural land borders the site on the west and north. A few farm residences exist in the area. An abandoned quarry occupies the west side of the site. The quarry is partially filled with processed dross waste material (Photo 4).

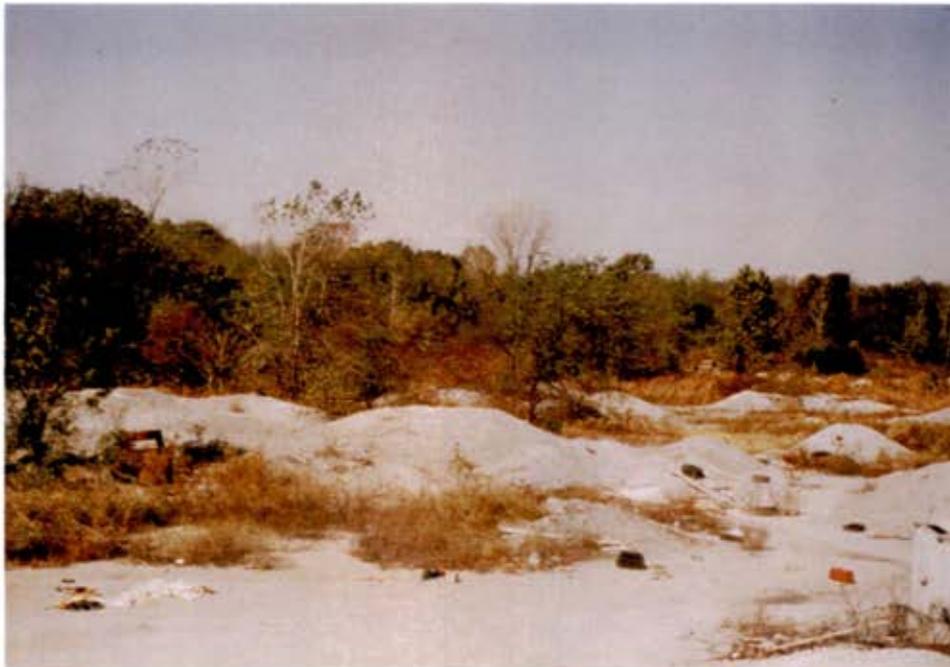
PHOTO #5

Date: October 24, 1995
Location: Wade's Aluminum Site
Ft. Scott, Kansas
Direction: Viewing northwest
Photographer: Travis Kogl, KDHE

Comments: Waste piles of
process dross.
