# Laser-Induced Fluorescence Survey

## Former Coastal Mart #7301 Site

10330 West Central Avenue  
Wichita, Kansas

KDHE Project Code: U2-087-13357

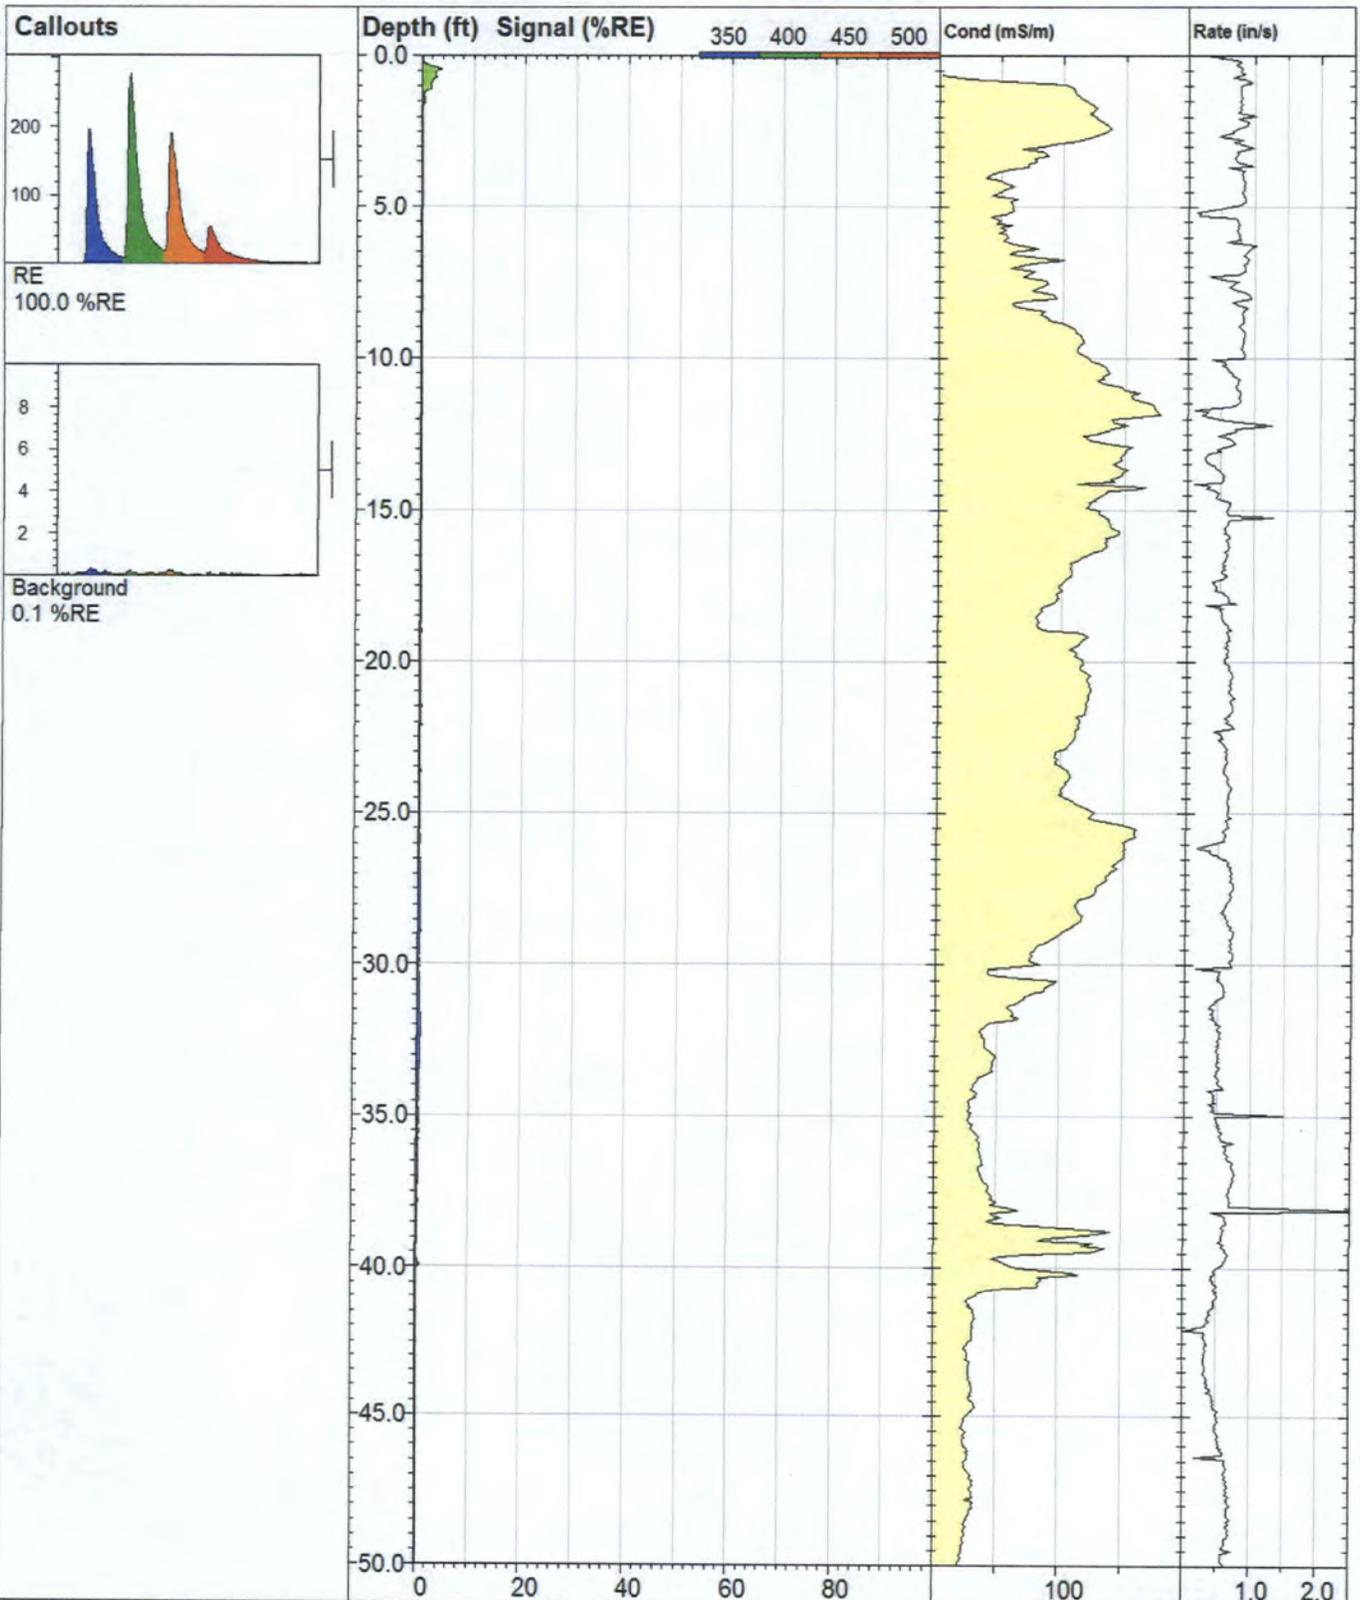
**LIF-01**

Final depth:  
50.07 ft

Max signal:  
3.7 %RE @ 0.44 ft

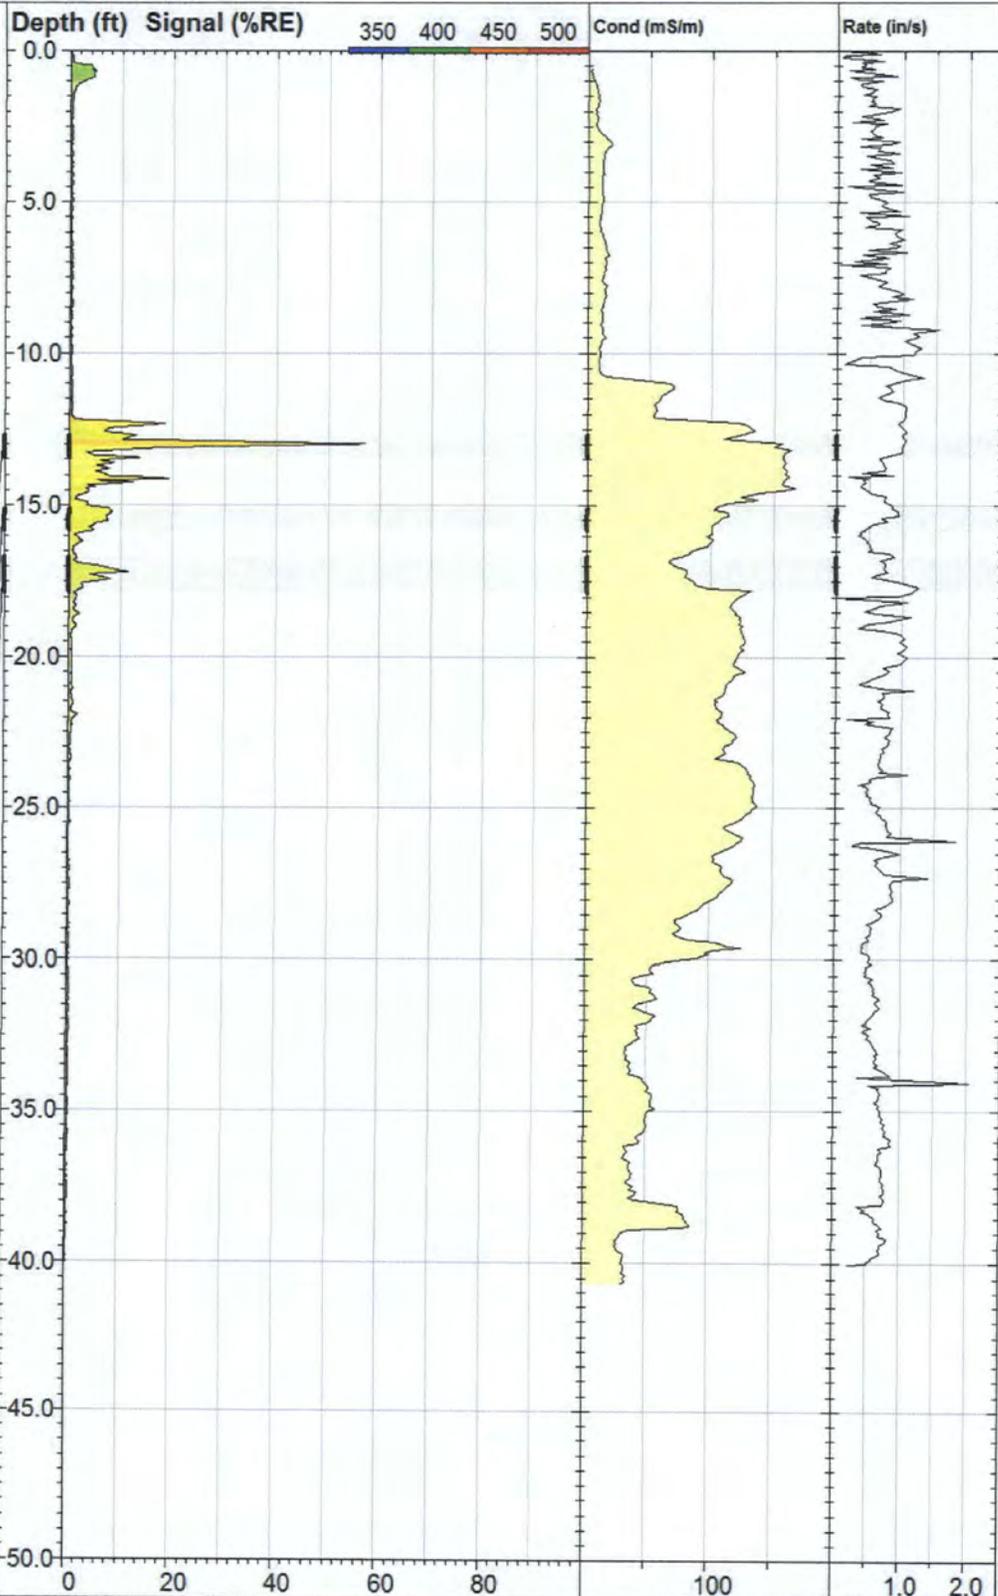
**LIF-07**

Max signal:  
57.1 %RE @ 12.97 ft

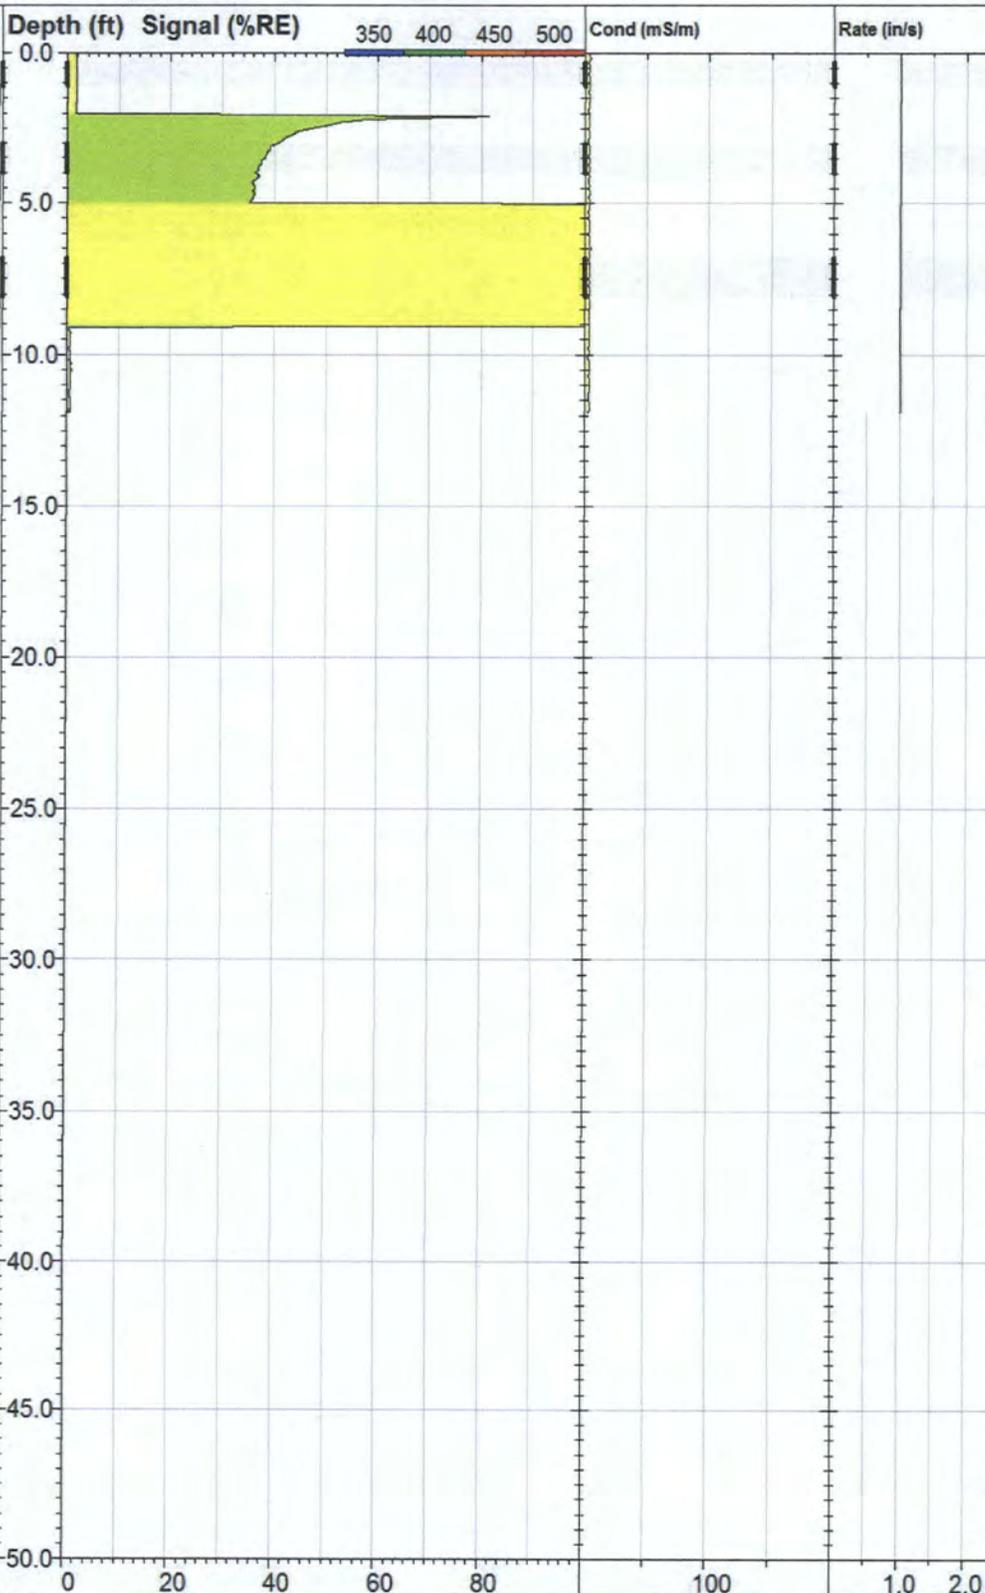
The Electrical Conductivity (EC) of the soil can be logged simultaneously with the UVOST data. EC often provides insight into the stratigraphy. Note the drop in EC from 10 to 13 feet, indicating a shift from finer (clay) to larger grain size (sand) stratigraphy. This correlates with the observed NAPL distribution.

The rate of probe advancement. Approx. 0.8 inches (2cm) per second is preferred. A noticeable decrease in the rate of advancement may be indicative of difficult probing conditions (gravel, angular sands, etc.) such as that seen here at approx. 5 ft.

Callouts can be a single depth (see 3rd callout) or a range (see 4th callout). The range is noted on the depth axis by a bold line. When the callout is a range, the average and standard deviation in %RE is given below the callout.

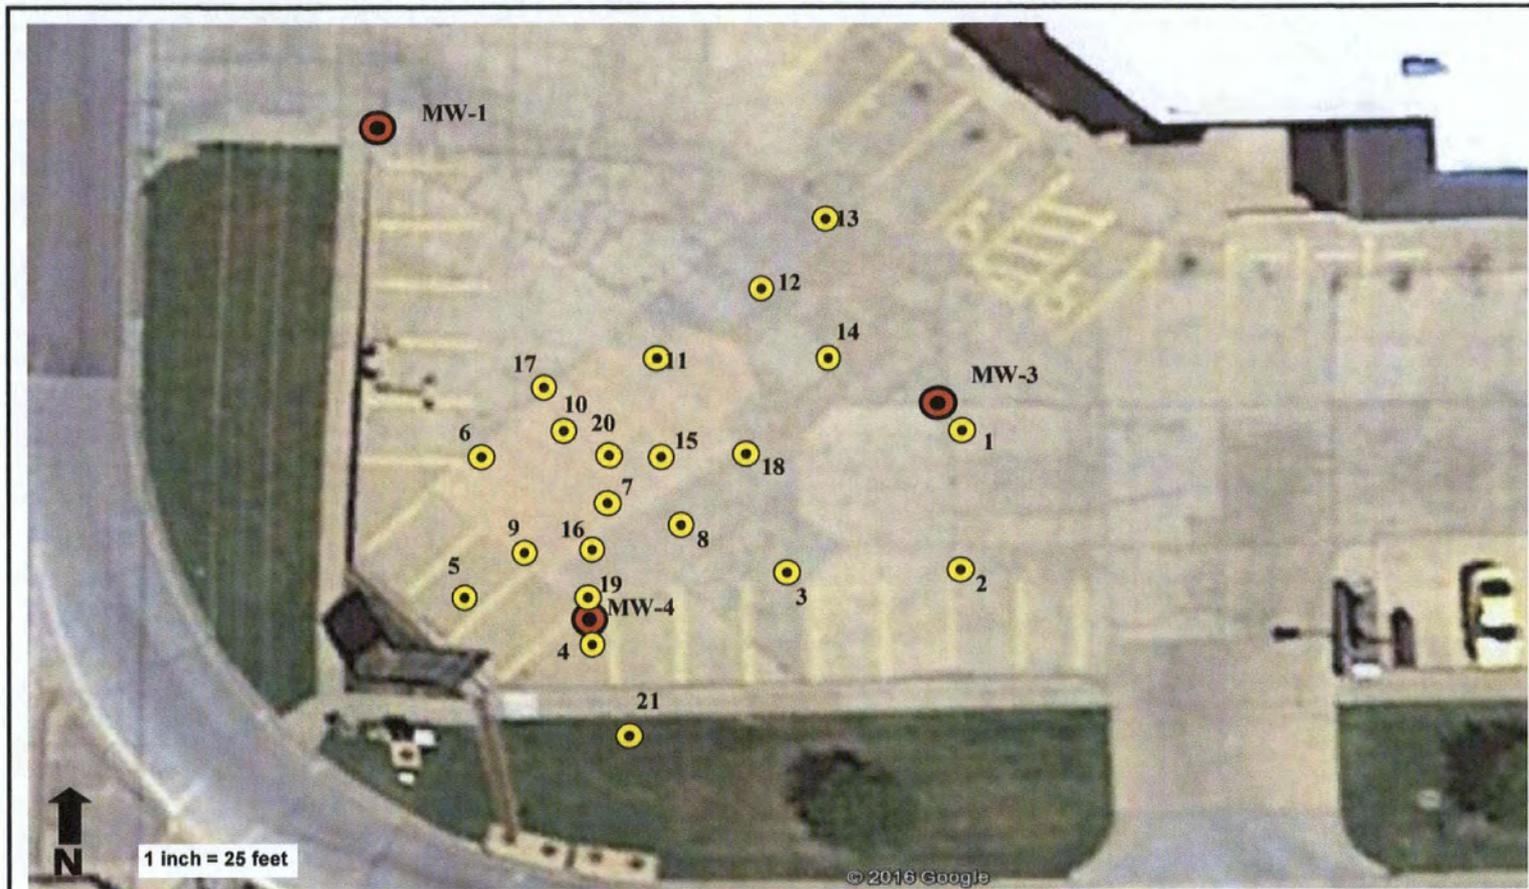
**Figure 1 - LIF Boring Locations**

Site monitoring wells MW1, MW2R, MW-3, MW-4, MW-5, MW-6, MW-7, and MW-8 and the 21 LIF borings were surveyed by a Kansas Licensed Surveyor. Survey data is provided in Appendix A.

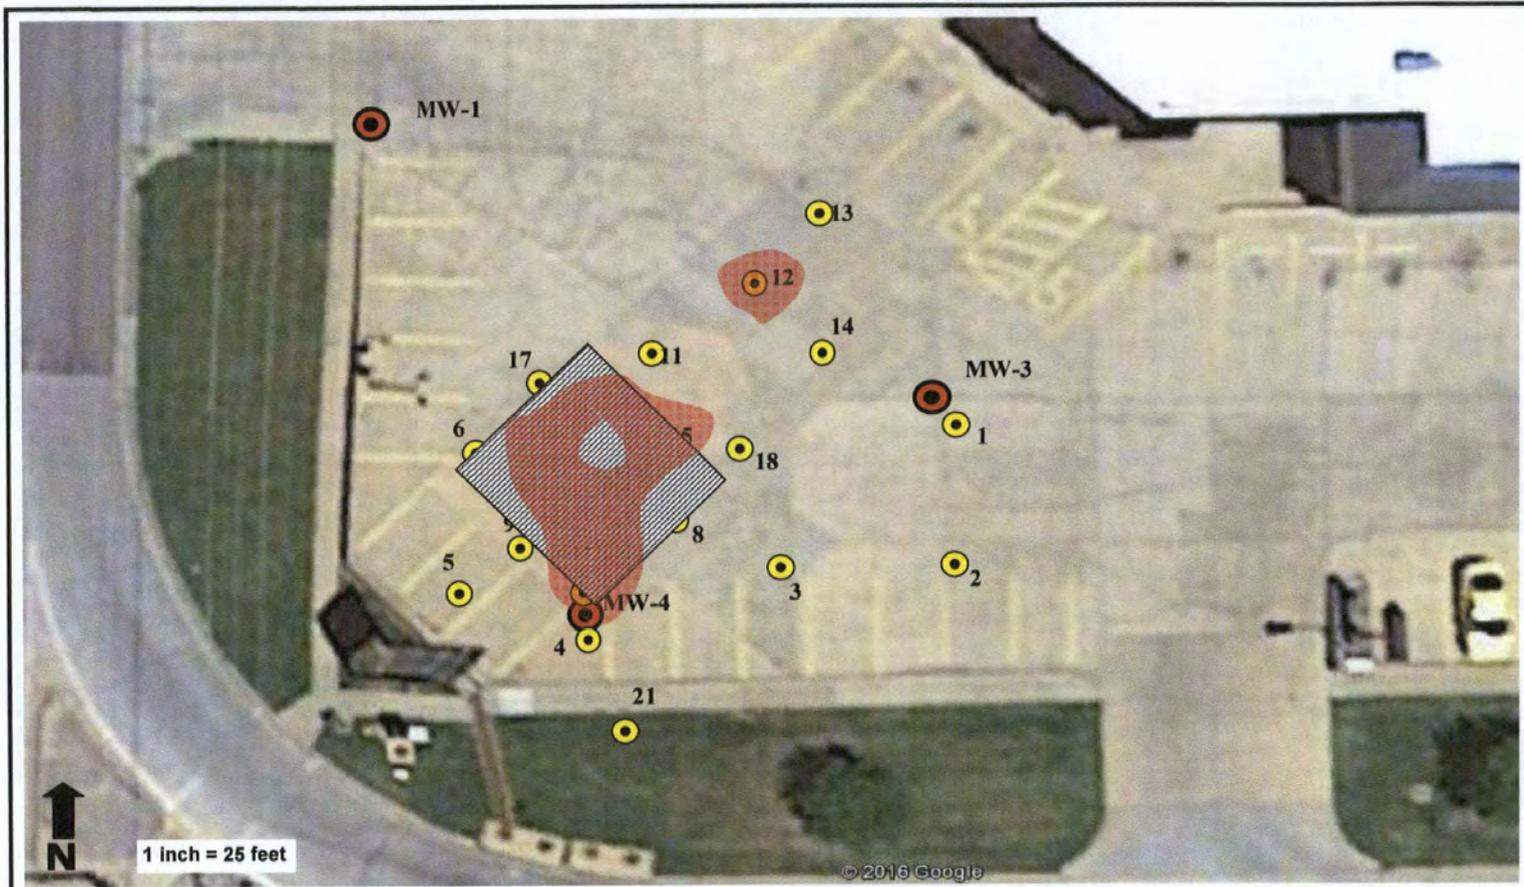
**Figure 3 - Former UST Basin**

EC logs indicate that 8 of the 21 LIF borings locations (LIF-06, LIF-07, LIF-08, LIF-10, LIF-15, LIF-16, LIF-17, and LIF-20) are within the backfill material as evidenced by differences in conductivity readings. This data is consistent with the approximate location of the former tank basin. Figure 3 approximates the location of the former UST basin based on the EC logs.

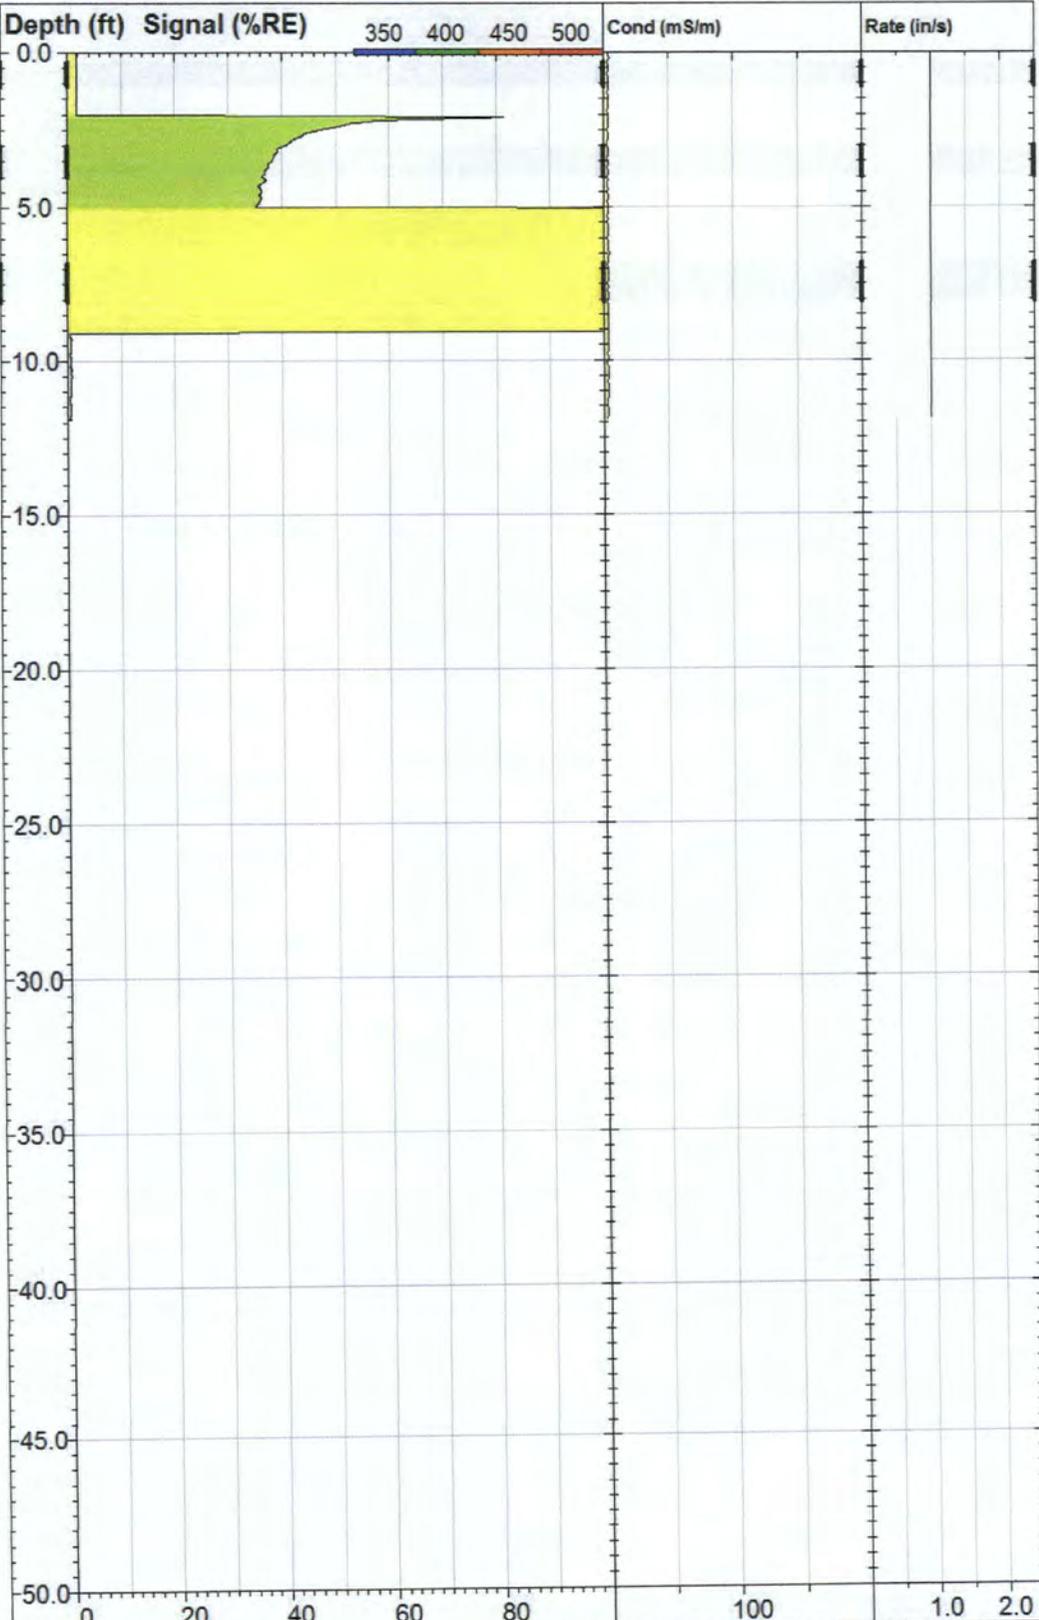
A small amount of LNAPL was collected and analyzed with the UVOST® tool for the purposes of performing a field emulation test. The results of this test were compared to example waveforms provided online at <http://www.dakotatechnologies.com/info/newsletters/article/2013/07/12/interpreting-lif-waveforms>. The LNAPL appears to emulate waveforms typical of weathering gasoline. The emulation log is included in Section 4.0.

<b>Emulation</b>		<b>UVOST® By Dakota</b> www.DakotaTechnologies.com
Site: Former Coastal Mart 7301	Y Coord.(Lat-N) / System: Unavailable / NA	Final depth: 11.90 ft
Client / Job: Larsen & Associates / 025	X Coord.(Lng-E) / Fix: Unavailable / NA	Max signal: 357.9 %RE @ 9.00 ft
Operator / Unit: JM/BG / UVOST1004	Elevation: Unavailable	Date & Time: 2016-09-28 16:16 CDT

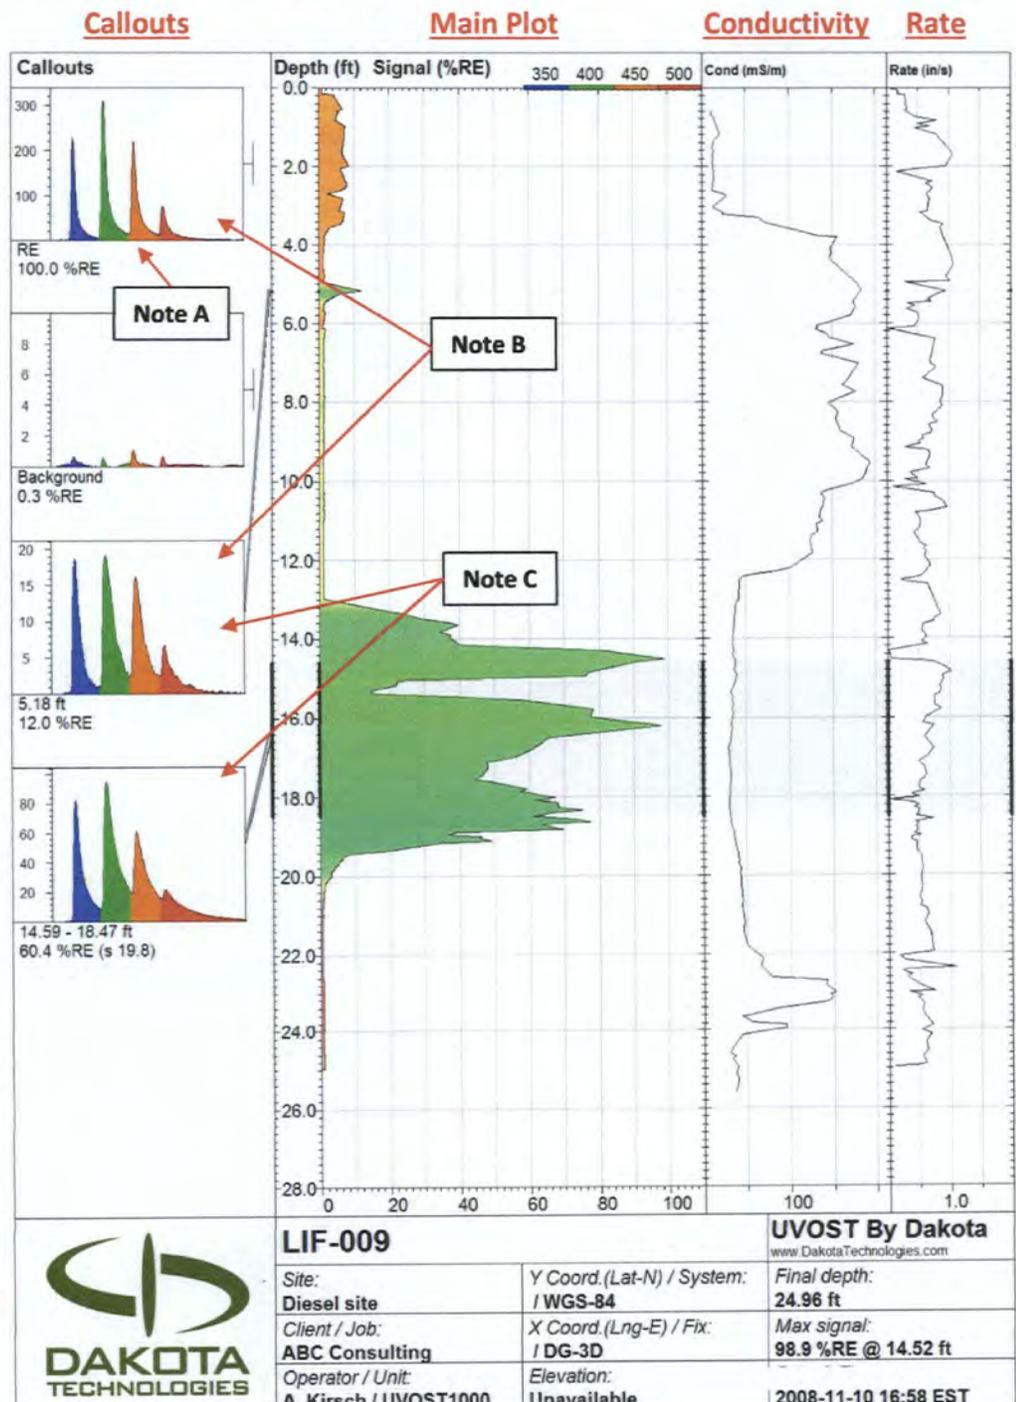
The Electrical Conductivity (EC) of the soil can be logged simultaneously with the UVOST data. EC often provides insight into the stratigraphy. Note the drop in EC from 10 to 13 feet, indicating a shift from finer (clay) to larger grain size (sand) stratigraphy. This correlates with the observed NAPL distribution.

The rate of probe advancement. Approx. 0.8 inches (2cm) per second is preferred. A noticeable decrease in the rate of advancement may be indicative of difficult probing conditions (gravel, angular sands, etc.) such as that seen here at approx. 5 ft.

Time is along the x axis. No scale is given on callouts, but it is a consistent 320ns wide. The y axis is in mV and directly corresponds to the amount of light striking the photodetector.

Callouts can be a single depth (see 3rd callout) or a range (see 4th callout). The range is noted on the depth axis by a bold line. When the callout is a range, the average and standard deviation in %RE is given below the callout.
