**RE: Koch Nitrogen Company, LLC – Dodge City, Kansas
EPA ID No. KSD044625010
Quarterly Progress Report for Fourth Quarter 2009**

**QUARTERLY PROGRESS REPORT
4th QUARTER 2009**

**DODGE CITY NITROGEN PLANT
KOCH NITROGEN COMPANY, LLC**

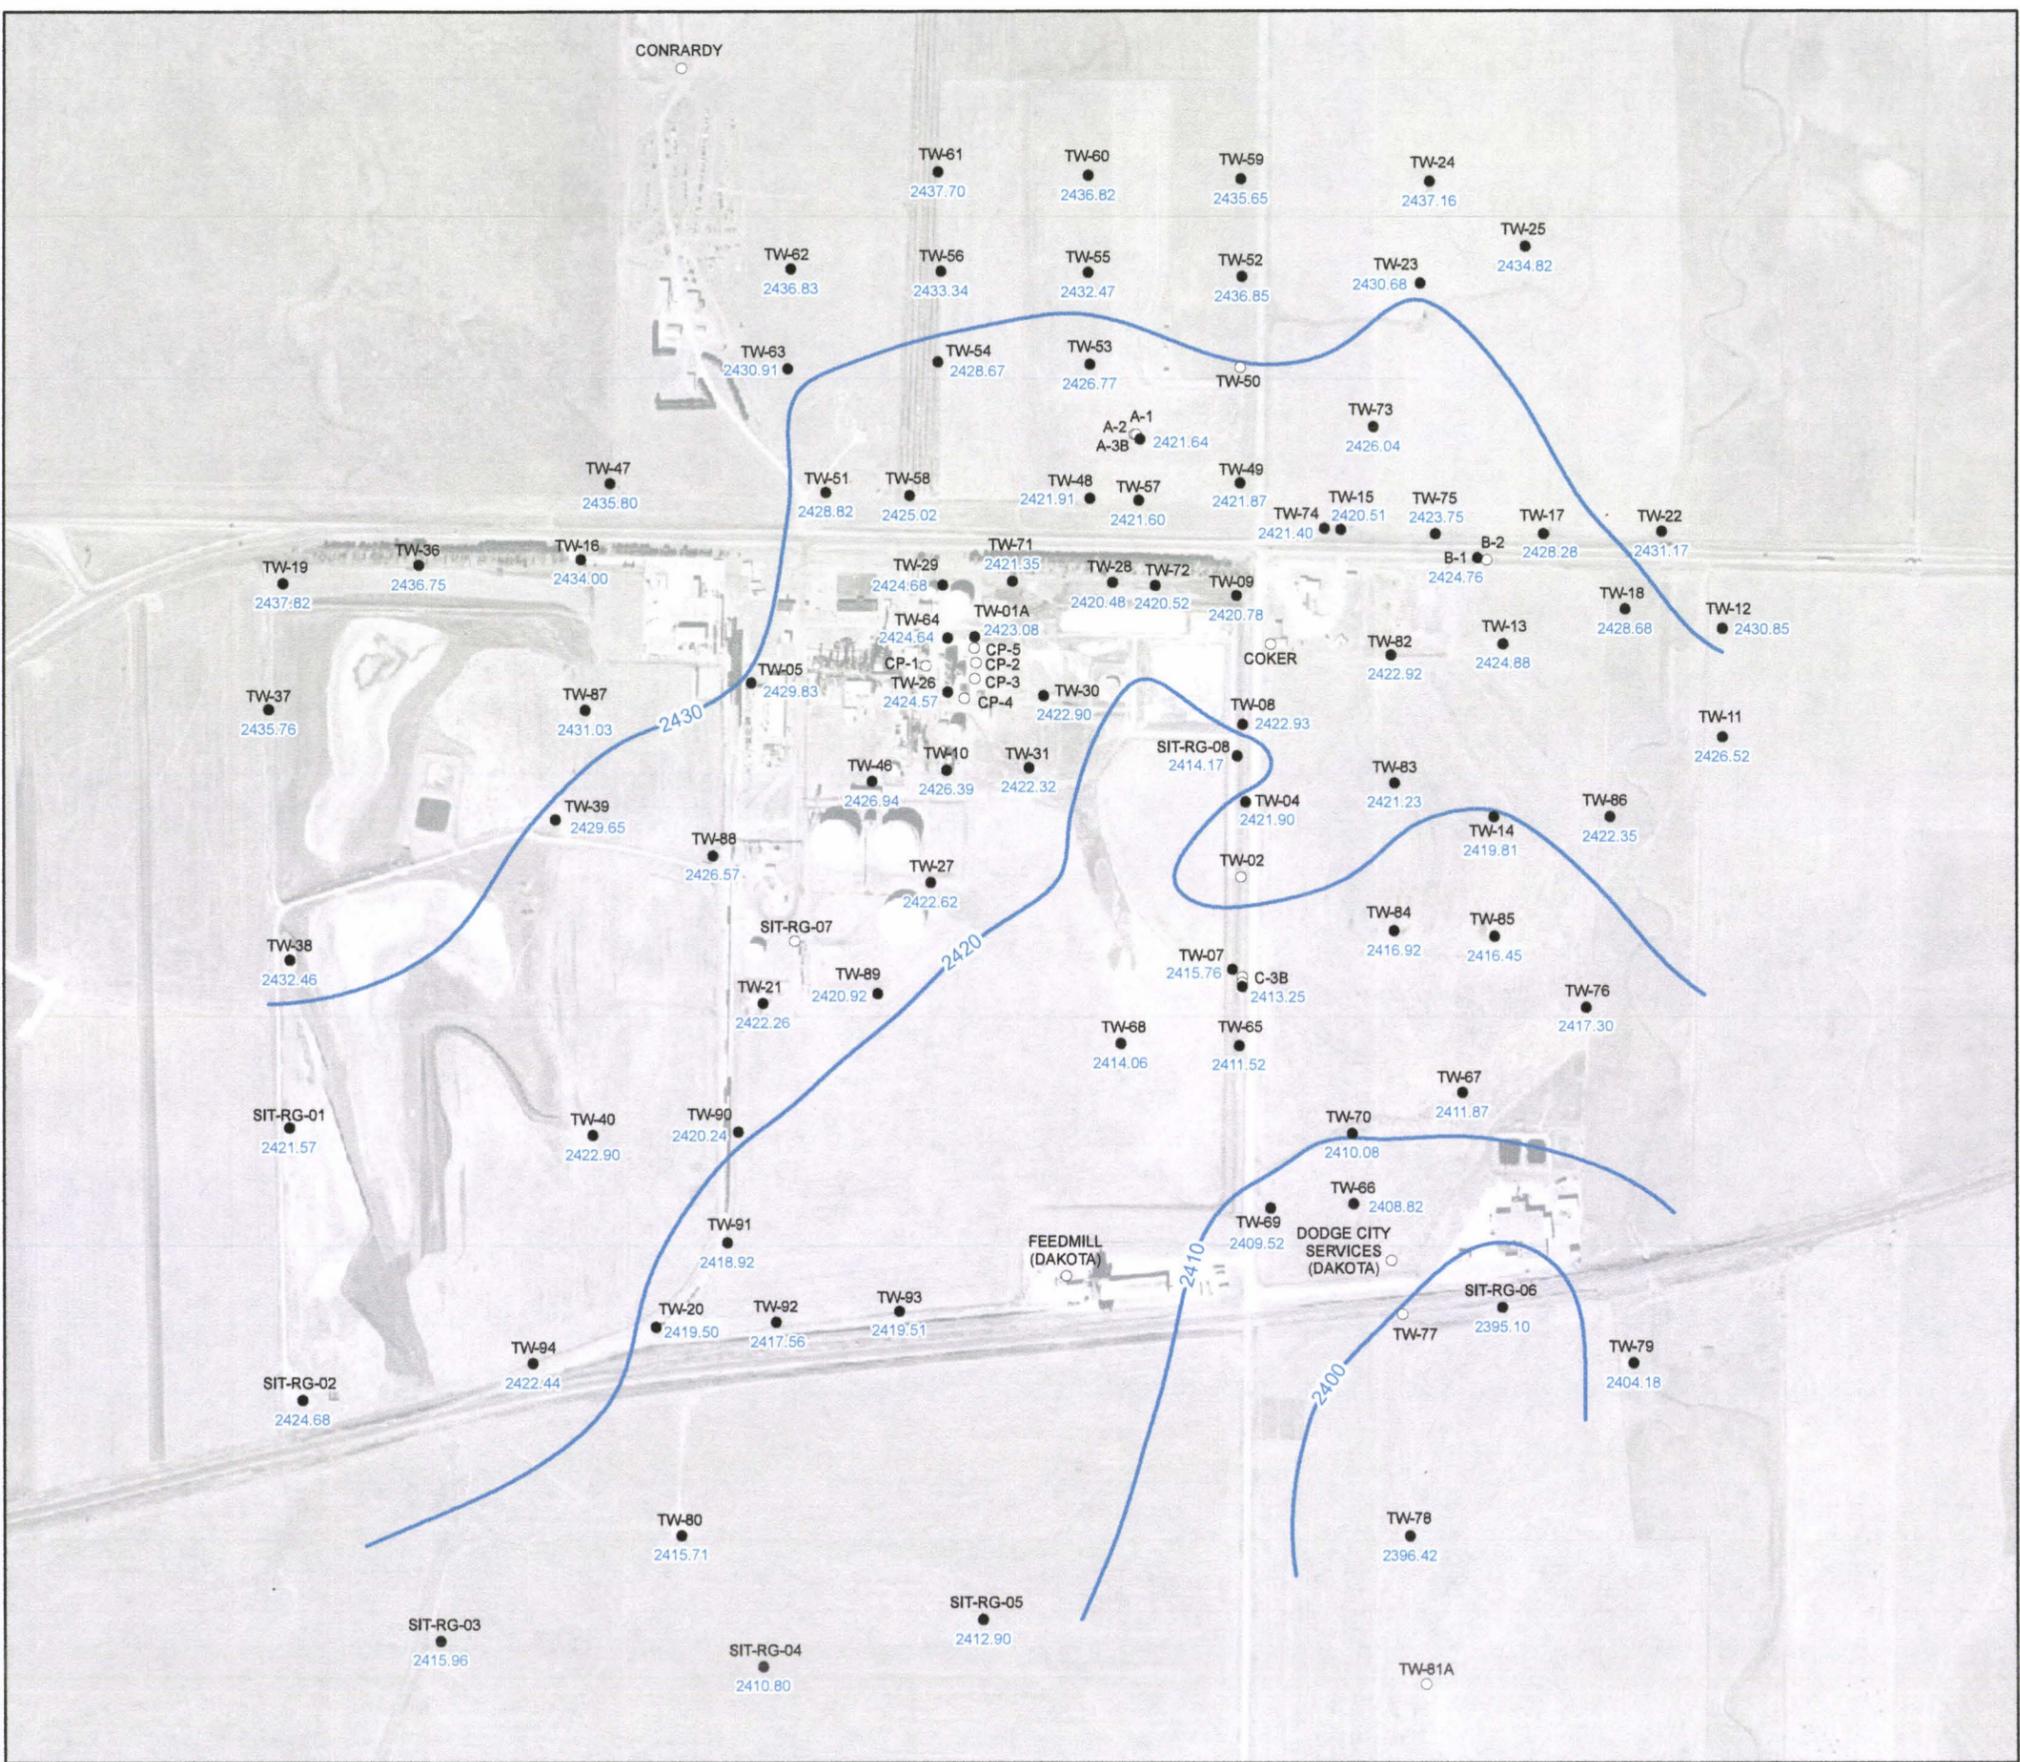
THIS POTENTIOMETRIC SURFACE REPRESENTS WATER TABLE CONDITIONS DURING THE PLANT'S TURNAROUND PERIOD WITH ALL PUMPING WELLS TURNED OFF.

**POTENTIOMETRIC SURFACE
MAP - OCTOBER 2009**

6. **See item 3.**
7. **KDHE will no longer accept potentiometric surface maps that include water level measurements from operating recovery wells.** – Completed. KNC will ensure that all future maps will include non pumping wells.

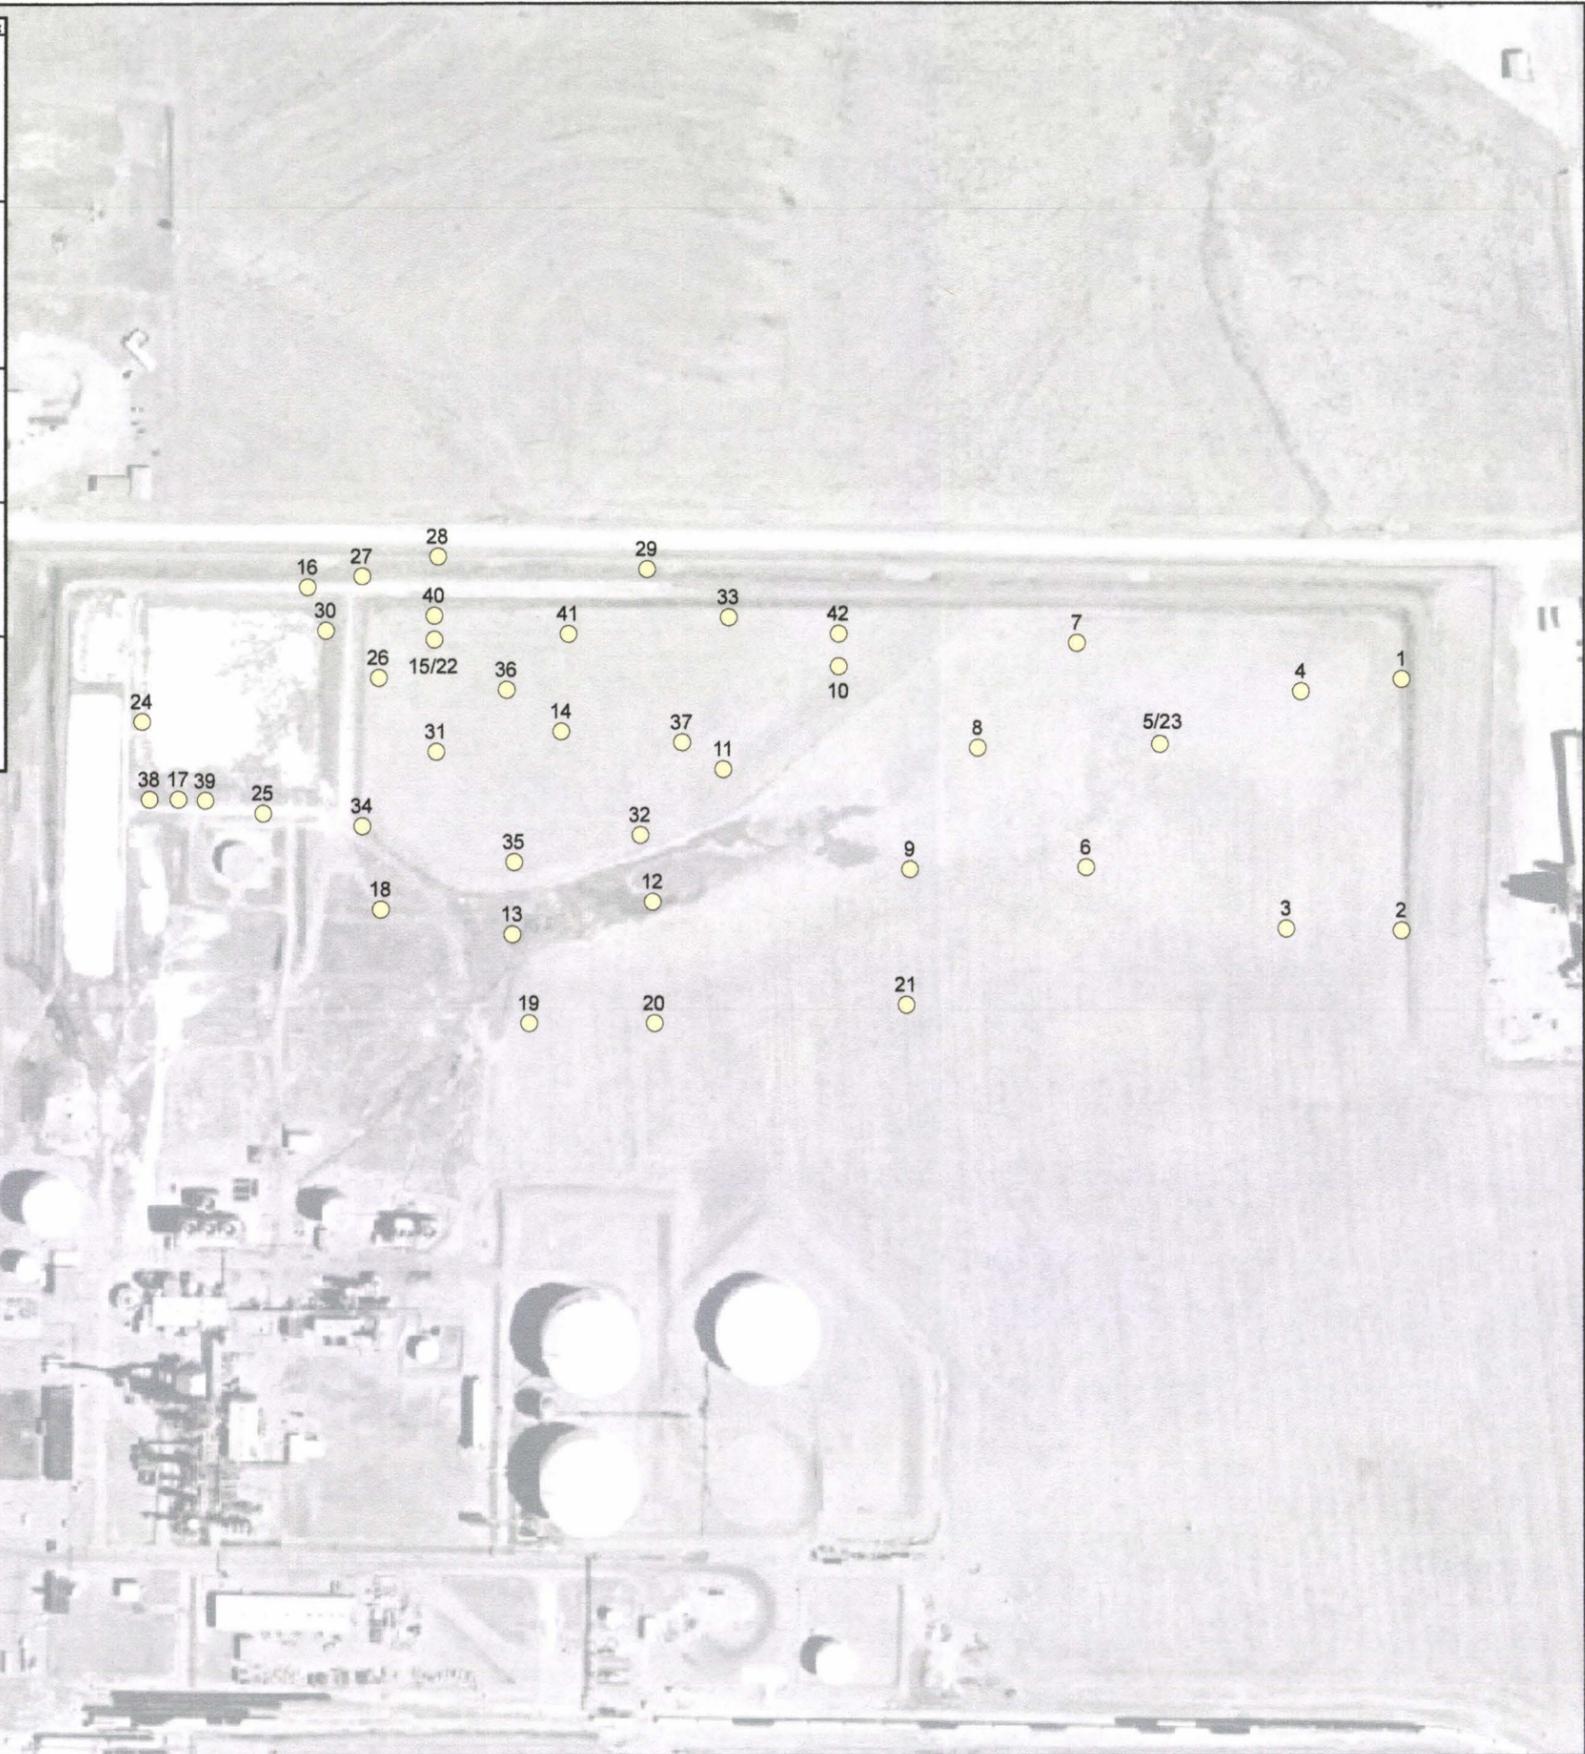
1. DATA TABLES INDICATE SWMU 3 SAMPLE LOCATIONS, SAMPLE DEPTHS IN FEET BELOW GROUND SURFACE, AND TOTAL CHROMIUM CONCENTRATIONS IN mg/kg.
2. MAP SAMPLE IDENTIFICATIONS ARE ABBREVIATED.

**SWMU 3
EAST POND SOIL
INVESTIGATION RESULTS FOR
TOTAL CHROMIUM**

- KNC completed preliminary sampling at SWMUs 3 and 7 under the approved Phase II Work Plan during the fourth quarter. Results of the analyses received as of January 25th are displayed in the attached preliminary figures. Also attached is a preliminary figure for sampling performed during the 3rd quarter at SWMU 14. The results for SWMU 14 were received after the 3rd quarter progress report was submitted. KNC is currently performing a more detailed evaluation of the results as described below.

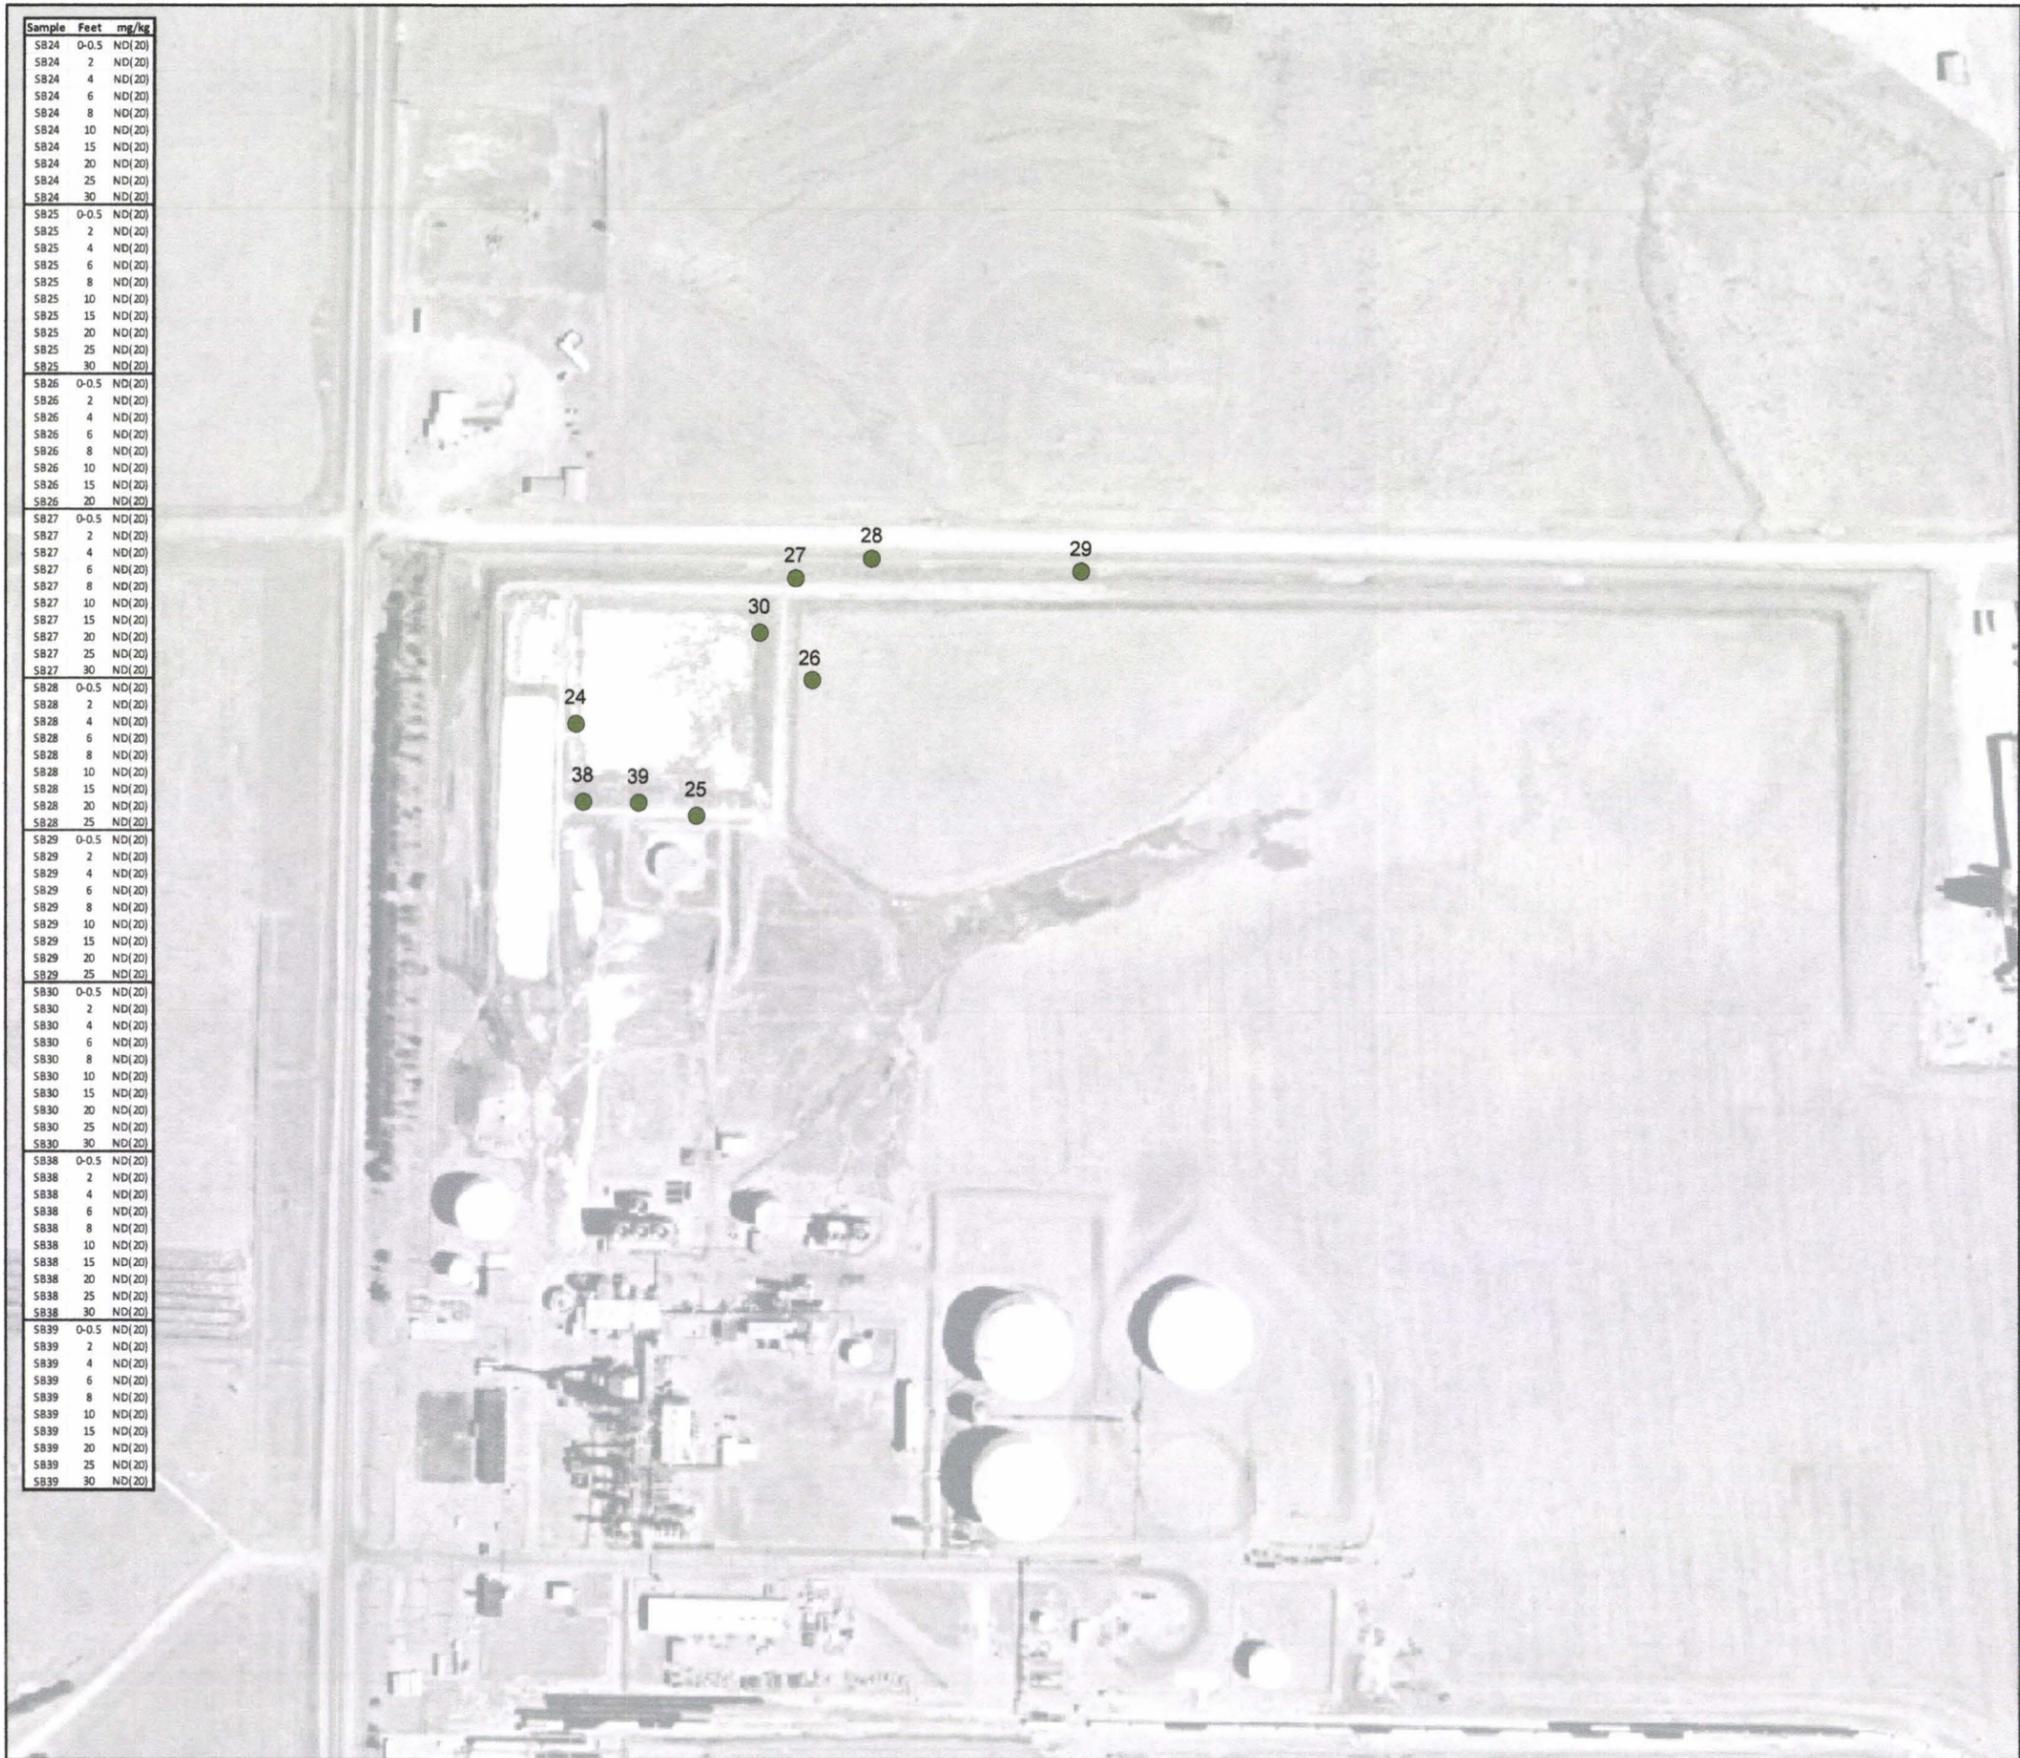
1. DATA TABLES INDICATE SWMU 3 SAMPLE LOCATIONS, SAMPLE DEPTHS IN FEET BELOW GROUND SURFACE, AND HEXAVALENT CHROMIUM CONCENTRATIONS IN mg/kg.
2. MAP SAMPLE IDENTIFICATIONS ARE ABBREVIATED.
3. ND = NOT DETECTED AT CONCENTRATIONS IN PARENTHESES.

SWMU 3
EAST POND SOIL
INVESTIGATION RESULTS FOR
HEXAVALENT CHROMIUM

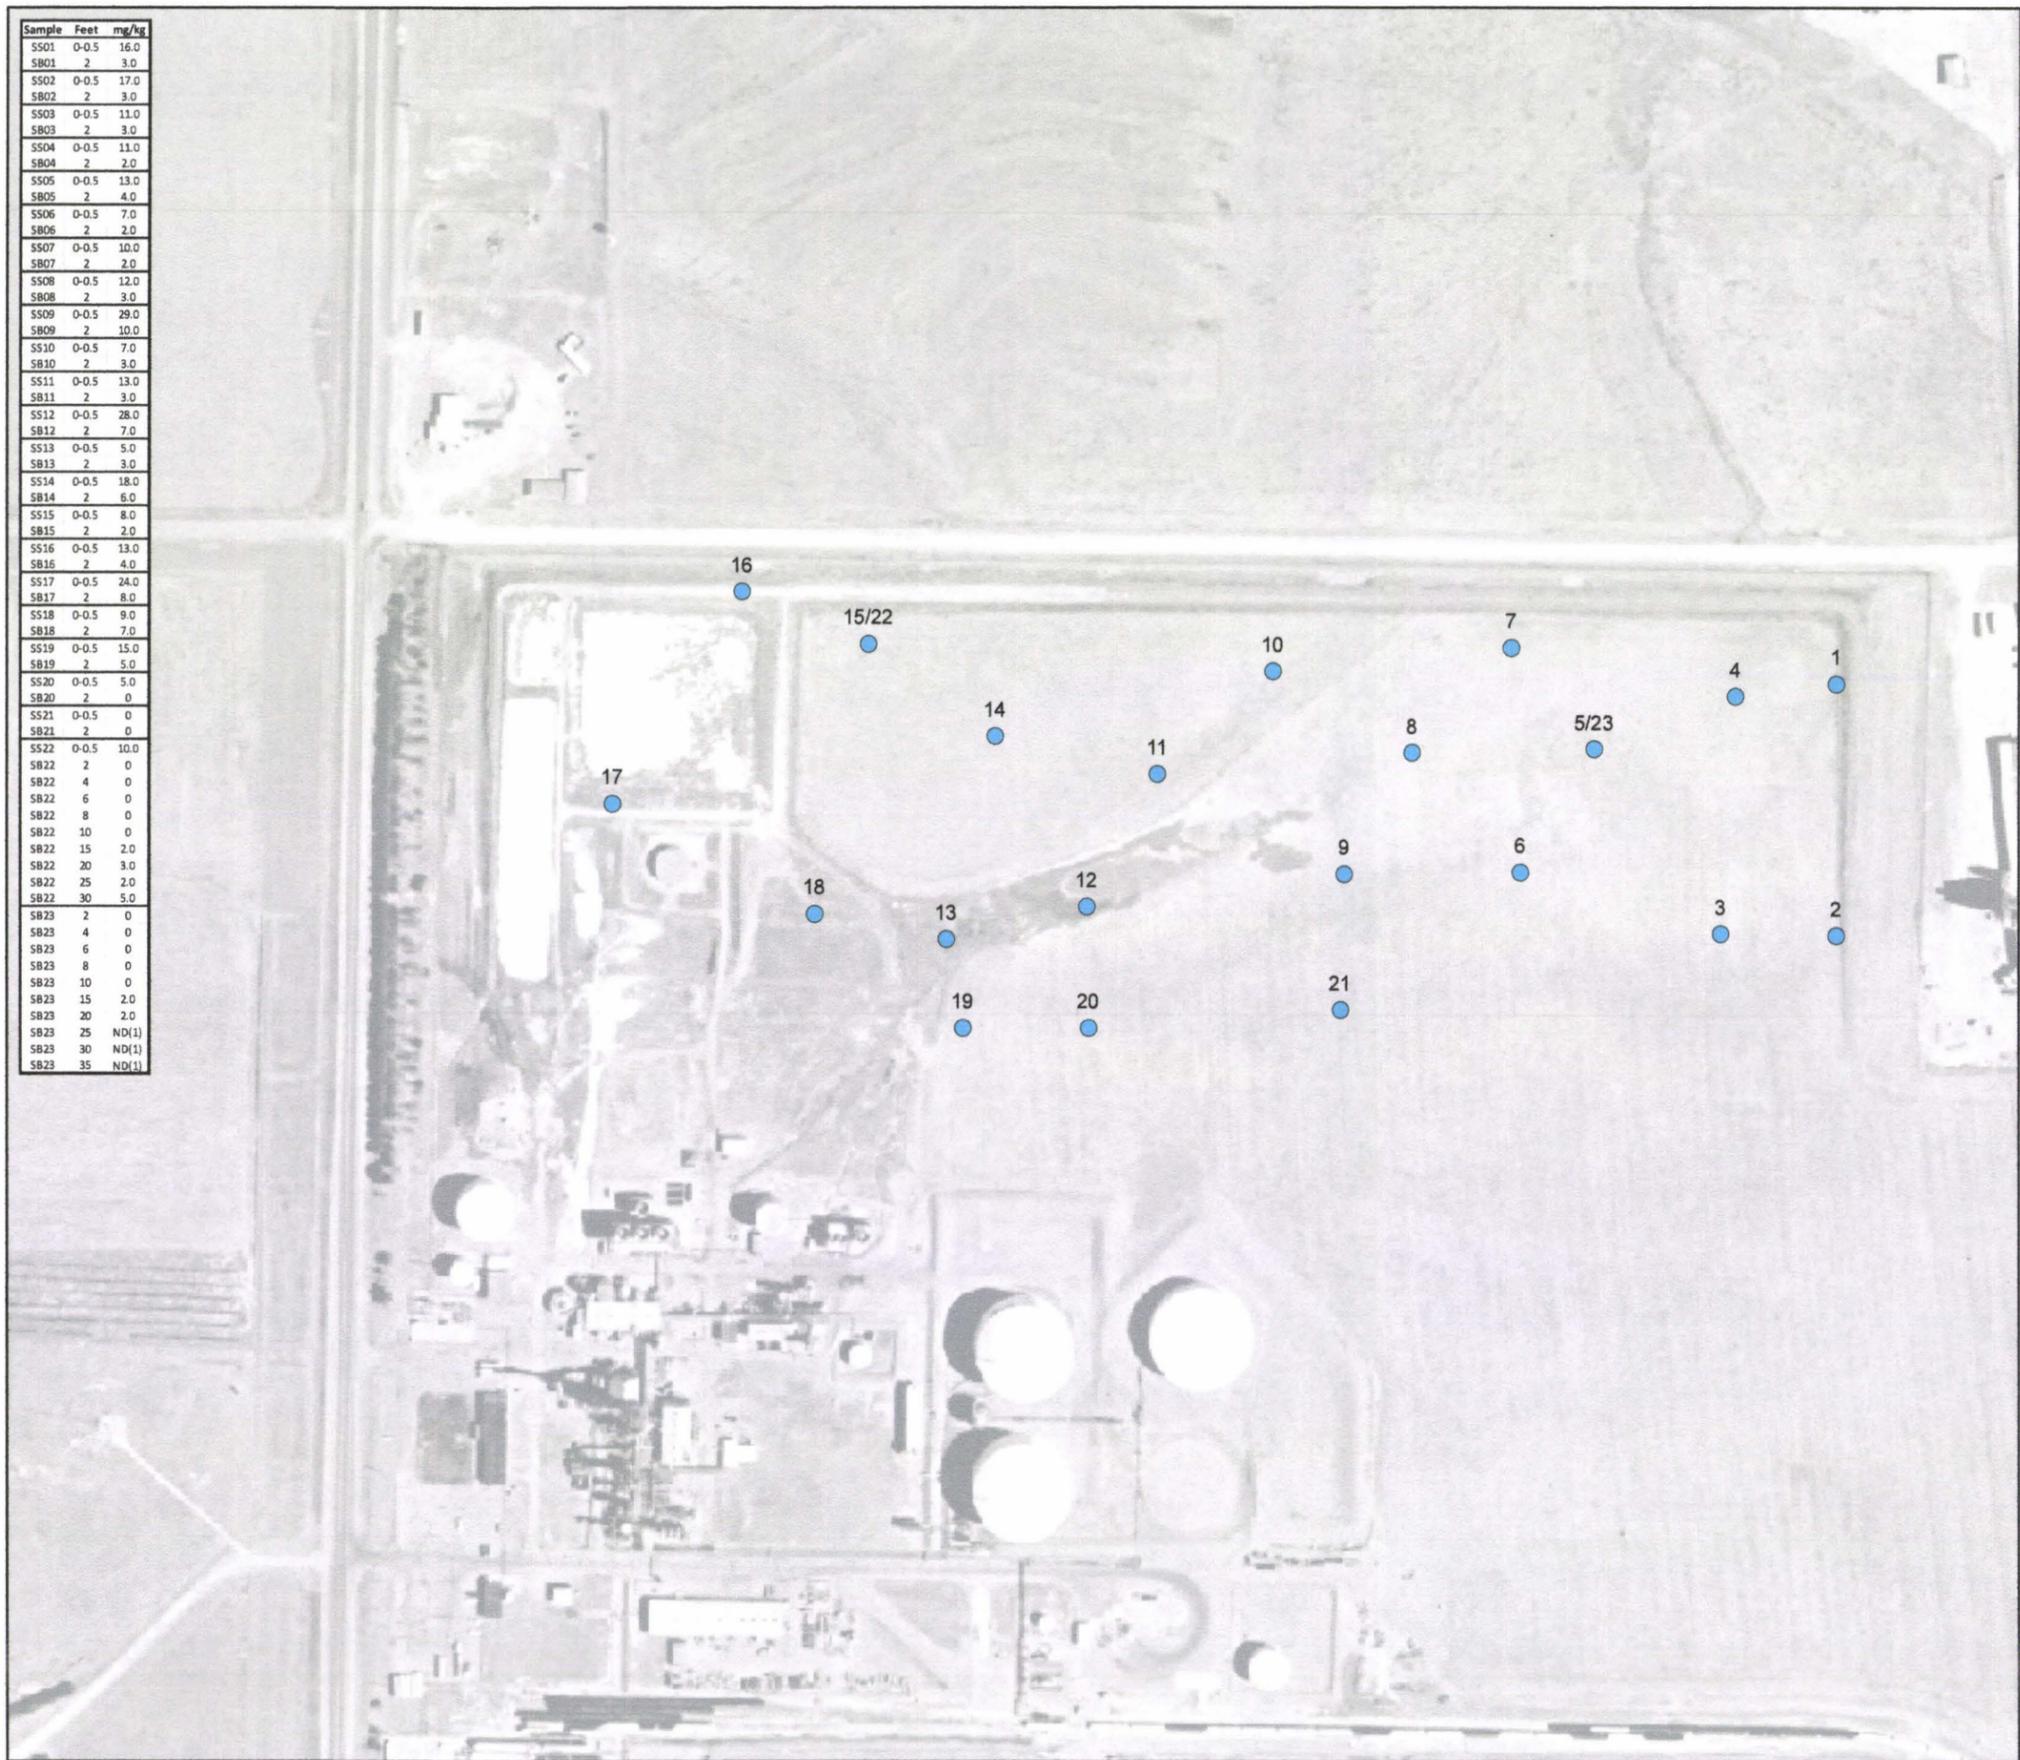
1. DATA TABLES INDICATE SWMU 3 SAMPLE LOCATIONS, SAMPLE DEPTHS IN FEET BELOW GROUND SURFACE, AND NITRATE+NITRITE (as N) CONCENTRATIONS IN mg/kg.
2. MAP SAMPLE IDENTIFICATIONS ARE ABBREVIATED.
3. ND = NOT DETECTED AT CONCENTRATIONS IN PARENTHESES.

SWMU 3 EAST POND SOIL INVESTIGATION RESULTS FOR NITRATE+NITRITE (as N)

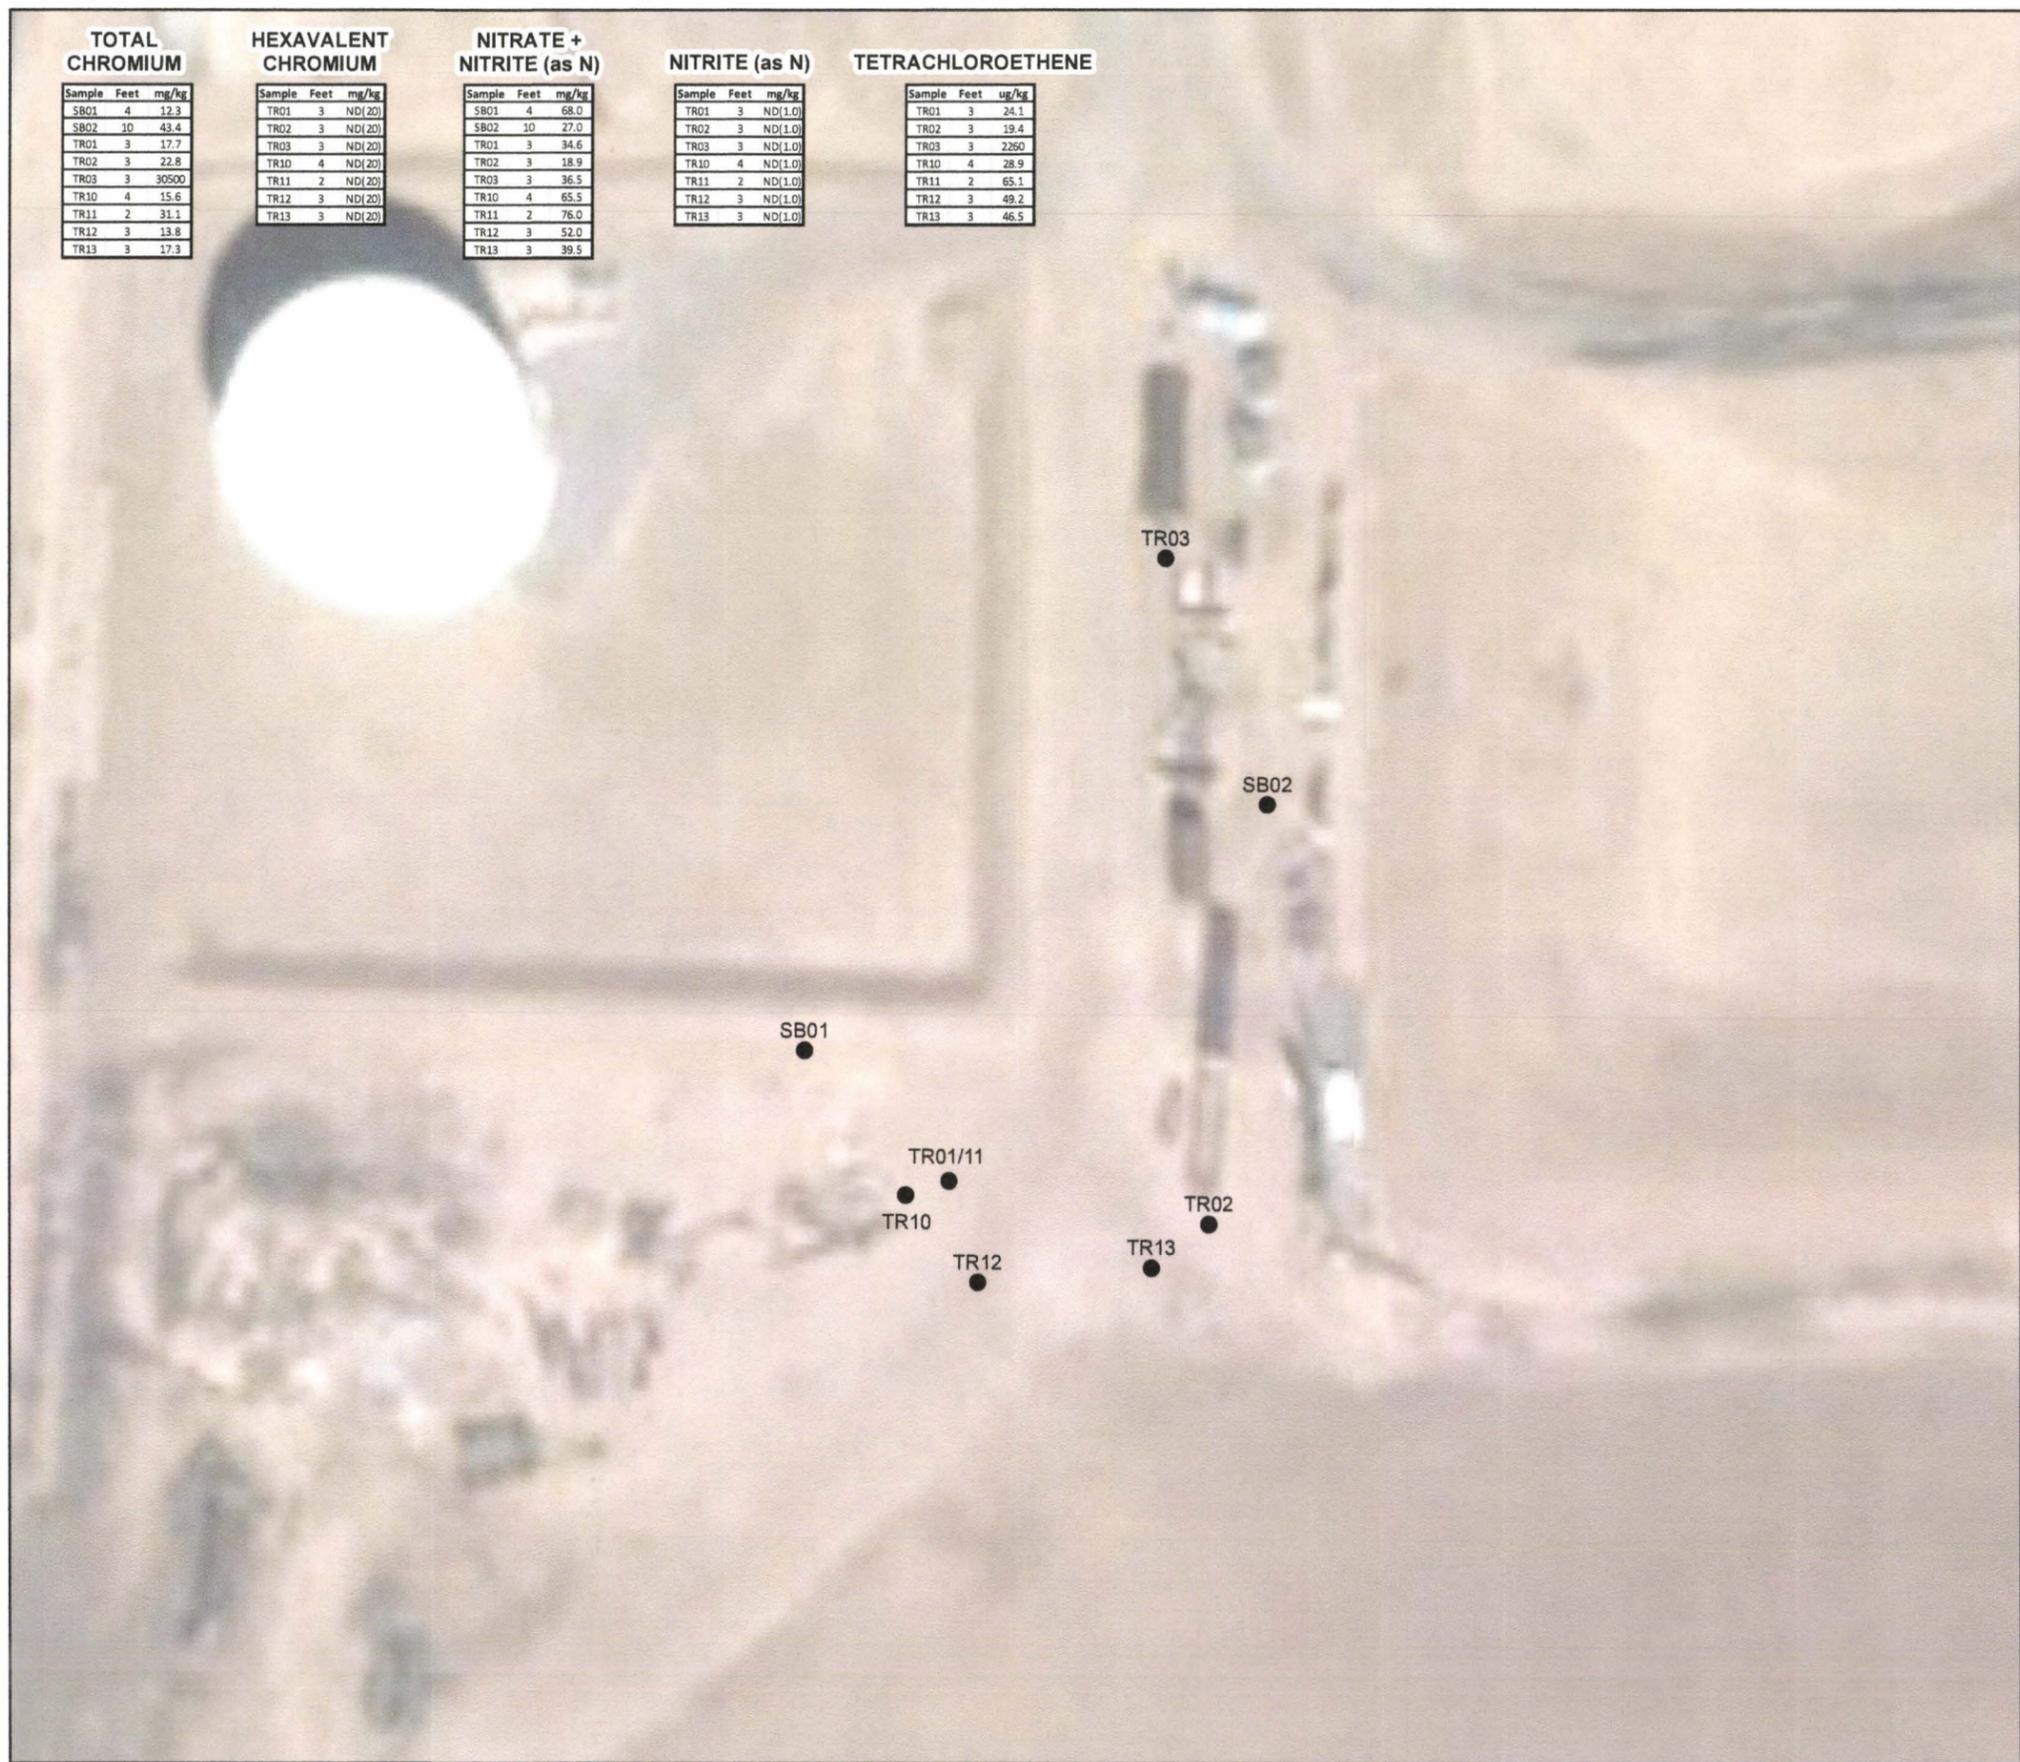
1. DATA TABLES INDICATE SWMU 7 SAMPLE LOCATIONS, SAMPLE DEPTHS IN FEET BELOW GROUND SURFACE, AND ANALYTE CONCENTRATIONS.
2. OTHER VOLATILE ORGANIC COMPOUNDS WERE ANALYZED. ONLY TETRACHLOROETHENE WAS DETECTED AND REPORTED IN THIS FIGURE.
3. MAP SAMPLE IDENTIFICATIONS ARE ABBREVIATED.

SWMU 7
LANDFILL FOR GENERAL PLANT TRASH SOIL INVESTIGATION RESULTS TOTAL CHROMIUM AND NITRATE+NITRITE (as N)

- At SWMU 7, seven samples had detections of Tetrachloroethene. Because of this, KNC will perform additional water sampling during the 2nd Quarter 2010. KNC will analyze wells TW-21, TW-88, and TW-89 for VOCs.

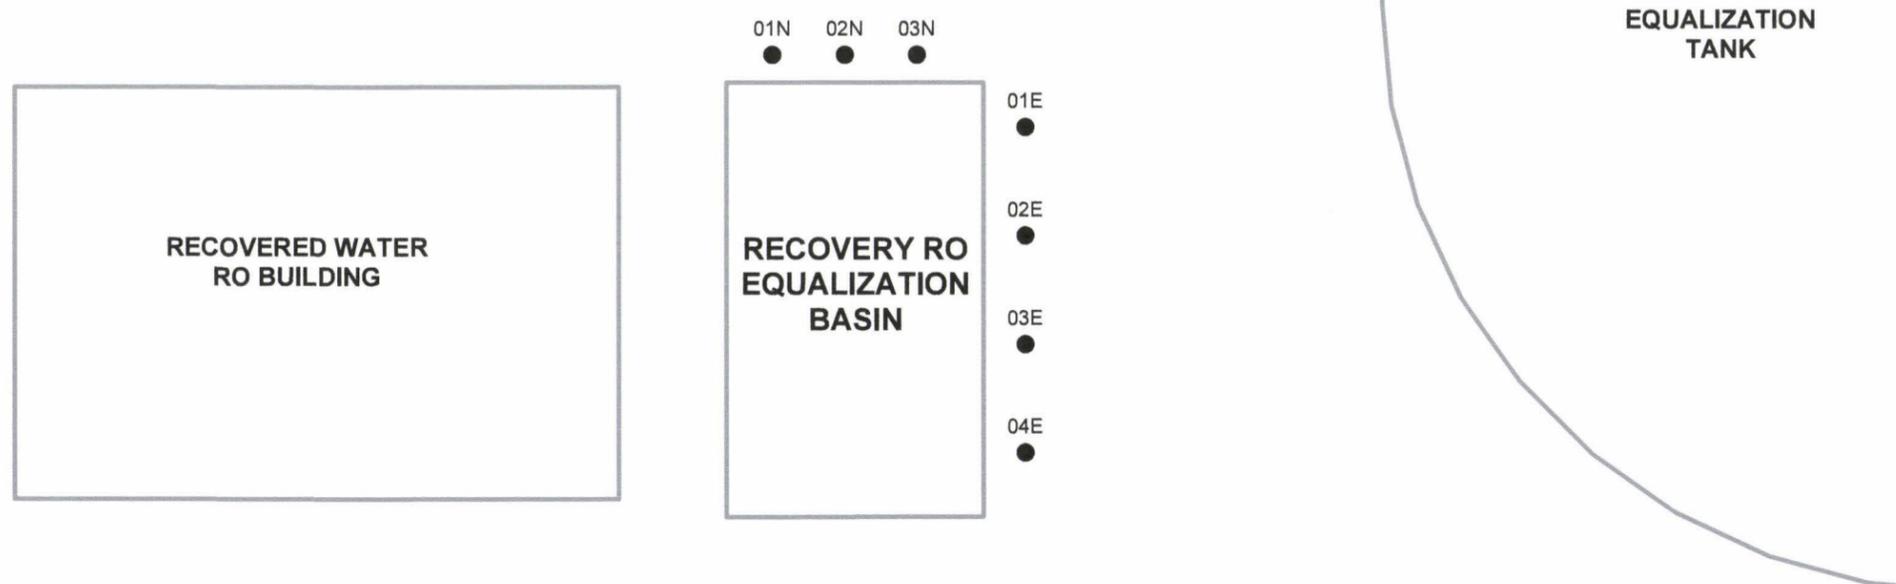
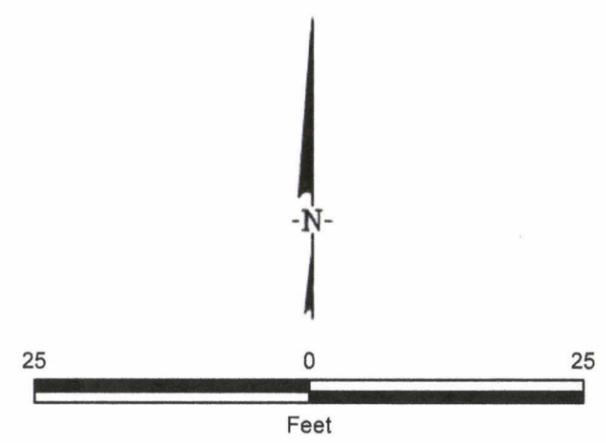
1. DATA TABLES INDICATE SWMU 14 SAMPLE LOCATIONS, SAMPLE DEPTHS IN FEET BELOW GROUND SURFACE, AND ANALYTE CONCENTRATIONS IN mg/kg.
2. MAP SAMPLE IDENTIFICATIONS ARE ABBREVIATED.
3. ND = NOT DETECTED AT CONCENTRATIONS IN PARENTHESES.

**SWMU 14
RECOVERY RO
EQUALIZATION BASIN
SOIL INVESTIGATION RESULTS**

- The sample results from SWMU 14 (area of the former Andco Basin) showed no detectable levels of hexavalent chromium. The analytical data showed low levels of trivalent chromium (12.5 to 29.5 mg/kg), consistent with earlier results from this area and from other SWMUs where chromate compounds were not directly handled. Nitrate + nitrite levels ranged from 3.9 to 15.4 mg/kg, also within the ranges of earlier samples in the area and other SWMUs where concentrated compounds were not directly managed. These results do not suggest any specific impact from past overflows or leakage from the basin. See attached figure.

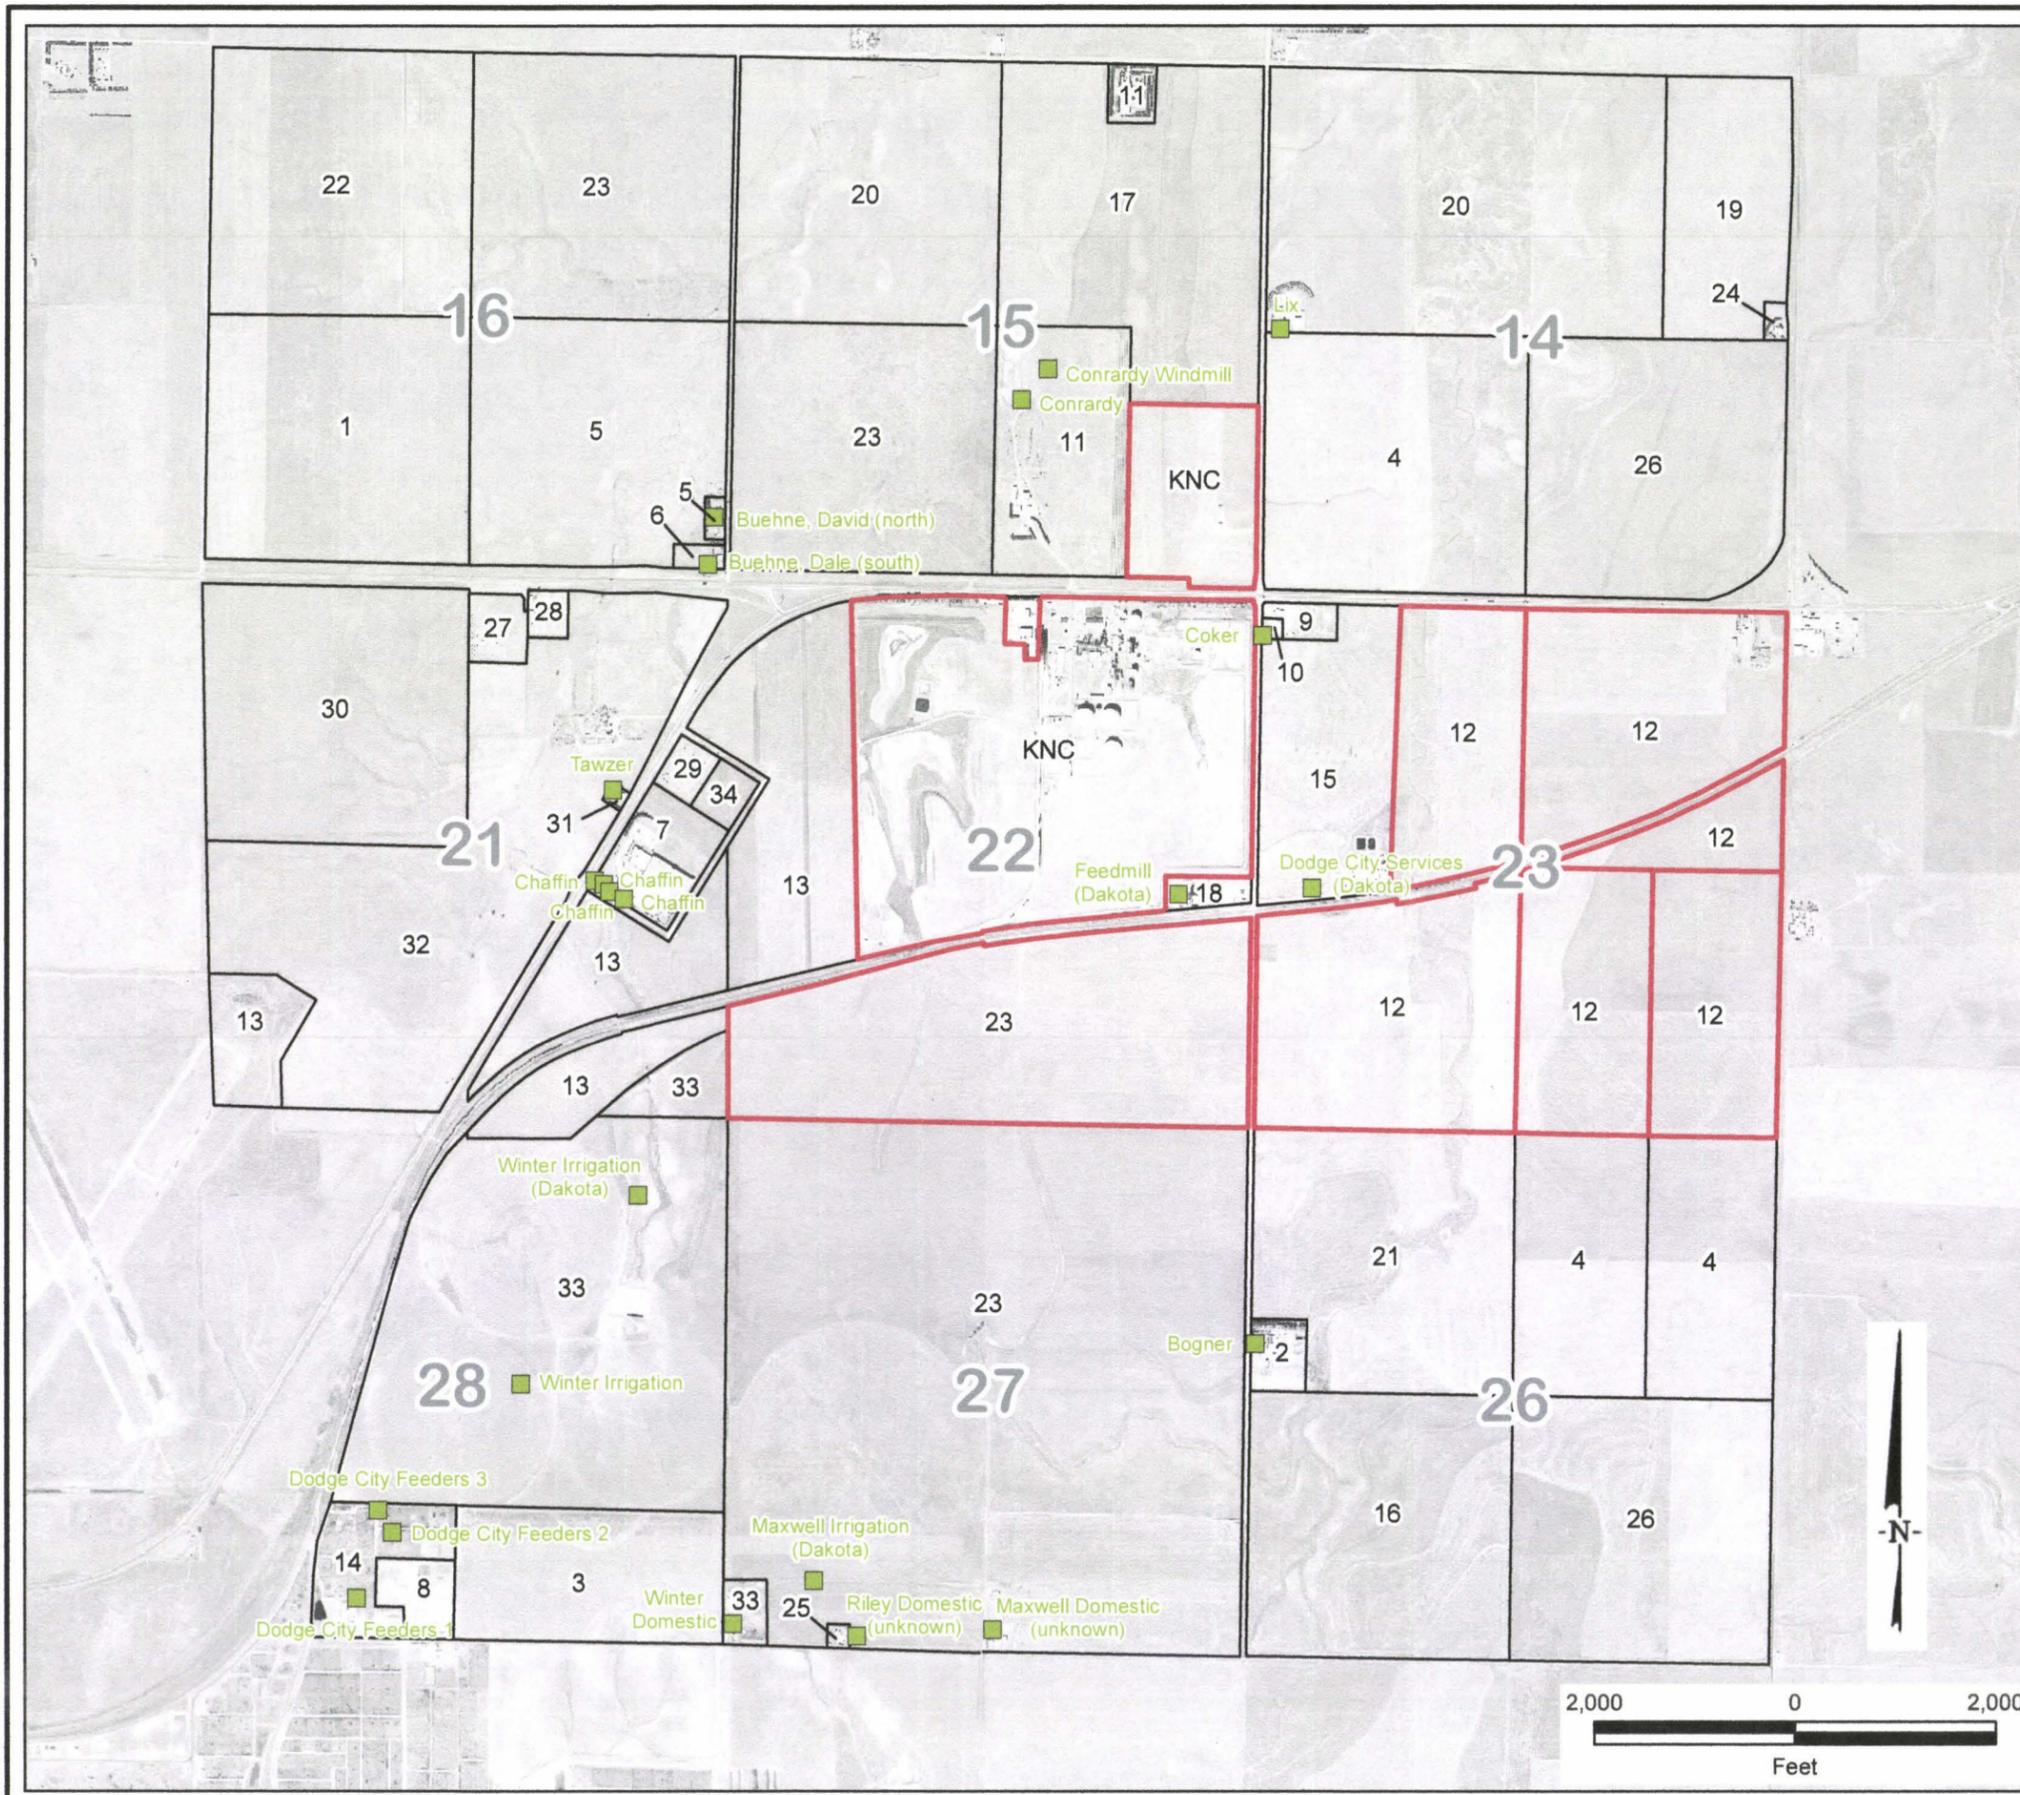
- KNC PROPERTY OR PROPERTY WHERE KNC HAS ACCESS AGREEMENTS IN PLACE
- PARCEL BOUNDARY (APPROXIMATE)
- 14** SECTION NUMBER IN T.26S., R.24W.
- PRIVATE WELL (OGALLALA UNLESS INDICATED)

PRIVATE PROPERTY OWNERS & PRIVATE WELL LOCATIONS

- As requested by EPA in the meeting on May 15, 2009 and summarized by letter date May 27, 2009, KNC has compiled a summary of the neighboring private water well information as presented on Table PW-01 and Figure PW-01. This information was gathered through discussions with the private well owners and their pump contractors, Kansas Geological Survey, and the Kansas Department of Agriculture - Division of Water Resources.
