INTERIM MEASURES CONSTRUCTION COMPLETION REPORT

El Paso Merchant Energy-Petroleum Company
Former El Dorado Refinery
El Dorado, Kansas

INTERIM REMEDIAL MEASURES
CONSTRUCTION COMPLETION REPORT

FORMER EL DORADO REFINERY
EL DORADO, KANSAS

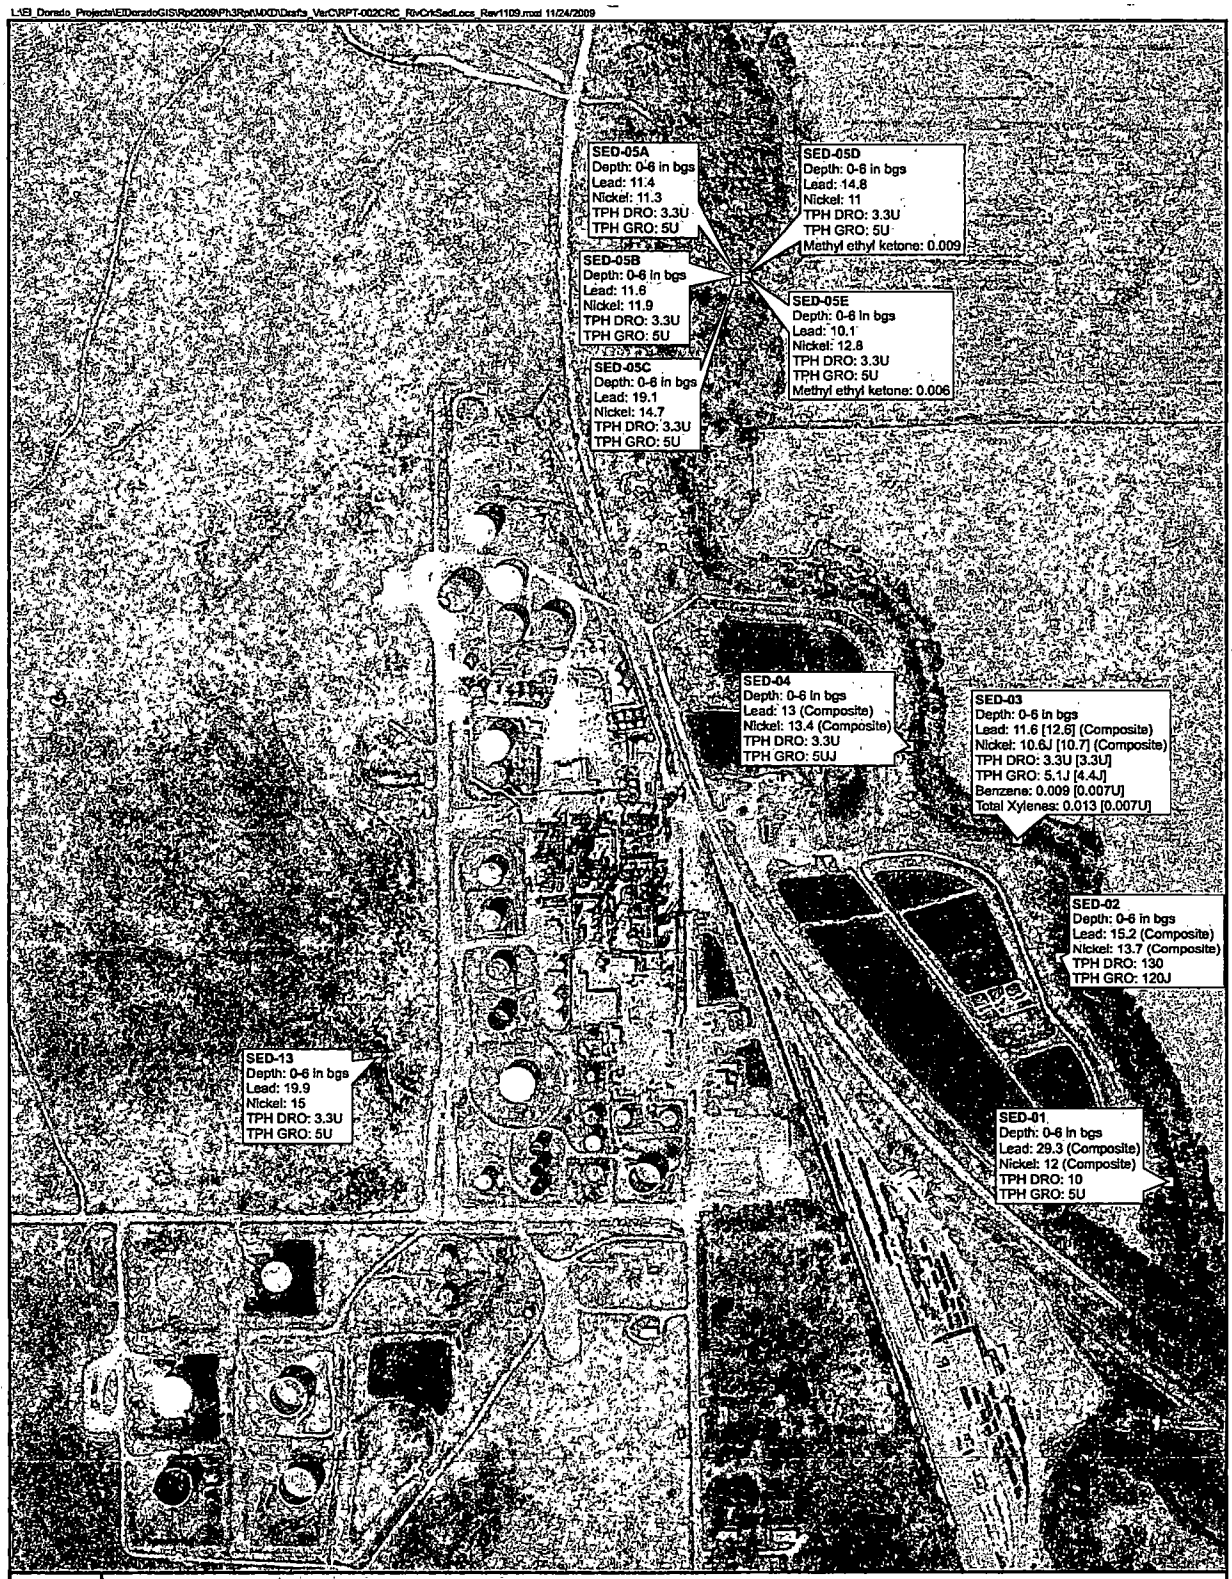
FIGURE
7

The locations and analytical results of the collected sediment samples are shown on **Figure 7** and **8**, and the analytical results of the sediment samples are shown in **Tables 4a** through **4d**. Analytical laboratory reports are presented in **Appendix B** for the river and creek sediment samples. There were 298 sample results that were above the laboratory reporting limits, of those, five were above the TECs. The river/creek sediment sample results above the Sediment Standard TEC values are summarized as follows:

The collected data were compared to individual background values from sample locations and to the applicable Sediment Standard TEC values. **Figure 7** and **8** show the river/creek sediment sample exceedances. The background sediment samples (samples SED-05A through SED-05E) did not exceed any of the Sediment Standard TEC values. The WBWR

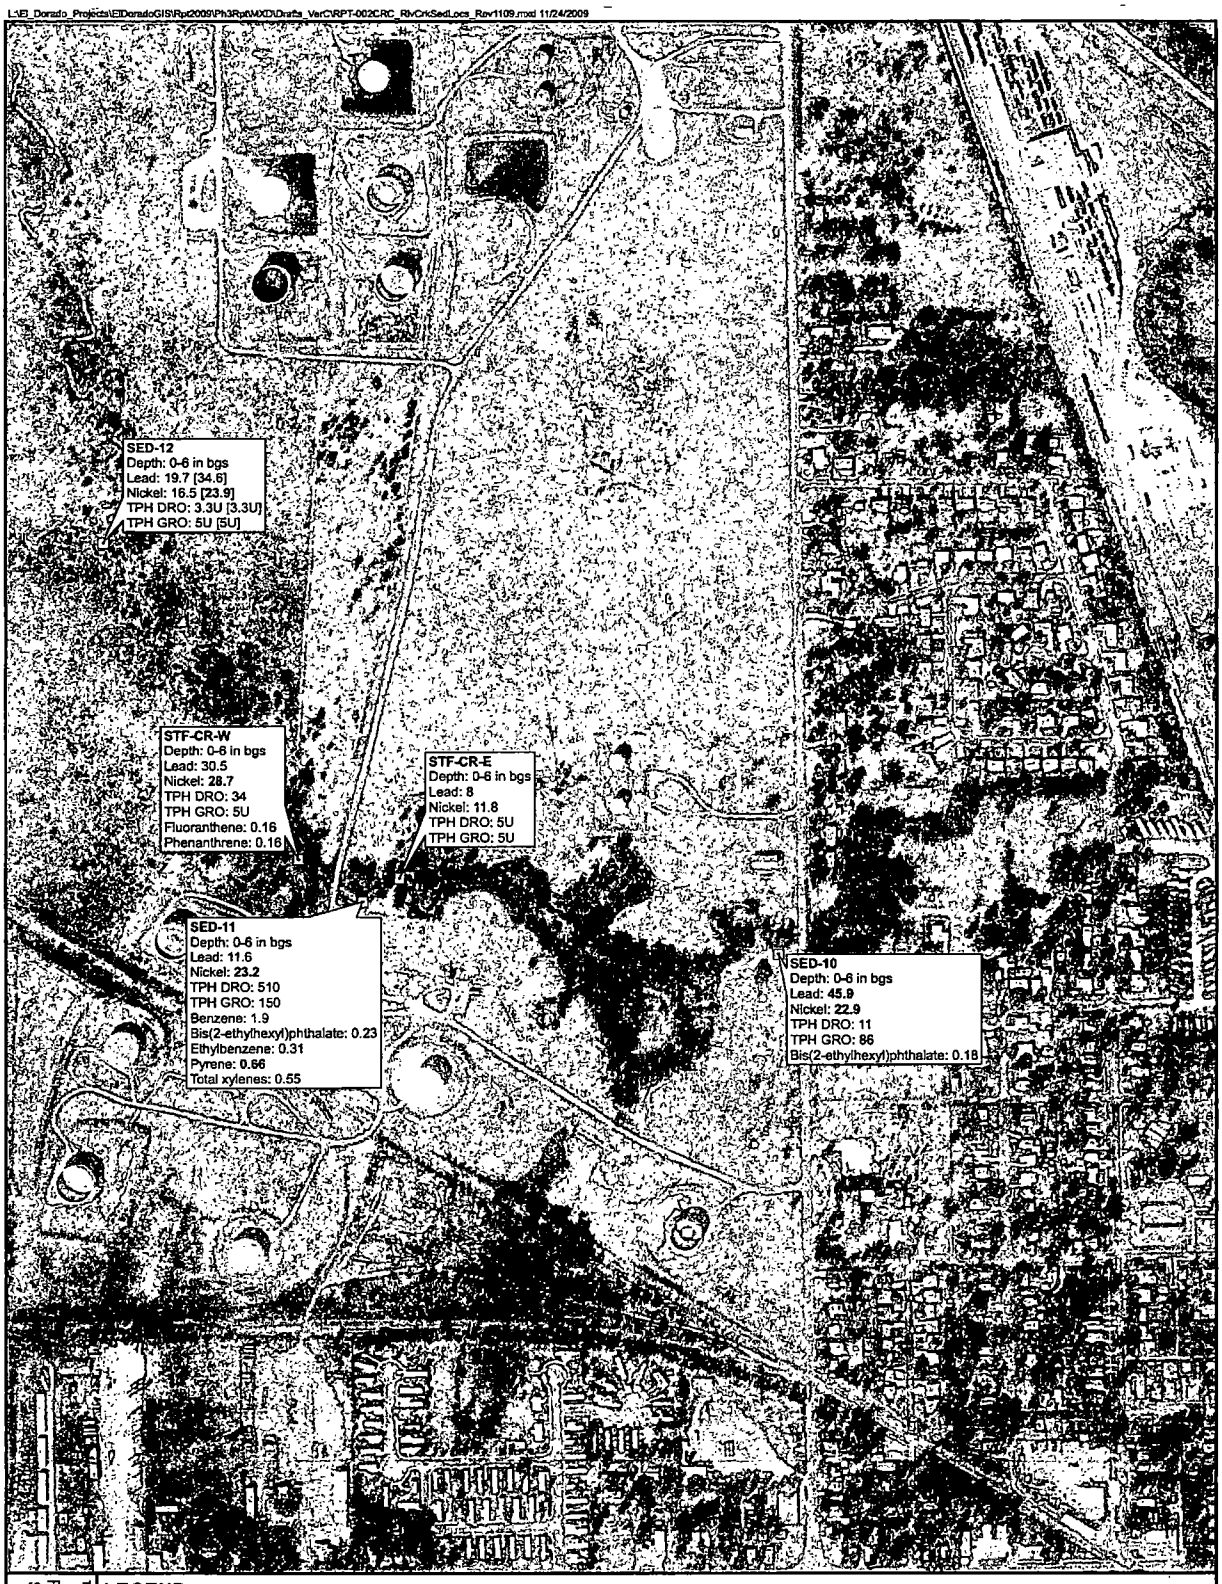
FIGURE: 8

The text has been revised to state that bis(2-ethylhexyl)phthalate was detected in sediment sample SED-10. Table 4b has been corrected to show the correct TEC values. Figure 8 was revised to show the pyrene (660 ug/kg) exeedance in sediment sample SED-11. The corrected report text, table, and figures are included herewith.

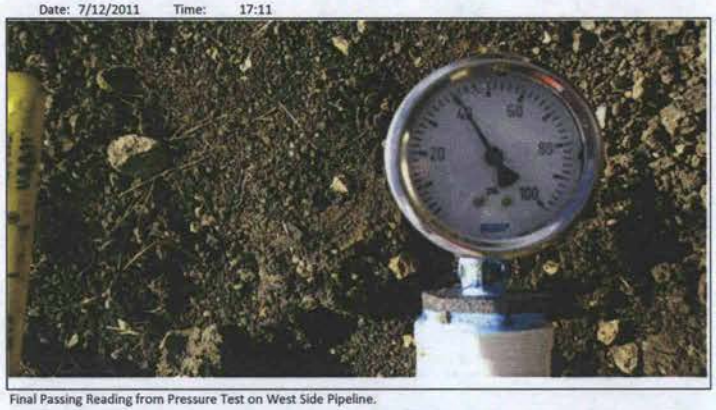
Final Passing Reading from Pressure Test on West Side Pipeline.

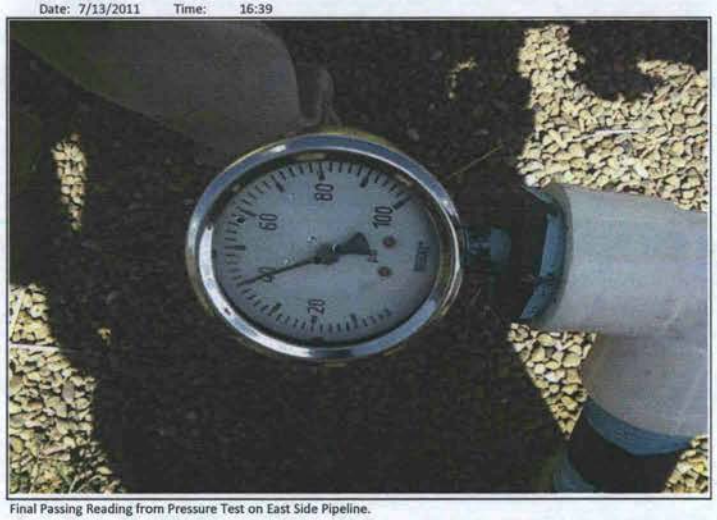
Final Passing Reading from Pressure Test on East Side Pipeline.

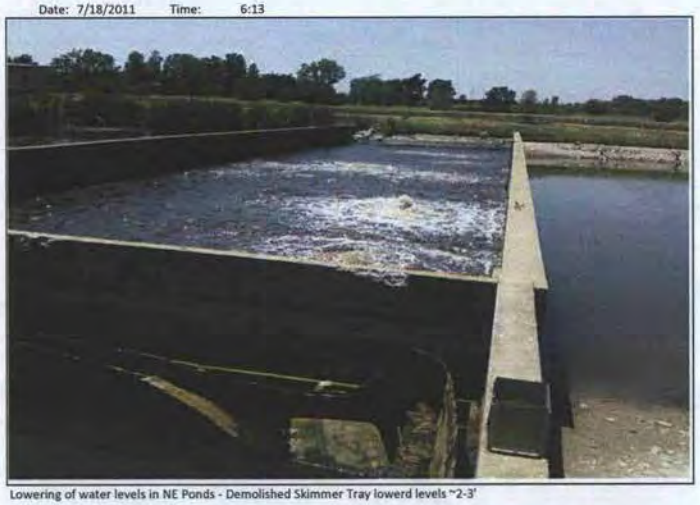
Lowering of water levels in NE Ponds - Demolished Skimmer Tray lowerd levels ~2-3'

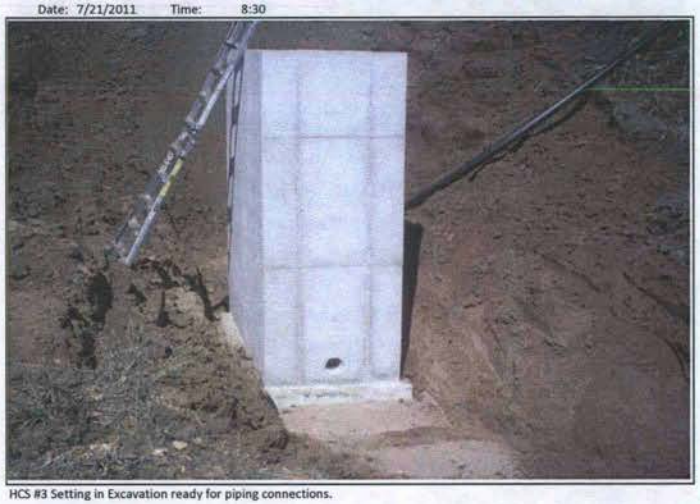
HCS #3 Setting in Excavation ready for piping connections.

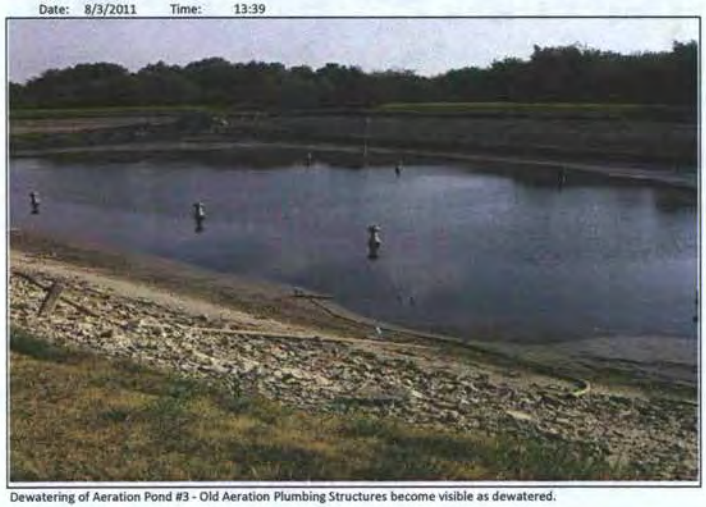
Dewatering of Aeration Pond #3 - Old Aeration Plumbing Structures become visible as dewatered.

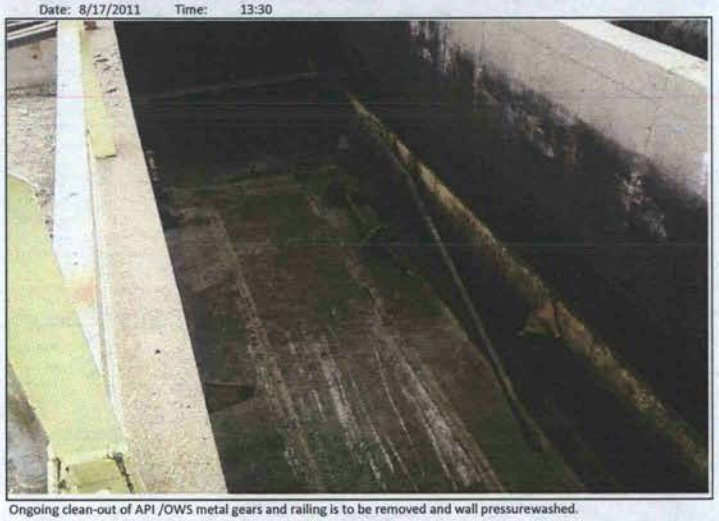
Ongoing clean-out of API /OWS metal gears and railing is to be removed and wall pressurewashed.
Metal gears and railing are part of the former chain driven sludge removal (rotating scraper boards) system.

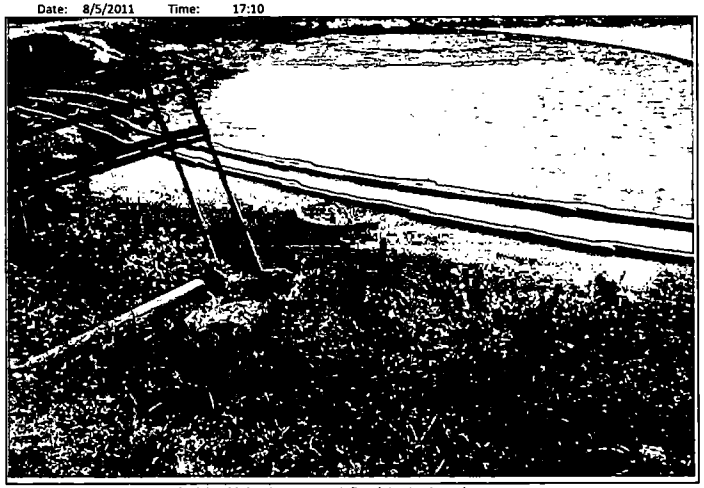
Stabilized SE Pond water level (~4' depth) despite constant inflow (pipe in picture).

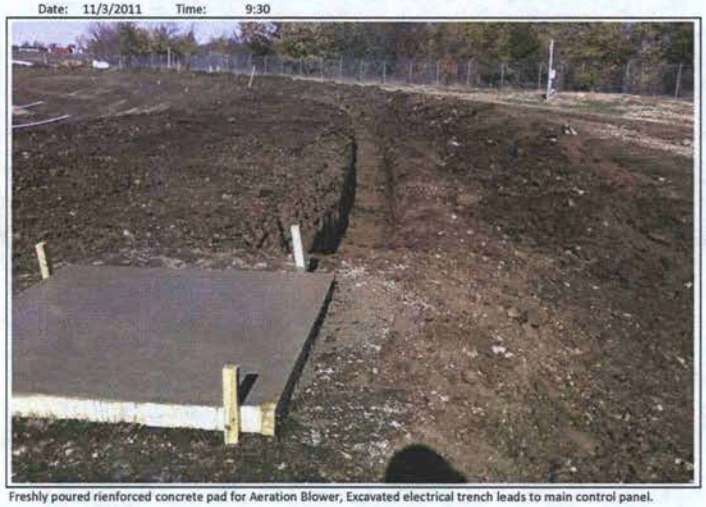
Freshly poured rienforced concrete pad for Aeration Blower, Excavated electrical trench leads to main control panel.

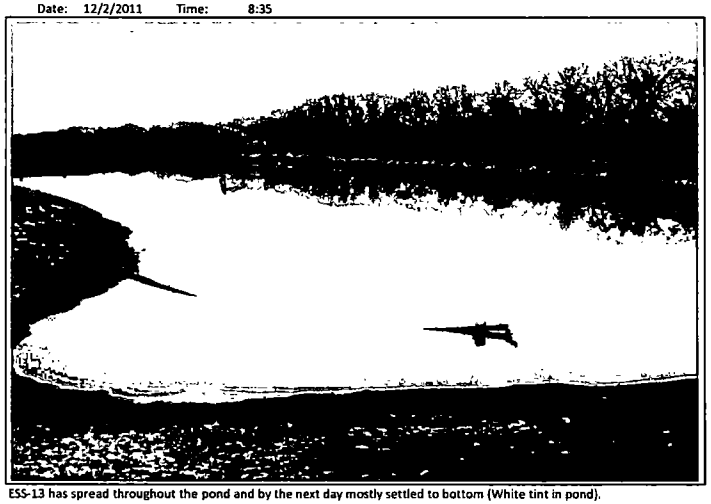
ESS-13 has spread throughout the pond and by the next day mostly settled to bottom (White tint in pond).
