June 8, 2011

ENT-LTR-7011-62

**Re: Summary Report for 8-Acre Cap and Site Problem Areas
National Zinc Company Site, Montgomery County, Kansas
KDHE Project #C3-063-00026
Consent Order: 03-E-0022**

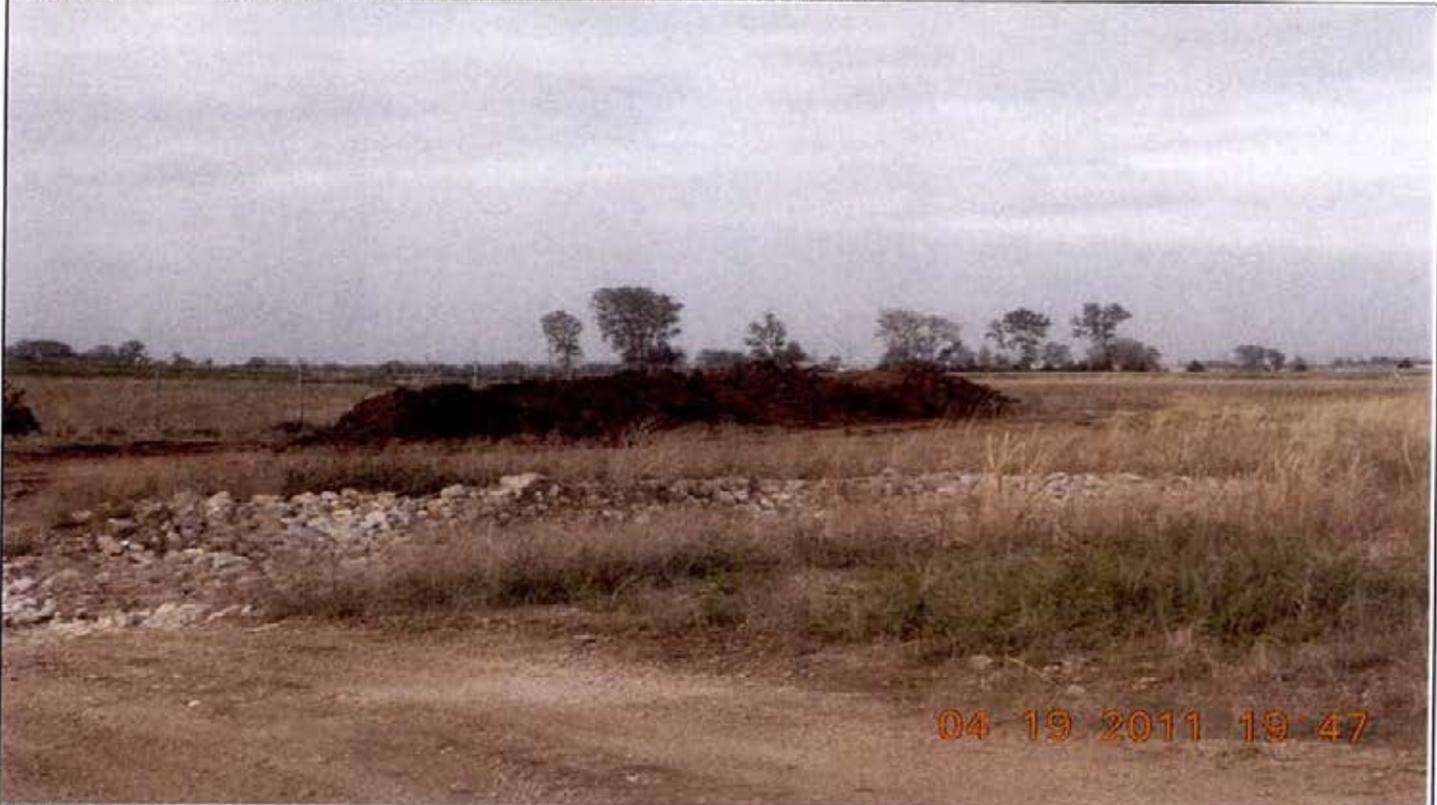
PHOTOGRAPH:	1	PHOTOGRAPHER:	RR
DATE:	19-Apr-11	TIME:	1041
PROJECT:	8-Acre Cap Repair Work Cherryvale Kansas April-May 2011		
SUBJECT:	Installation of rip rap along northern slope of southern drainage channel

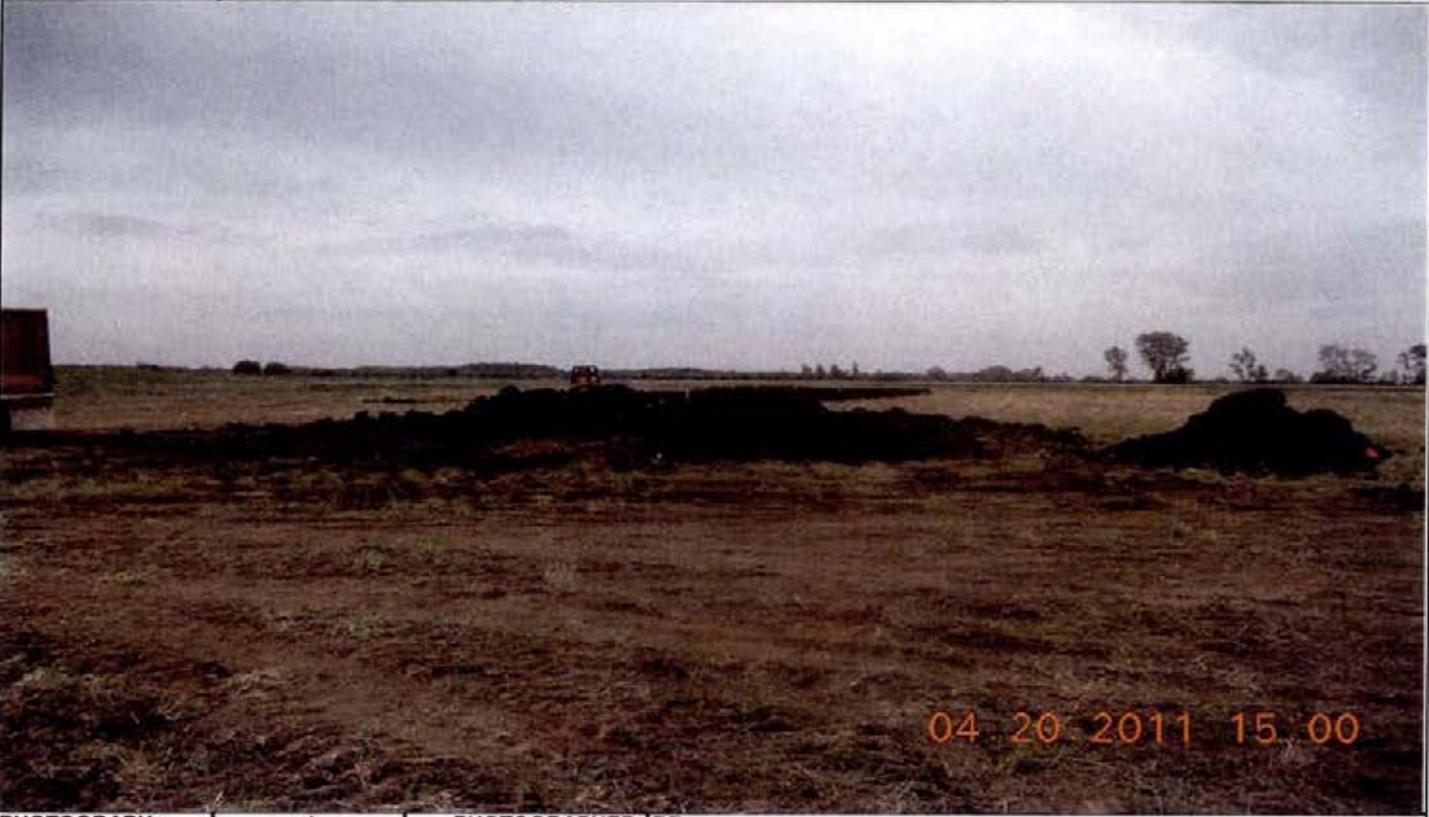
PHOTOGRAPH:	3	PHOTOGRAPHER:	RR
DATE:	20-Apr-11	TIME:	1500
PROJECT:	8-Acre Cap Repair Work Cherryvale Kansas April-May 2011		
SUBJECT:	Removal of material in sparsely vegetated areas of southern section of 8-Acre Cap

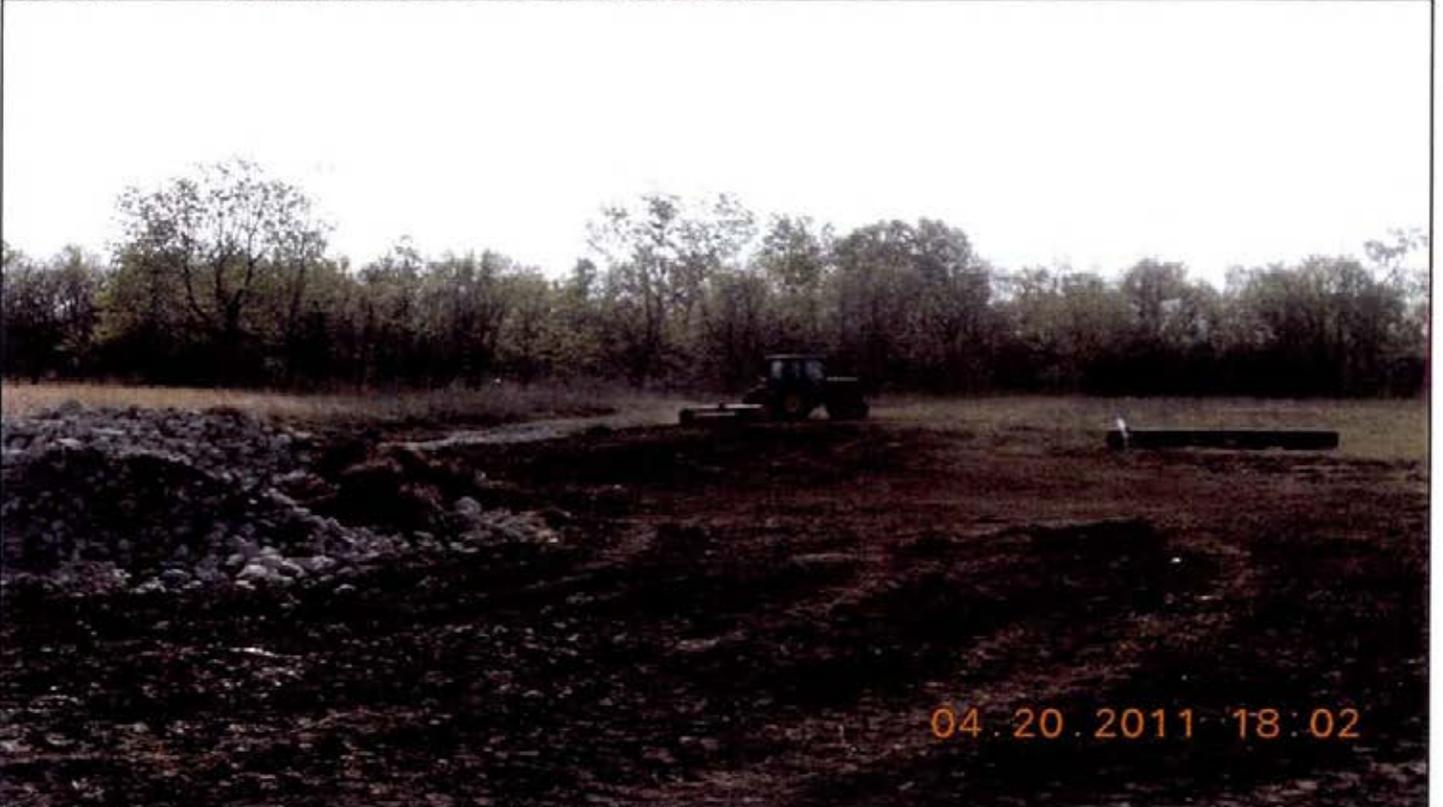
PHOTOGRAPH:	5	PHOTOGRAPHER:	RR
DATE:	20-Apr-11	TIME:	1704
PROJECT:	8-Acre Cap Repair Work Cherryvale Kansas April-May 2011		
SUBJECT:	Two excavated areas of southern section of 8-Acre Cap

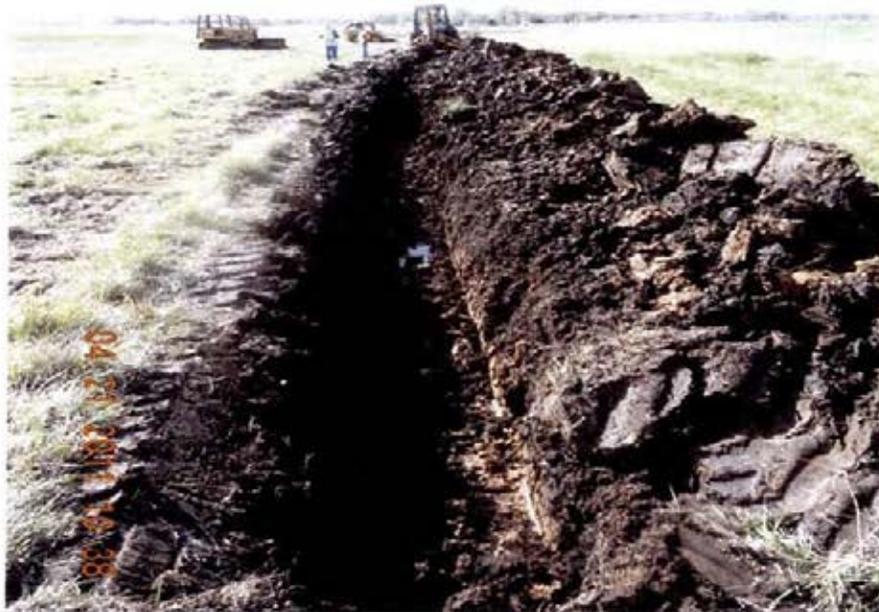
PHOTOGRAPH:	7	PHOTOGRAPHER:	RR
DATE:	21-Apr-11	TIME:	1006
PROJECT:	8-Acre Cap Repair Work Cherryvale Kansas April-May 2011		
SUBJECT:	Measurement of clean cap material over slag in 8-Acre Cap drainage swale excavation

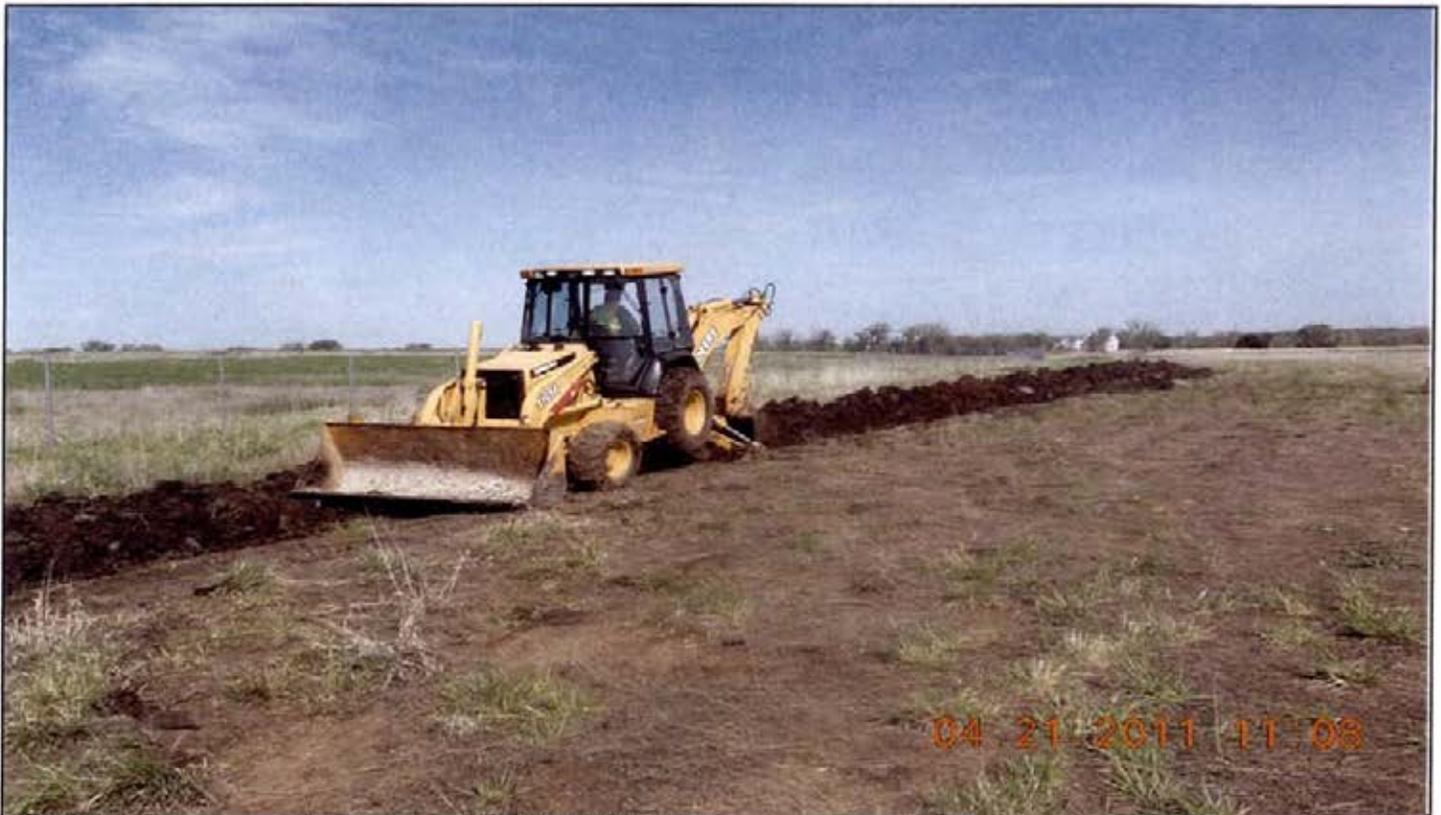
PHOTOGRAPH:	8	PHOTOGRAPHER:	RR
DATE/TIME:	21-Apr-11	TIME:	1038
PROJECT:	8-Acre Cap Repair Work Cherryvale Kansas April-May 2011		
SUBJECT:	Excavation of 8-Acre Cap drainage swale

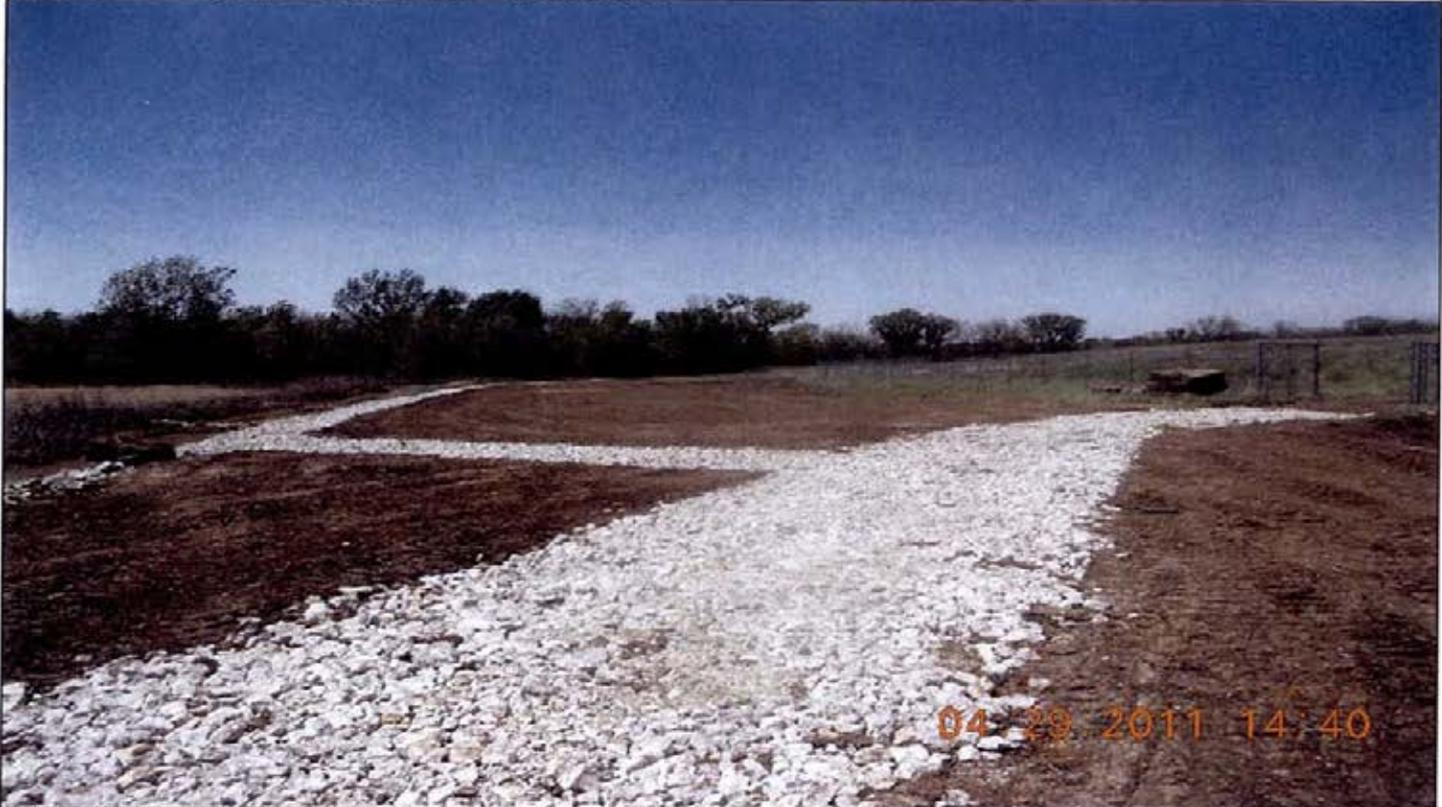
PHOTOGRAPH:	15	PHOTOGRAPHER:	RR
DATE:	29-Apr-11	TIME:	942
PROJECT:	8-Acre Cap Repair Work Cherryvale Kansas April-May 2011		
SUBJECT:	Repair of erosional rills on north side of ODA

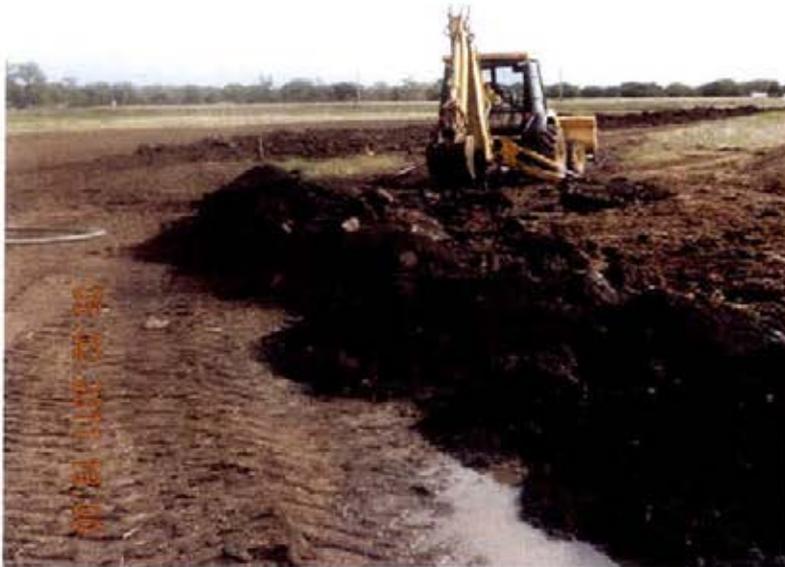
PHOTOGRAPH:	17	PHOTOGRAPHER:	RR
DATE:	2-May-11	TIME:	1745
PROJECT:	8-Acre Cap Repair Work Cherryvale Kansas April-May 2011		
SUBJECT:	Backfill of 8-Acre Cap excavation with overburden material

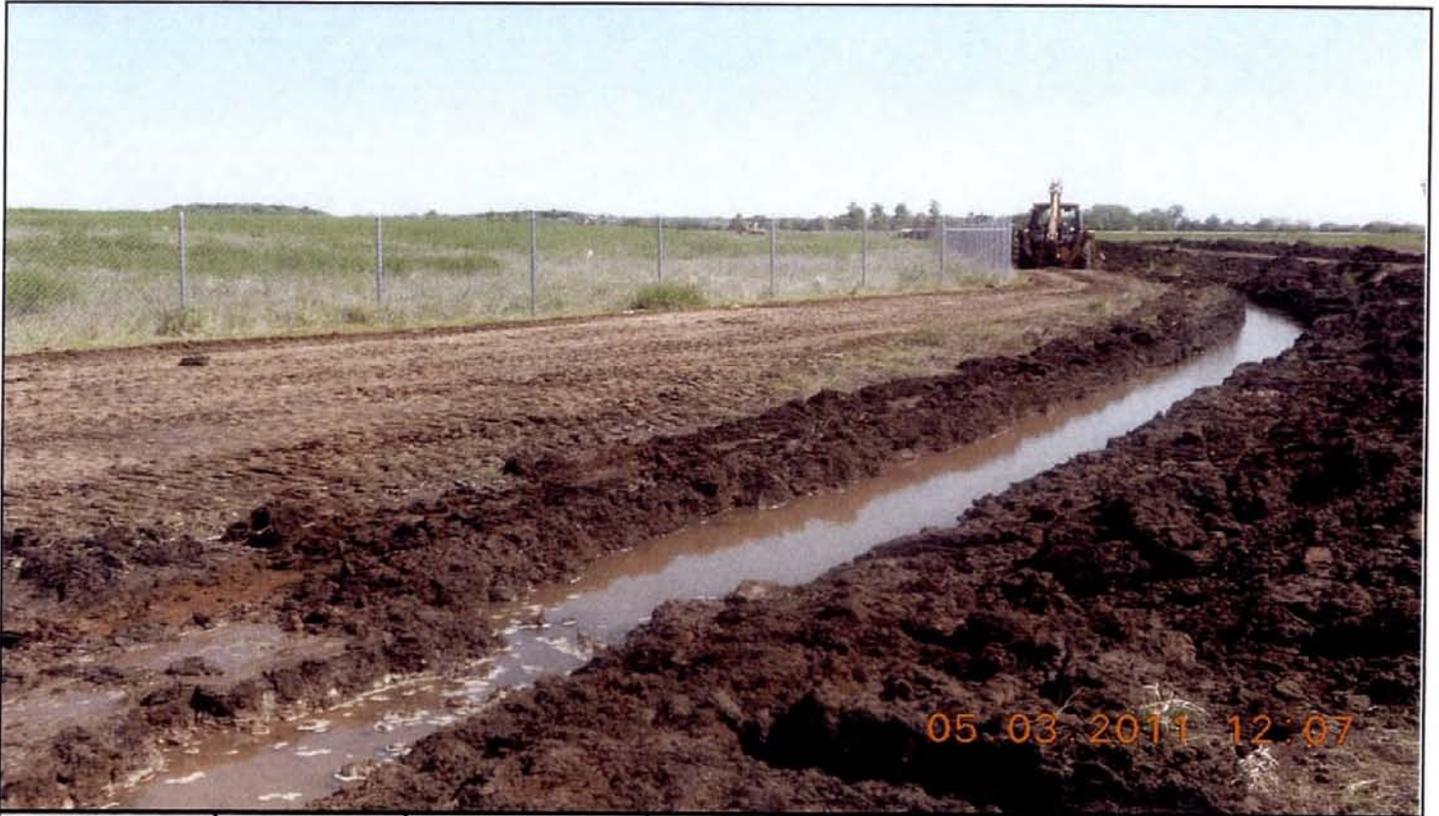
PHOTOGRAPH:	18	PHOTOGRAPHER:	RR
DATE/TIME:	2-May-11	TIME:	1800
PROJECT:	8-Acre Cap Repair Work Cherryvale Kansas April-May 2011		
SUBJECT:	Excavation of 8-Acre Cap drainage swale

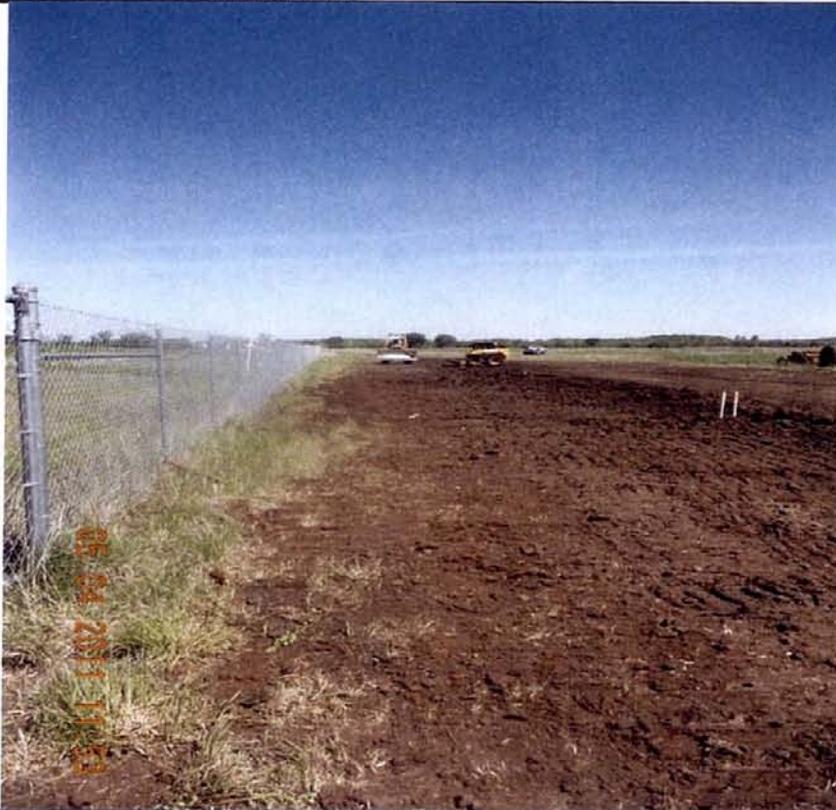
PHOTOGRAPH:	19	PHOTOGRAPHER:	RR
DATE:	3-May-11	TIME:	1207
PROJECT:	8-Acre Cap Repair Work Cherryvale Kansas April-May 2011		
SUBJECT:	Excavation of 8-Acre Cap drainage swale

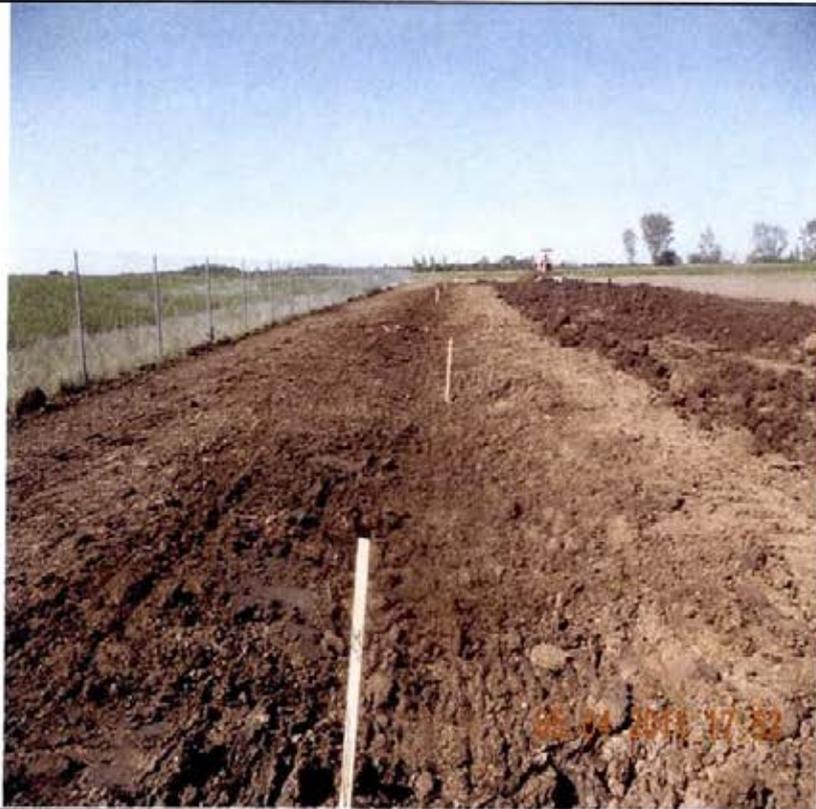
PHOTOGRAPH:	20	PHOTOGRAPHER:	RR
DATE/TIME:	4-May-11	TIME:	1153
PROJECT:	8-Acre Cap Repair Work Cherryvale Kansas April-May 2011		
SUBJECT:	Backfill of 8-Acre Cap excavation

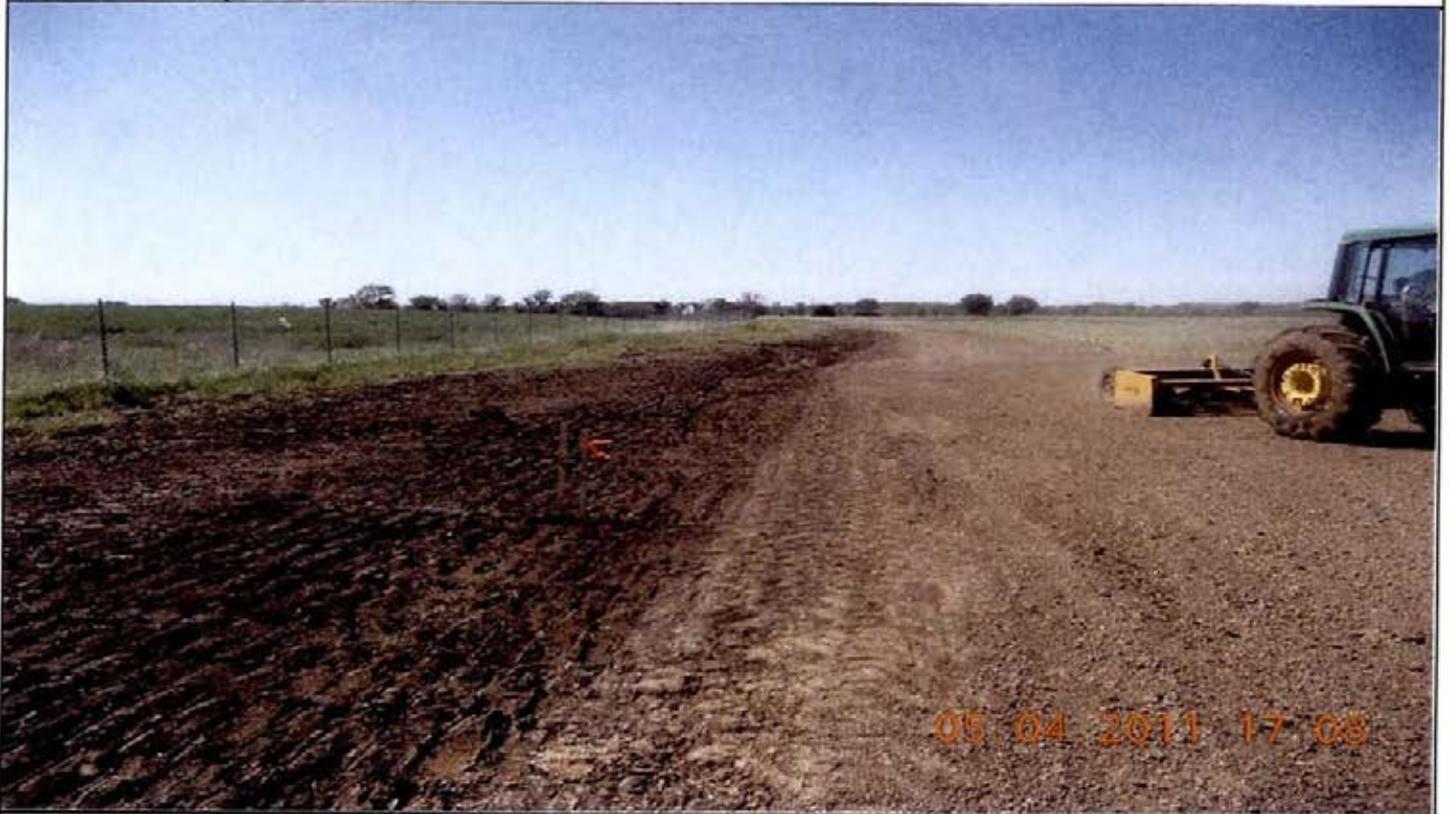
PHOTOGRAPH:	21	PHOTOGRAPHER:	RR
DATE:	4-May-11	TIME:	1752
PROJECT:	8-Acre Cap Repair Work Cherryvale Kansas April-May 2011		
SUBJECT:	Grading 8-Acre Cap

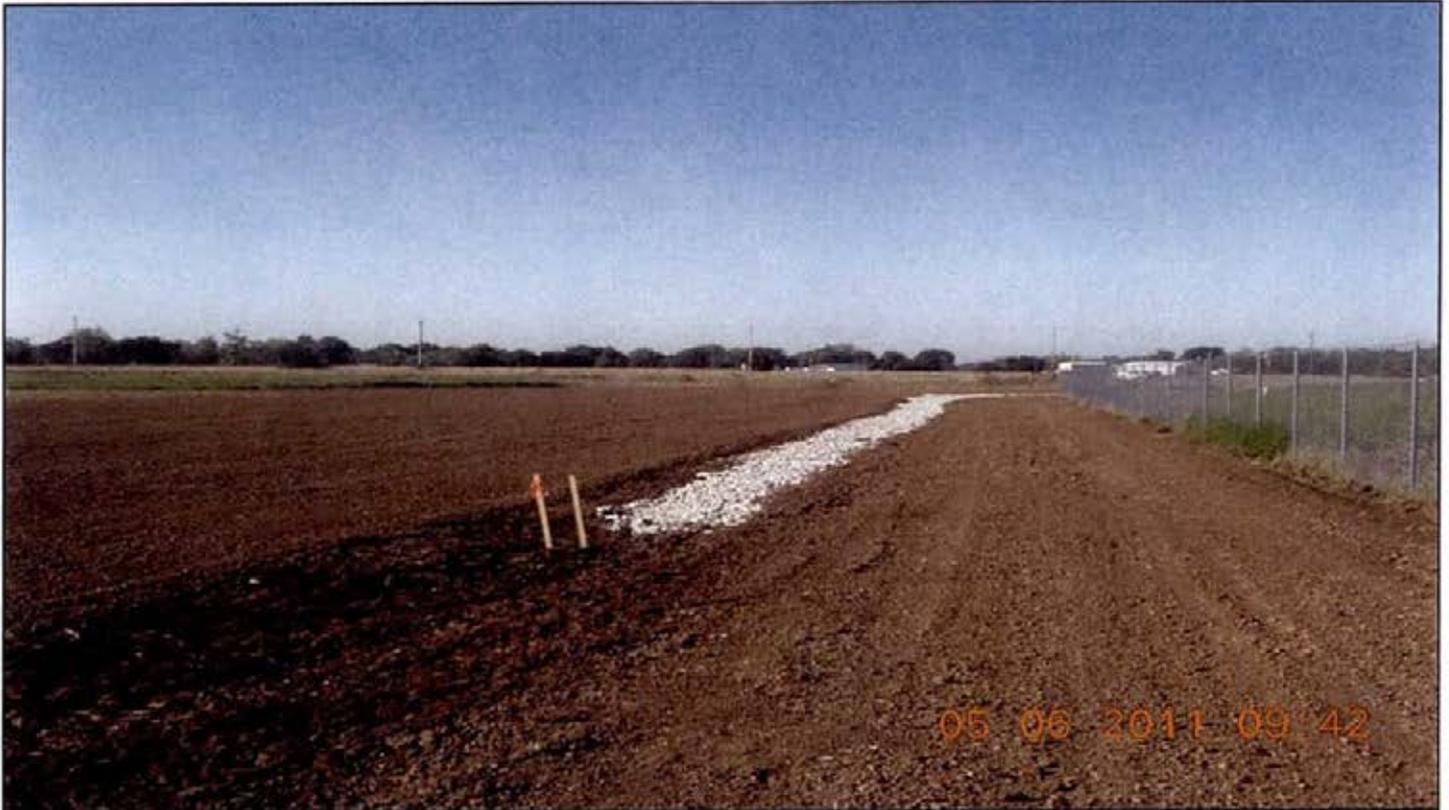
PHOTOGRAPH:	30	PHOTOGRAPHER:	RR
DATE/TIME:	6-May-11	TIME:	940
PROJECT:	8-Acre Cap Repair Work Cherryvale Kansas April-May 2011		
SUBJECT:	Repair of erosion southwest corner of ODA-outside fence at southern drainage swale

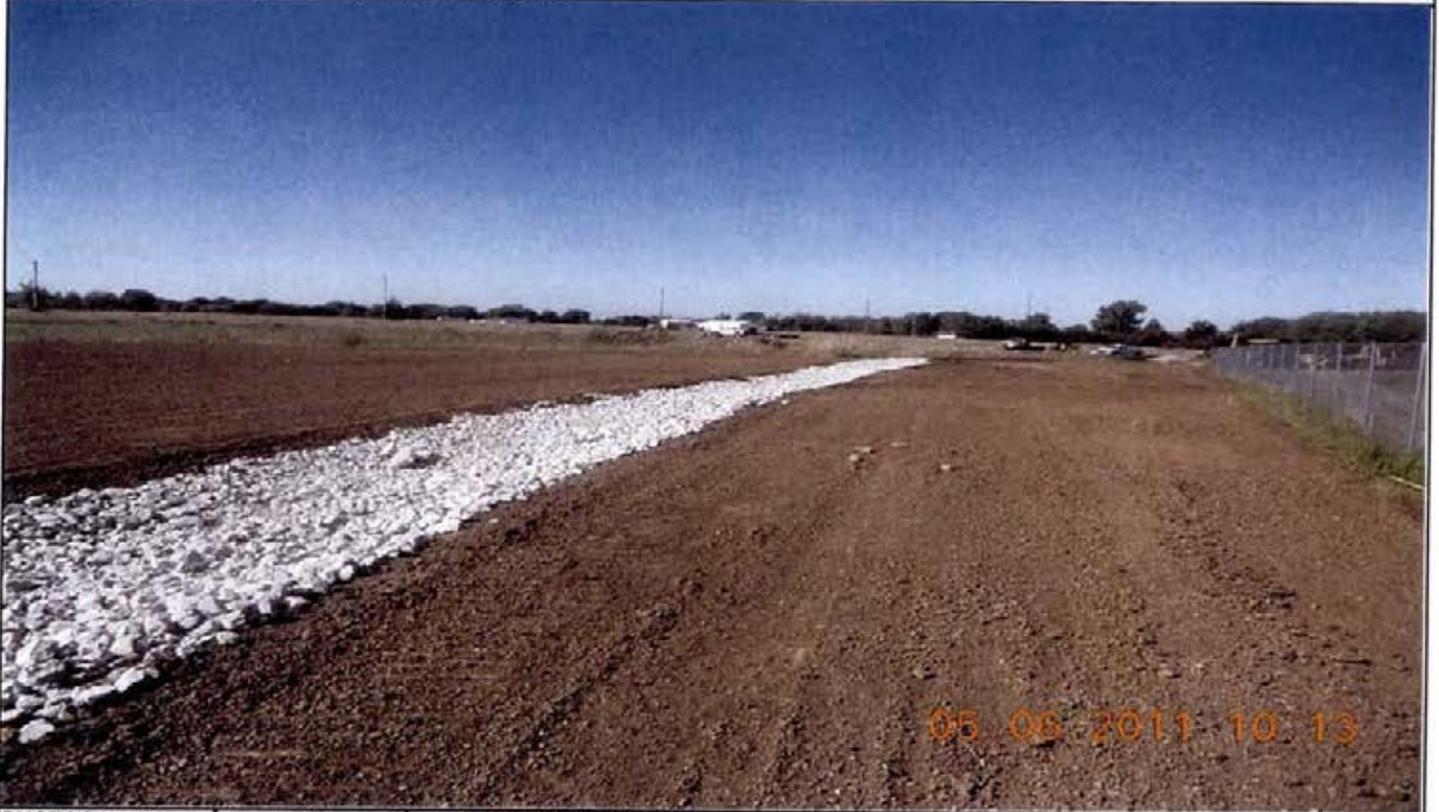
PHOTOGRAPH:	37	PHOTOGRAPHER:	RR
DATE:	6-May-11	TIME:	950
PROJECT:	8-Acre Cap Repair Work Cherryvale Kansas April-May 2011		
SUBJECT:	Repairs being made to Wedge area
