Elevator Groundwater Containment System Constructed in Salina

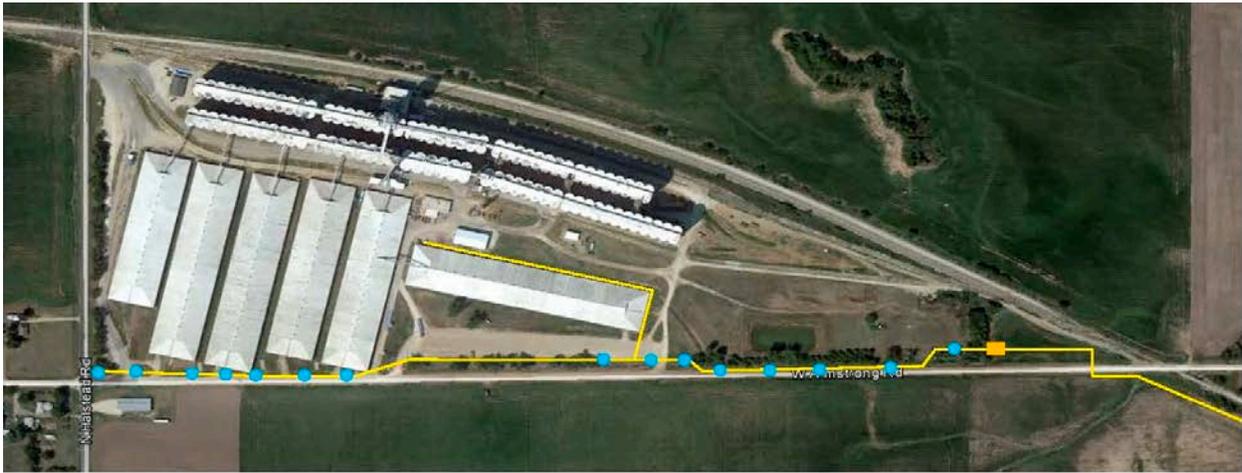
Groundwater Containment System, represented by the yellow line.

The GCS is designed control groundwater migration by pumping groundwater from 15 extraction wells (blue dots) and transferring it to an air stripper located inside the groundwater treatment building (orange square). The air stripper consists of six perforated trays creating turbulent flow and a high air-to-liquid surface area for efficient removal of volatile organic compounds. The treated groundwater is then discharged to Mulberry Creek via subsurface piping and a constructed outfall.

A half mile long Groundwater Containment System (GCS) was completed in June 2013 as an interim remedial measure to capture contaminated groundwater migrating from the grain elevator. The objective of the GCS is to maintain hydraulic control of the groundwater plume in the vicinity of the down-gradient property boundary through active extraction, treatment, and discharge.

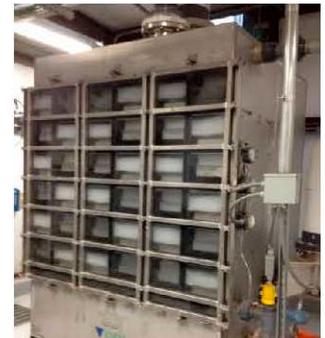
An air stripper inside the treatment building.

The GCS has operated continuously since starting up in June 2013. Initial performance data indicate the system successfully depresses the groundwater surface, resulting in a significant zone of containment along the southern property boundary and preventing off-site migration of contaminated groundwater.
