RE: Koch Nitrogen Company – Dodge City, Kansas
EPA ID NO. KSD044625010
Soil Sampling – Andco Overflow and Recovery Well Pipeline Fracture Sites

Sampling and Analysis Plan

Andco Clarifier Basin Overflow and Pipe Fracture Groundwater Release

**KOCH NITROGEN FACILITY
DODGE CITY, KANSAS**

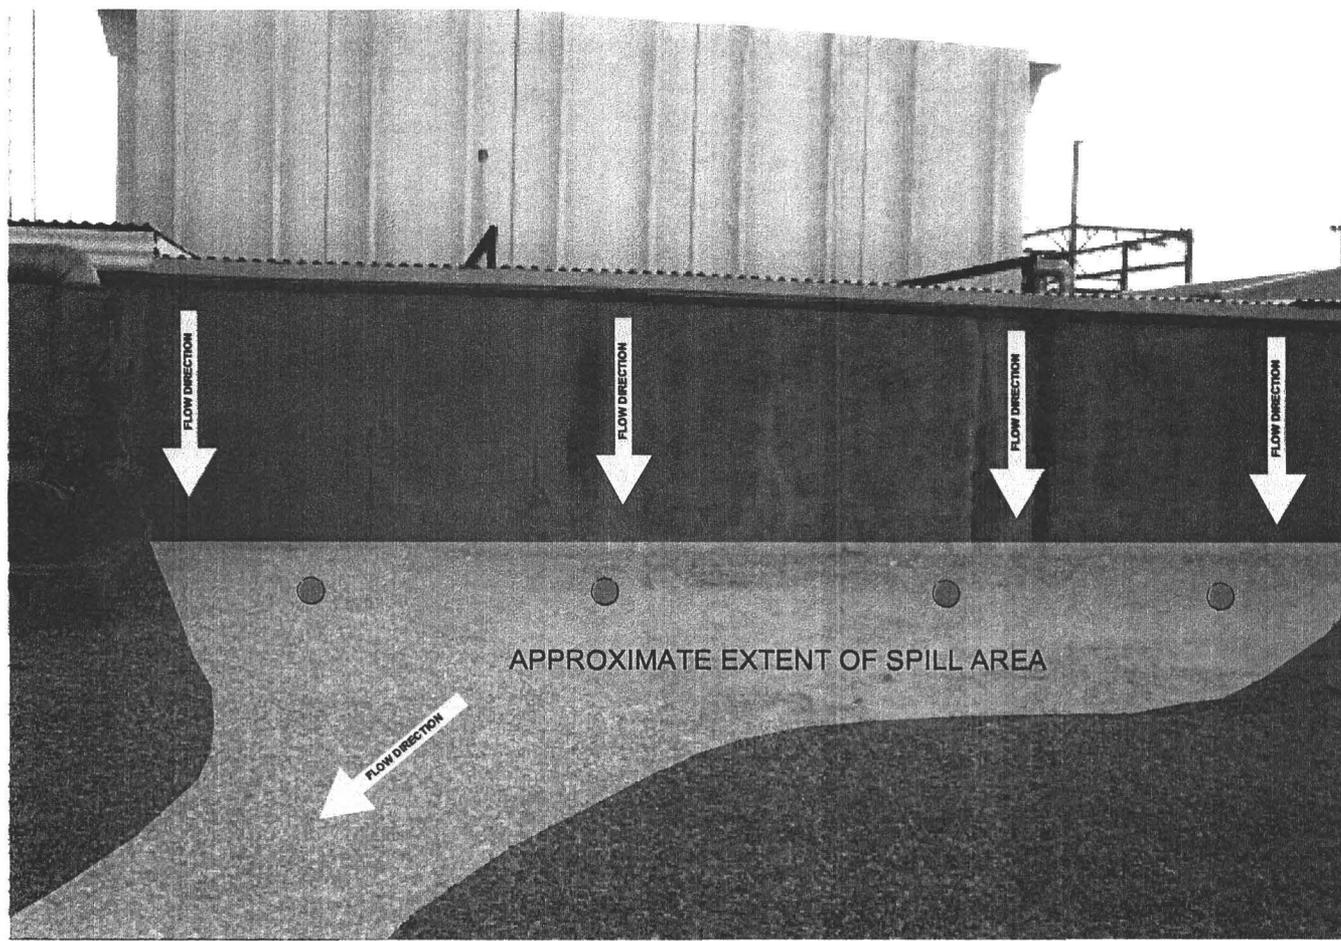
GeoStat	
PROJECT NO.	FIGURE NO.	2	
DATE.	JULY 2005	FILE NO.

VIEW OF EAST SIDE OF CLARIFIER BASIN AND SPILL AREA

OVERFLOW AREAS, FLOW DIRECTIONS, AND SAMPLING LOCATIONS

The Koch Nitrogen Plant (KNC) experienced two minor groundwater spills during 2005. This plan addresses these two spills. On June 24, 2005, approximately 1,000 gallons of recovered groundwater was released (overflowed) from the Andco Clarifier Basin (Figure 1 and 2). The release occurred as the result of a shutoff malfunction during installation of the Bogner's potable water line. An area operator noticed the overflow and immediately took action to stop the release by putting the recovery system in manual override to shutdown the pumps.

Four composite samples will be collected in the upper soil horizon (0 to 6 inches) at each sampling location (Figure 2 and Figure 3). Composite samples will be thoroughly mixed and placed into appropriate sample containers prior to shipment to the laboratory for analysis. All applicable health and safety procedures associated with the Koch Nitrogen Plant will be strictly followed during all sampling activities.
